R2R Program & Cyprus

***Treating a High Risk
Infrastructure Site
On Cyprus Road Network***

Brussels, Sept 2009

Black Spot On Intercity Lakatamia - Deftera Road Network (1)

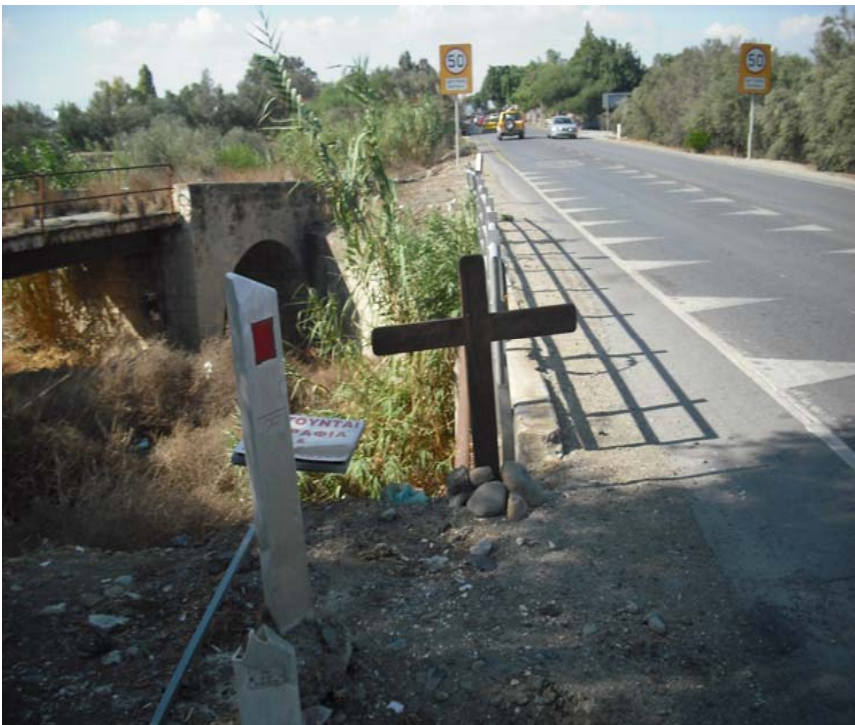
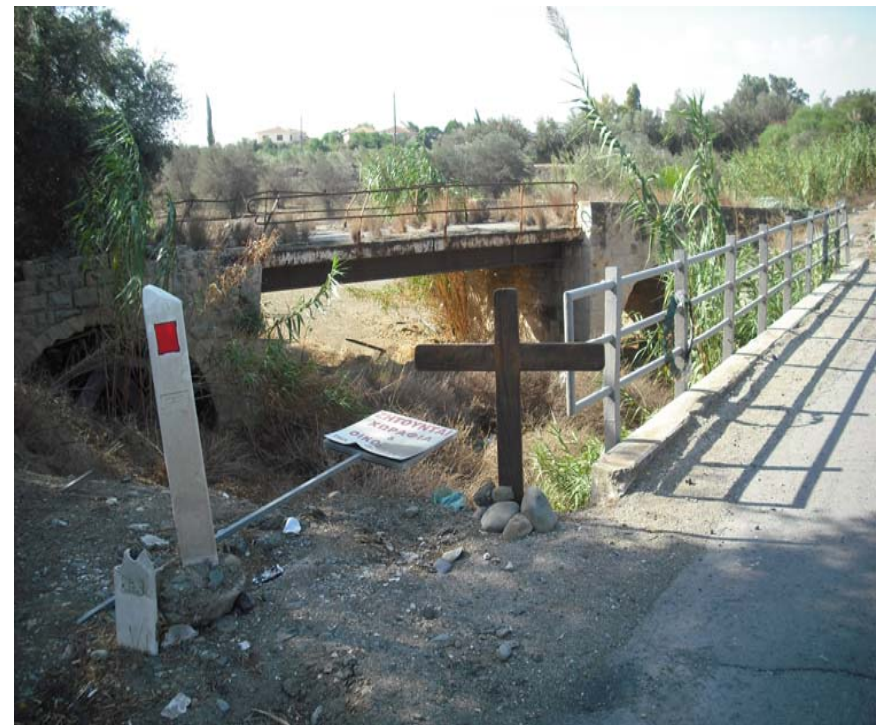
Type Of Black Spot

This “Black Spot” is a 1,5 km road which links Lakatamia town with Deftera village and it is a section of the Arch. Makariou III main Avenue. It is now identified as a black spot firstly by Ministry Of Communications And Works and by the Police Research Department because of the rate and seriousness of occurring accidents (*2 deaths only in 2008*).

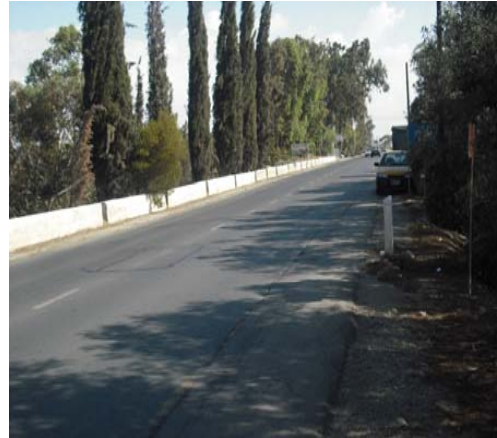
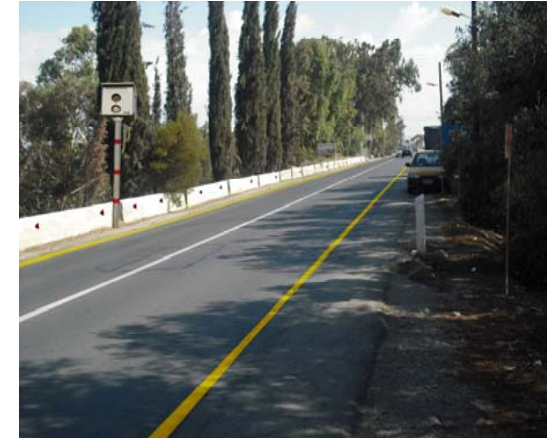
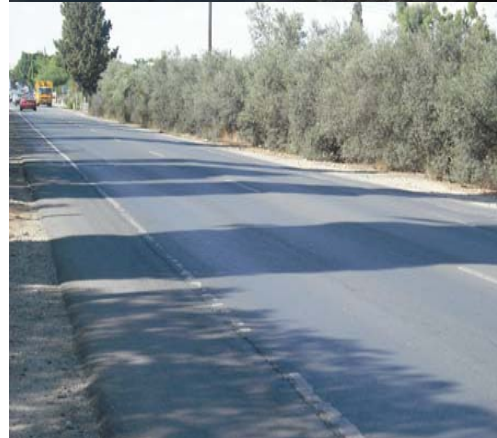
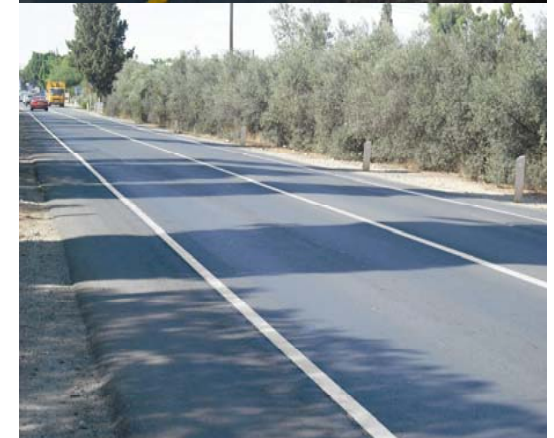
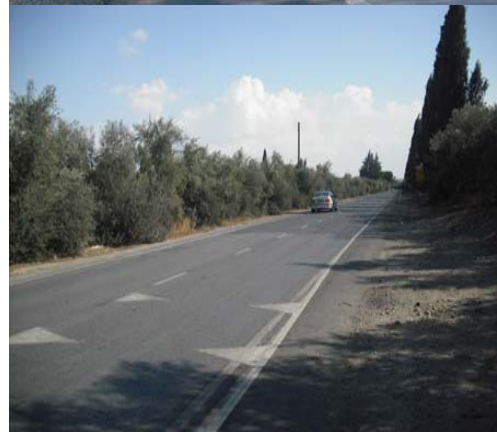
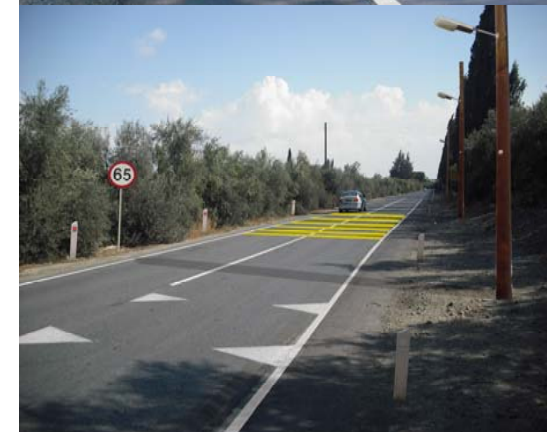
(1)

(Virtual Photos Of the Proposed measures)

- Creating new, clear and visible road markings
- Addition of proper traffic signs indicating the location of the junctions
- Relocating and adding more signs about the speed limit.
- Installing traffic cameras approximately on the middle of the road distance

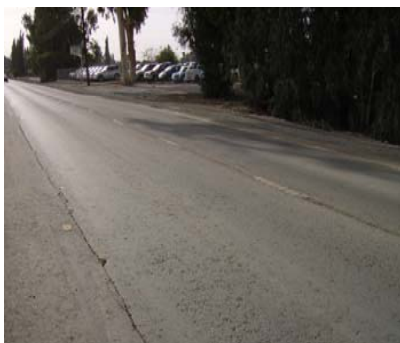
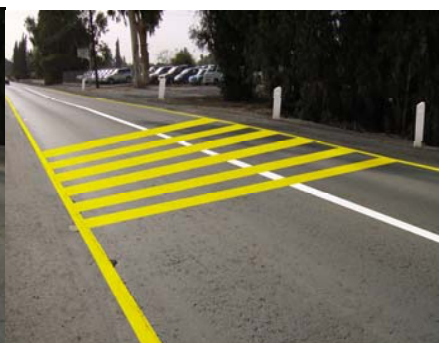
(Virtual Photos Of the Proposed measures) (2)

- Installation of lights along this section of the road
- Road shoulders should be cleaned, in synergy with high levels of maintenance all year round
- Improving the markings of the junctions
- Implementing the use of rumble strips as a way of warning drivers

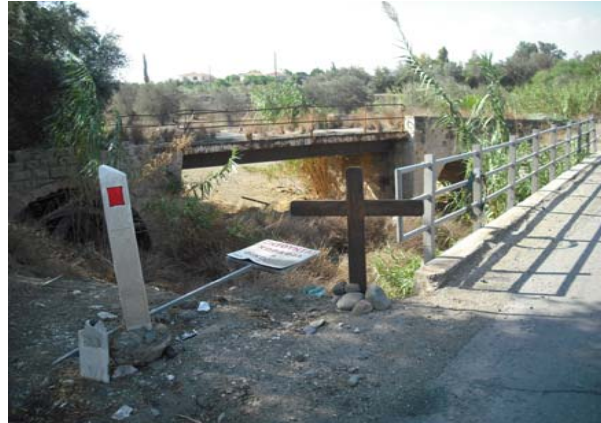
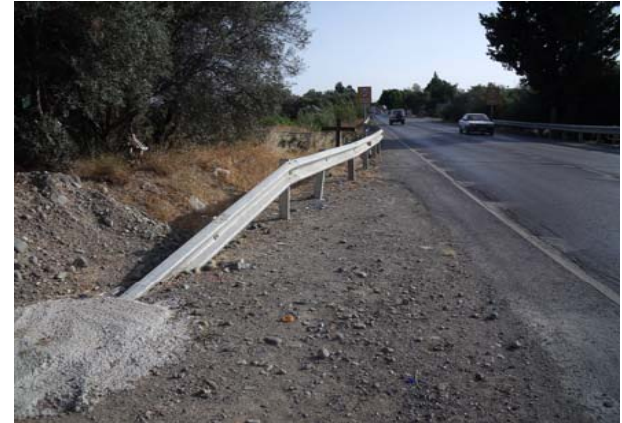
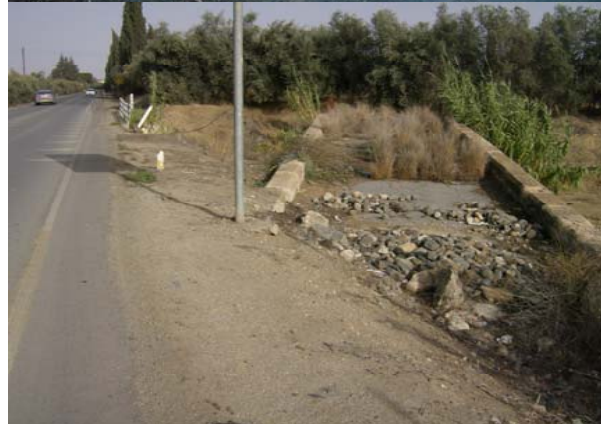
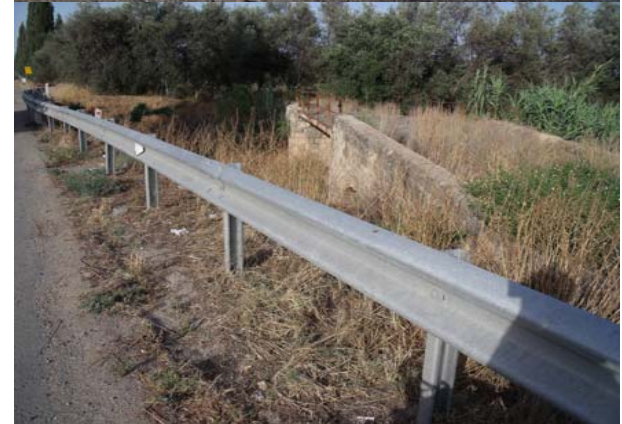
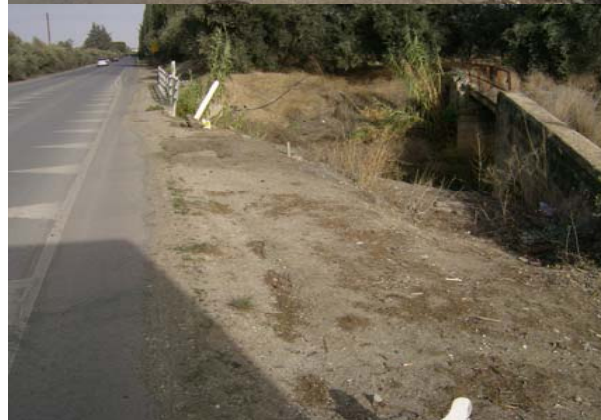
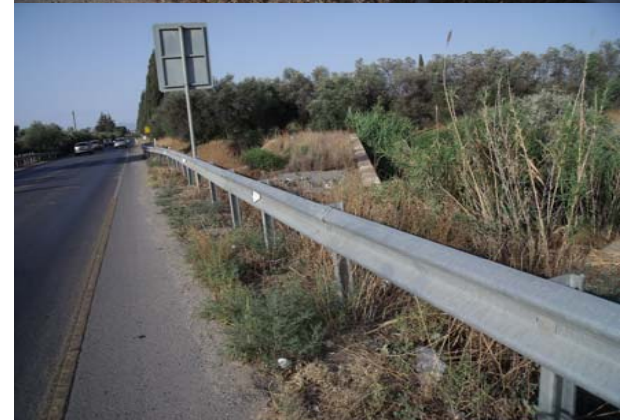
(1)

Current Situation

- Installment of metal guard rails - crush barriers so that road forgiveness is implemented
