Presentation of the projects in Chalkidiki and in Xanthi city

Presentation of the site in Chalkidiki

Presentation of the site in Xanthi City

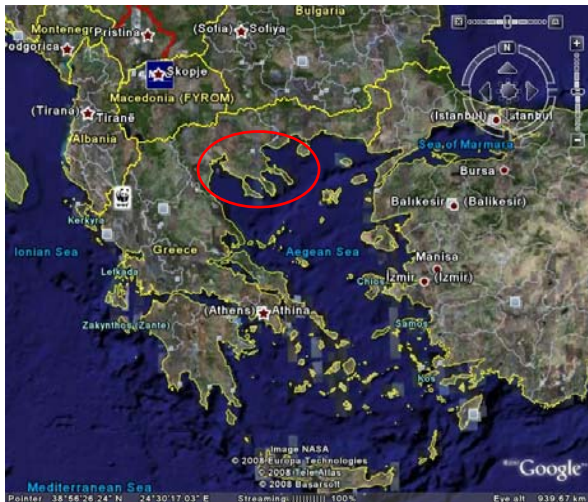
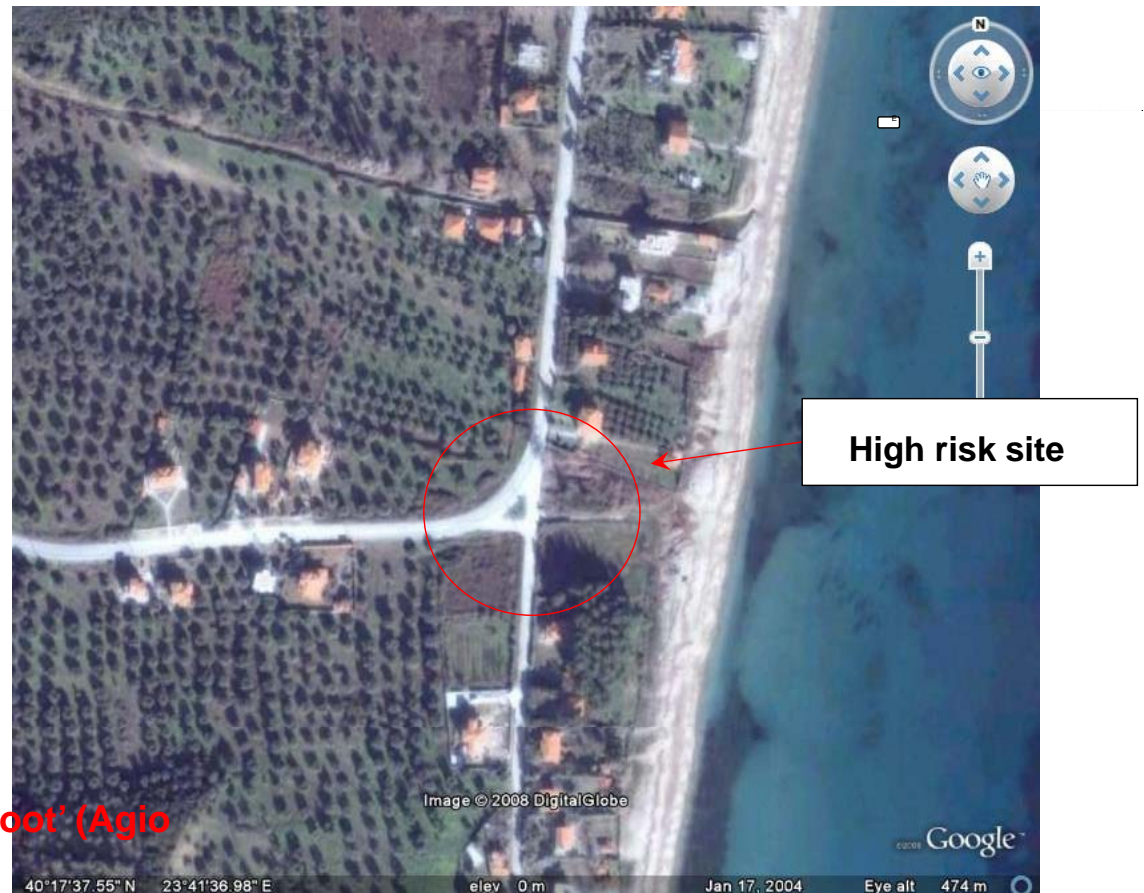
The high risk site is located in a built-up area named 'Akti Salonikiou', which tends to get very busy during the summer months as it is crossed by the main road that links the 2nd and the 3rd 'foot' (Peninsula) in Chalkidiki, the most popular summer resort in Northern Greece.

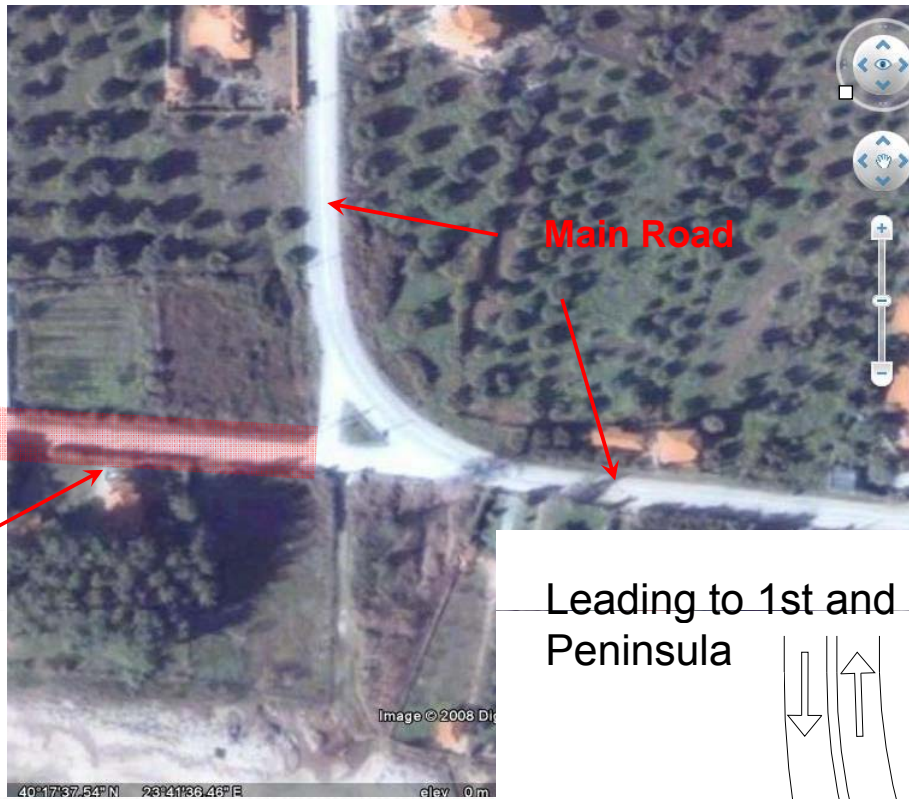
The junction

Secondary Road

Leading to 1st and 2nd Peninsula

Traffic flows

Leading to the local Bar and then the road becomes a dirt road

Leading to 3rd Peninsula (Agio Oros)

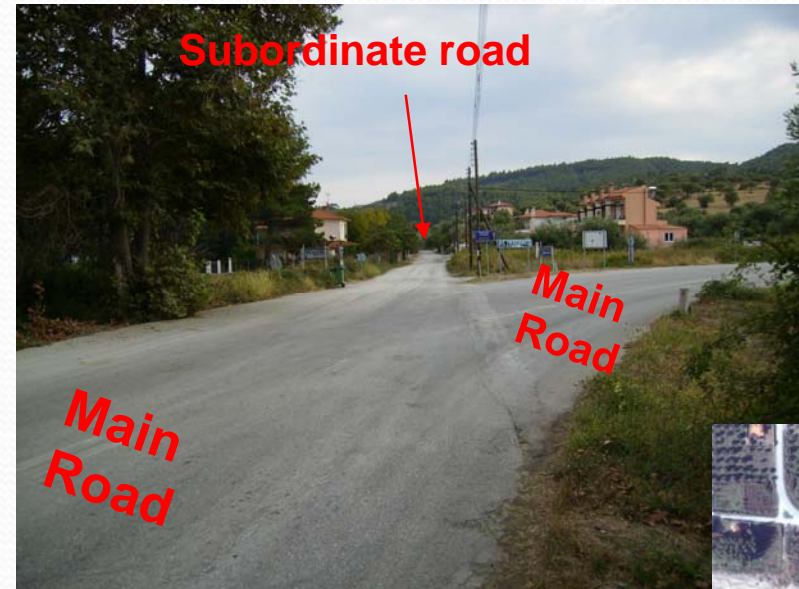
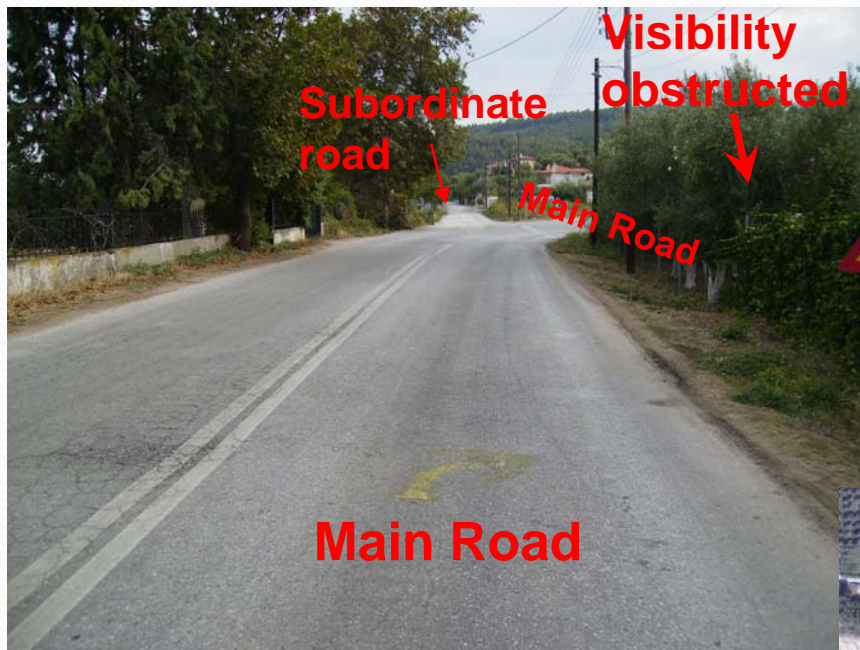
- Due to (high) vegetation on the sides of the road the curve of the main road is not visible.

- The vertical direction markings:

- At the junction only and not before it.
- There is poor maintenance of signs (graffiti rendered the signs illegible, which urged locals to refresh the signs by hand(!) and this was done in Greek only. Consequently, foreigners have no clue which way to go).

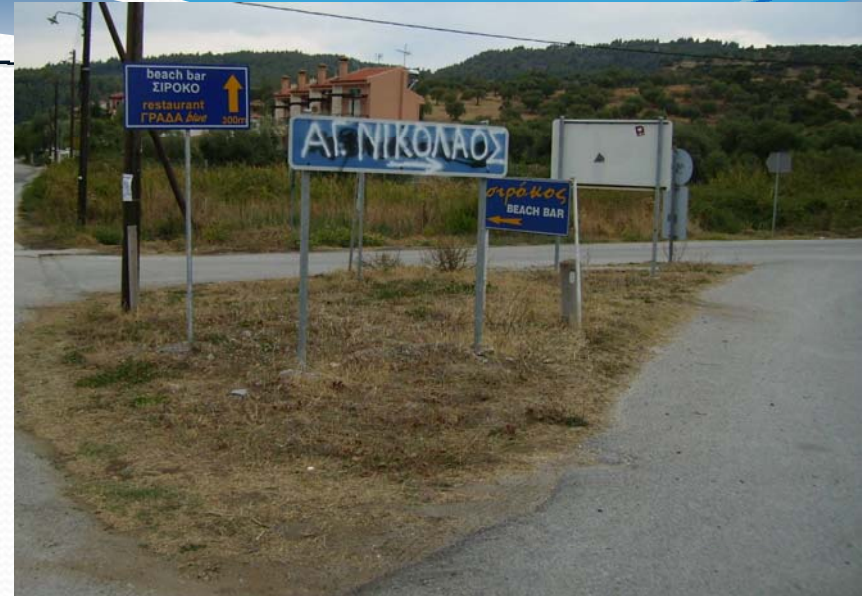
- There are 3 vertical traffic signs showing that the drivers have to pay attention, that there is a junction ahead, and the third sign showing that the main road turns right.

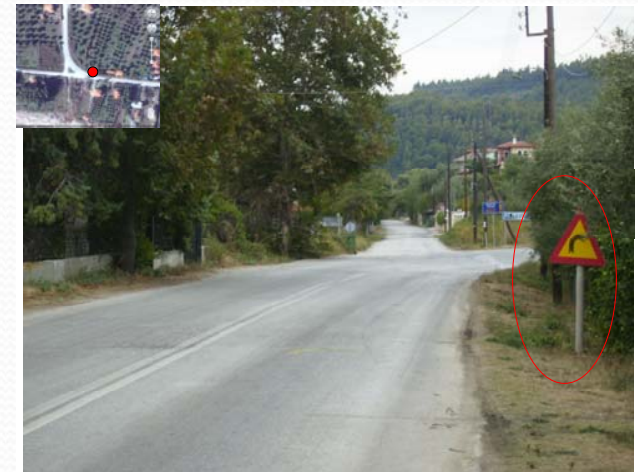
However, road users disregard these traffic signs and use their common sense, which says that:
The main road continues straight ahead and it is the secondary (subordinate) road that curves.

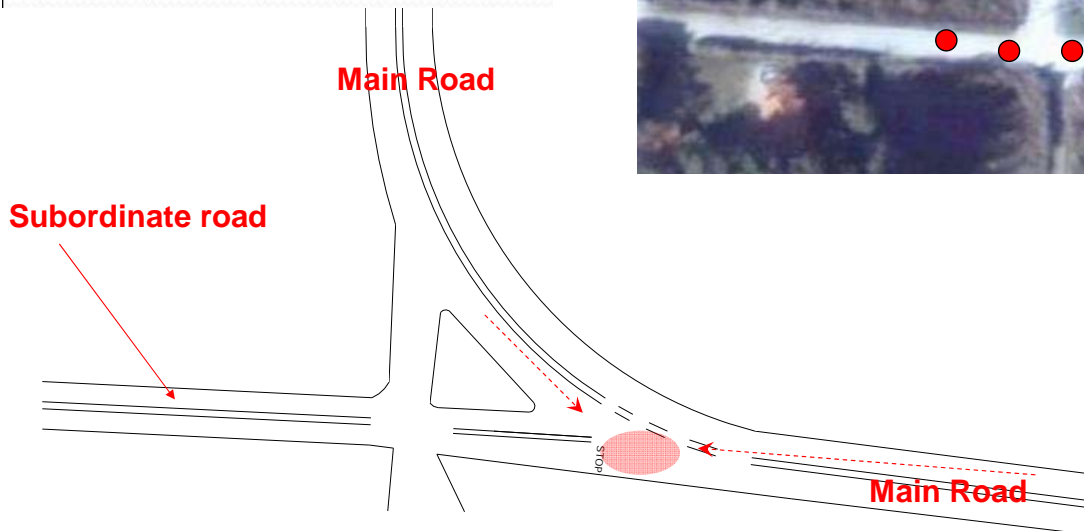
- Also drivers going the opposite direction are unsuspecting as they are on the main road, have no reason to pay attention or reduce speed in the junction and as a result collide with drivers who mistakenly continue straight ahead instead of turning right to continue to the main road.

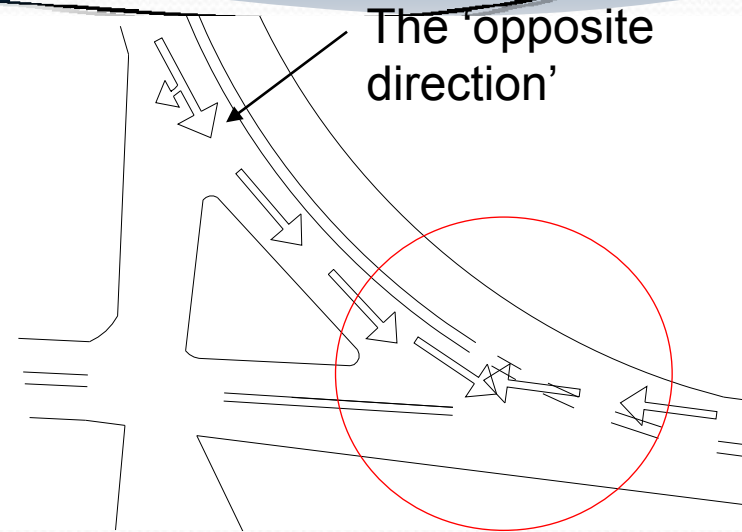
- No provision has been made for drivers coming out of the subordinate road intending to turn left.

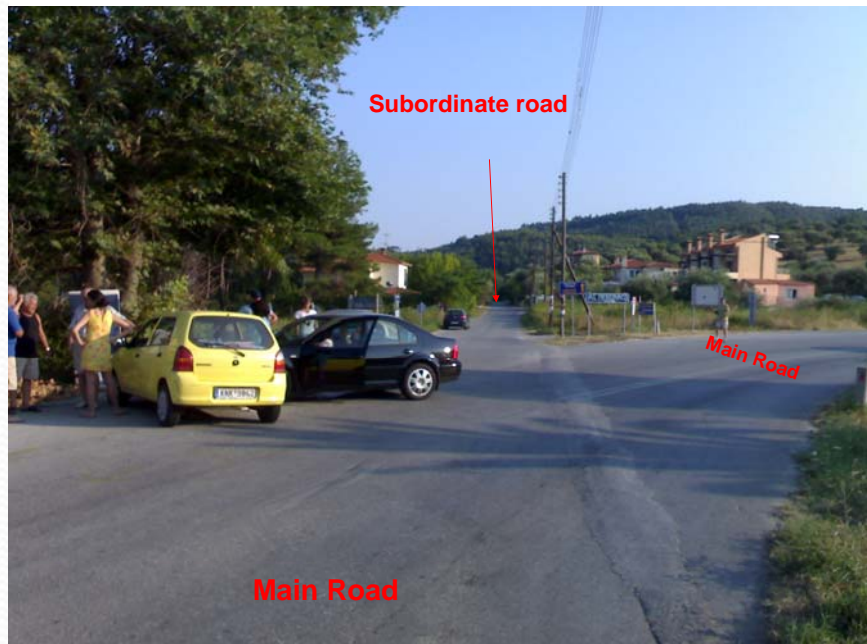
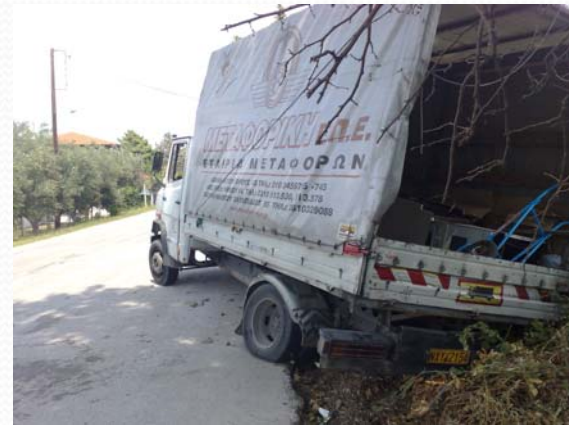
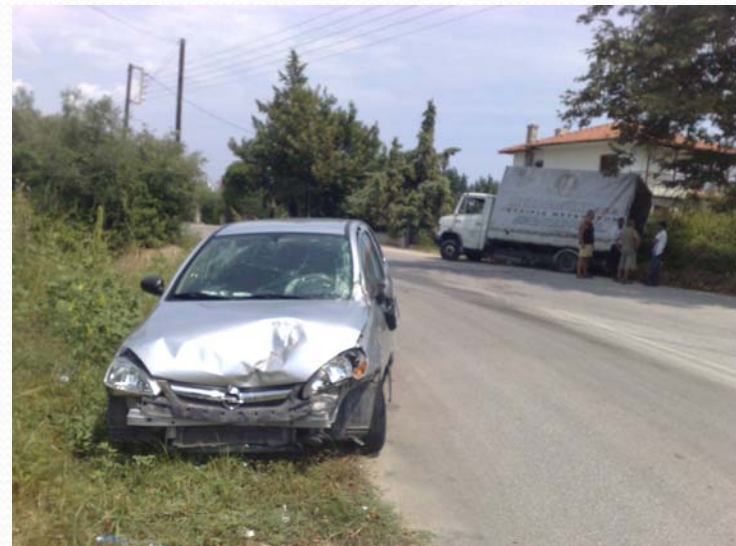
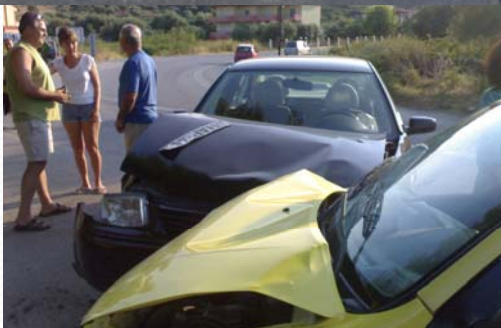
Very frequent collisions (the majority of accidents occur during the summer months, July, August, when the volume of traffic increases dramatically) resulting in injuries (more serious or less serious) but also fatal accidents when drivers exceed the speed limit (50Kph) allowed in the area.

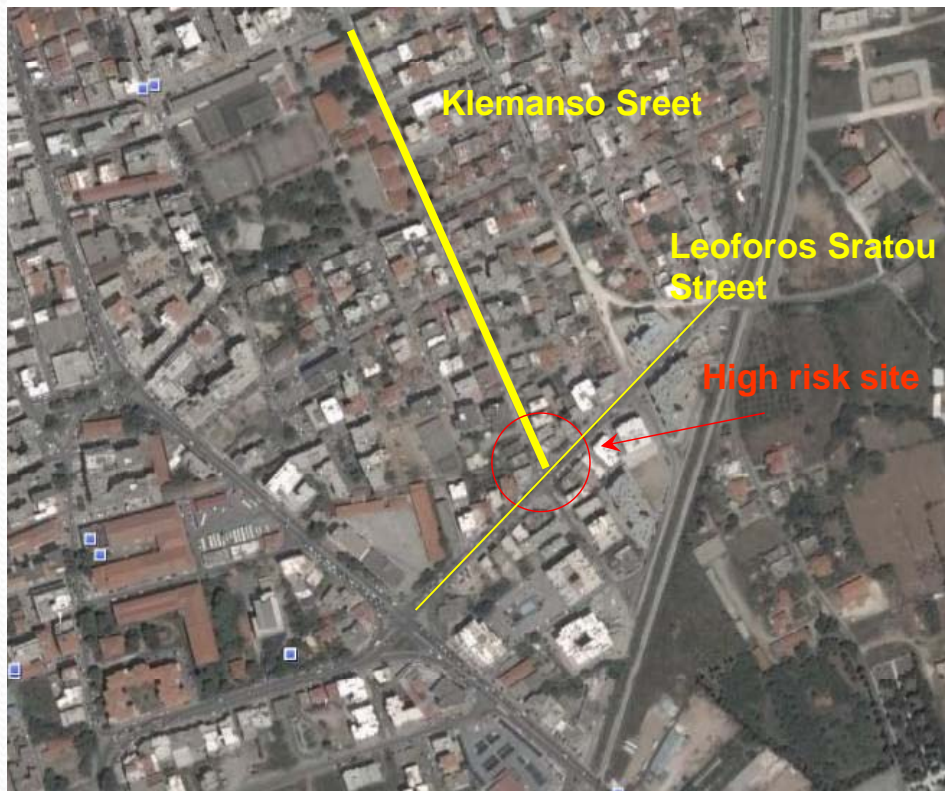
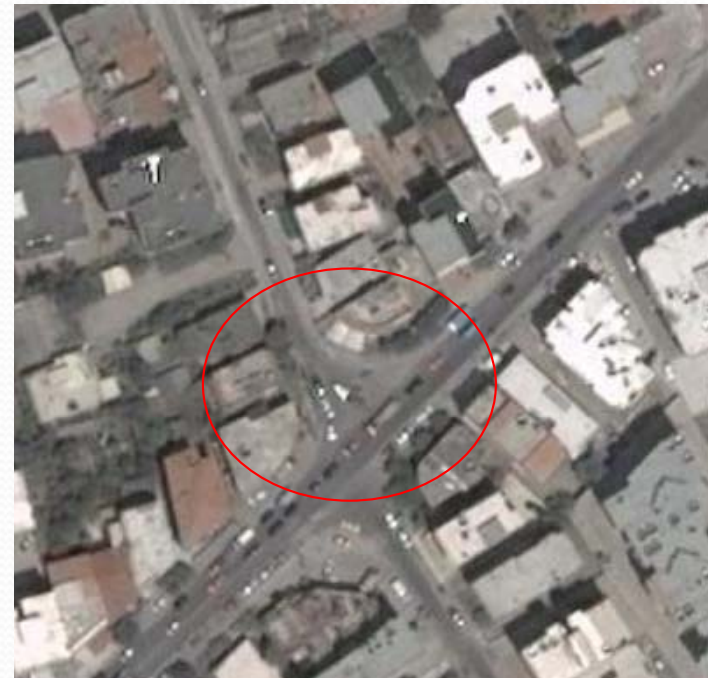
Clemenceau Street is a very busy and crucial subordinate road. It is one way street leading into Leoforos Stratou street. We can locate a high risk site at the end of the street where it meets 'Leoforos Stratou', a very important and busy main road.

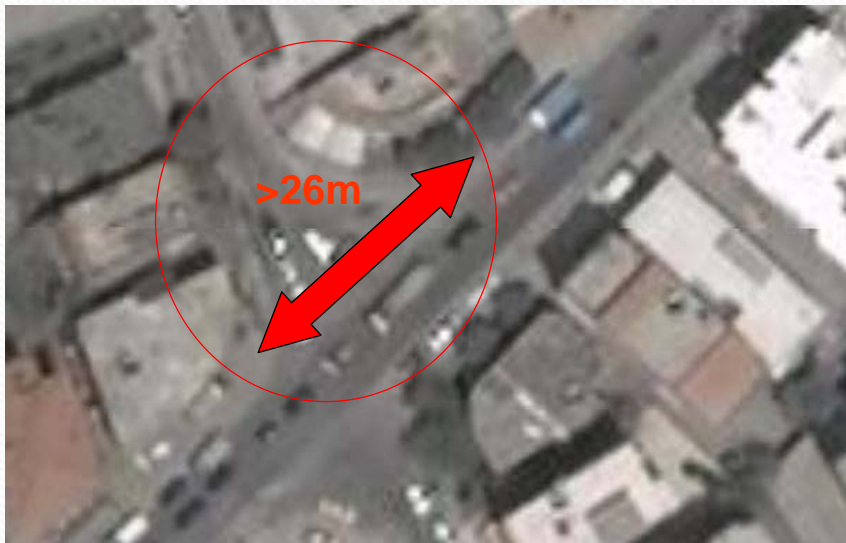
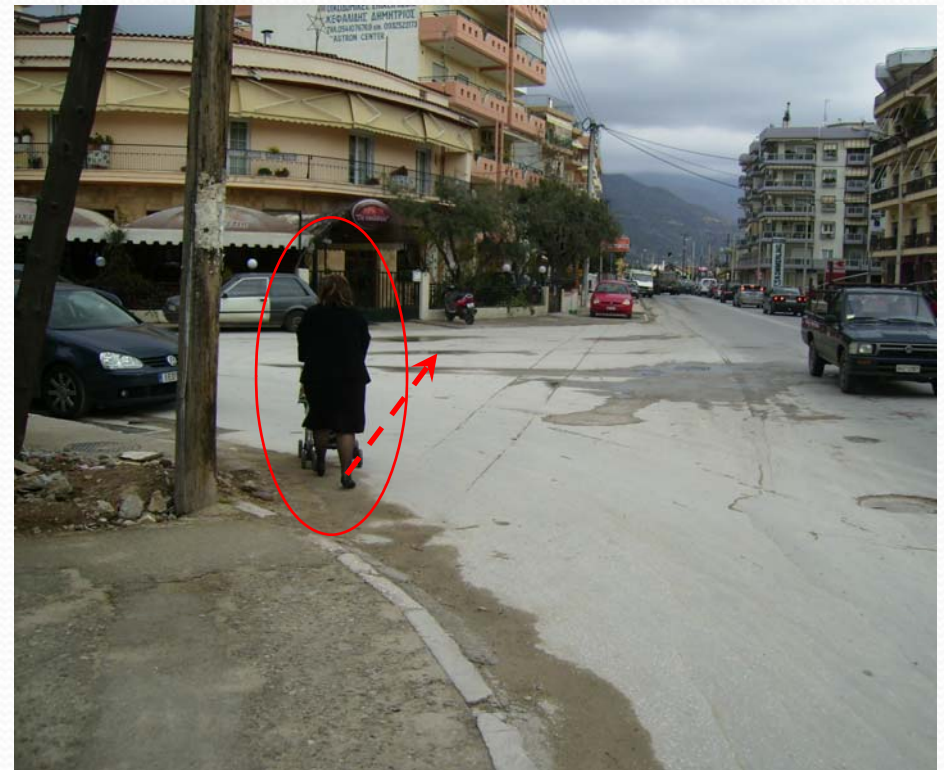
- Pedestrians have to cross an enormous distance in order to go from one pavement to the other.

The woman with the baby in the push-chair has to cross all this distance!!

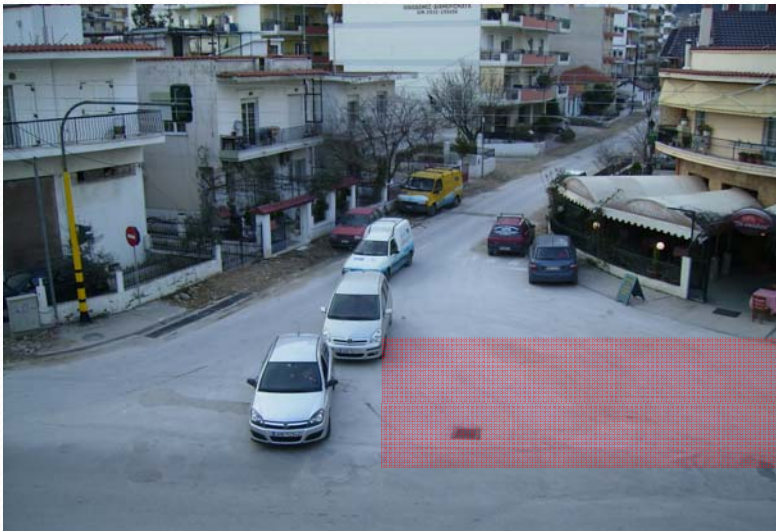
- The movements of the vehicles are not patterned and the drivers stop wherever they want.

As a result, sometimes in the day we can see pictures like that. Simultaneously 3 cars are trying to turn left. This can cause accidents. One can imagine the danger when pedestrians need to cross the spot.

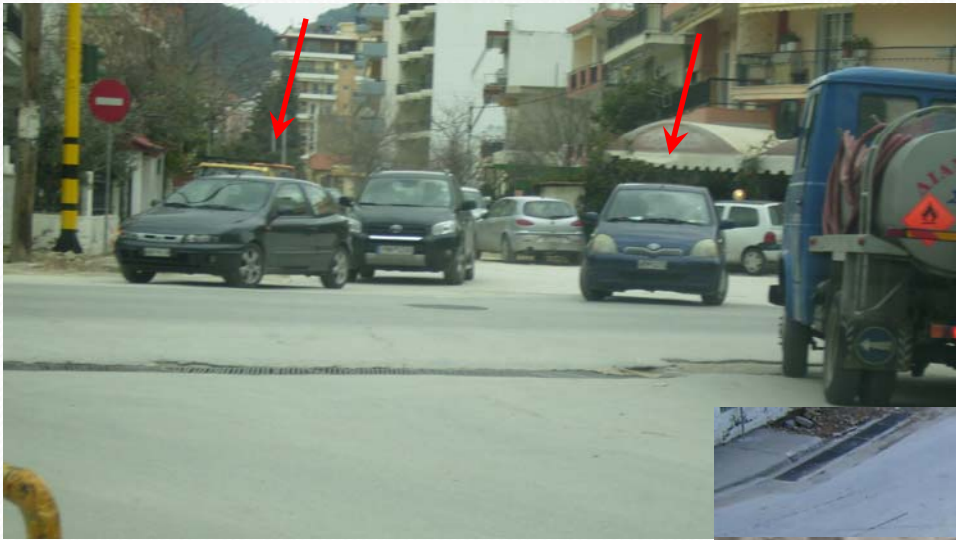
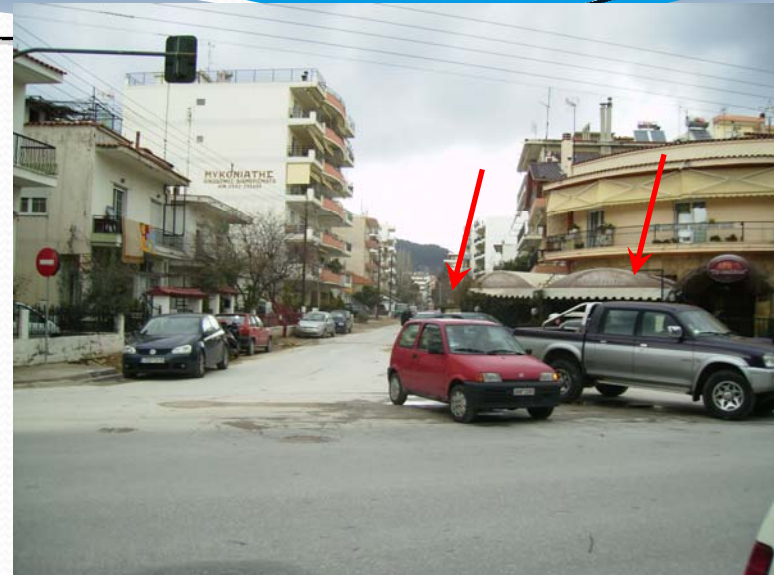
Both cars are trying simultaneously to turn into the same direction

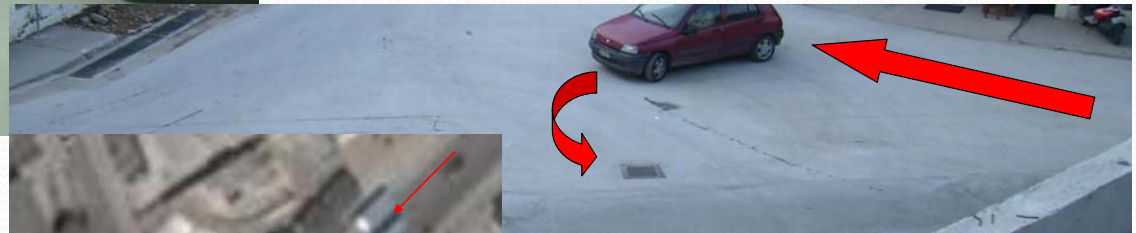
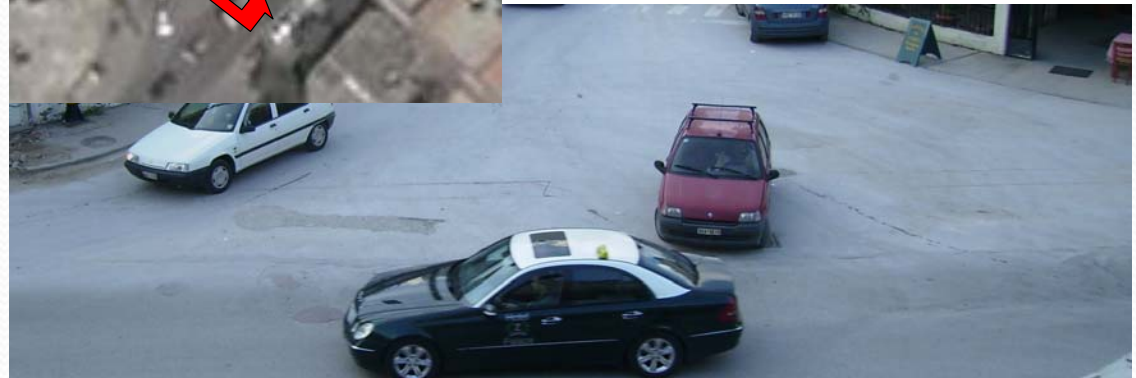
- Some other traffic violations which can cause accidents. (U-Turn)

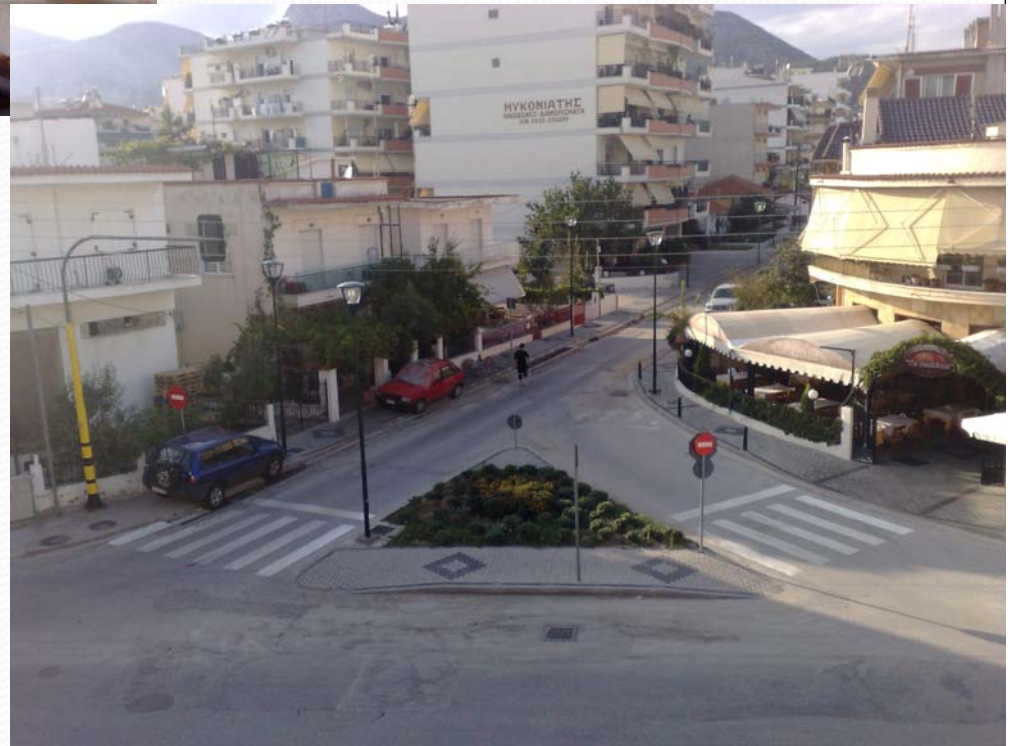
Before

**Current
Situation**
