Roads to Respect 2010, Students Progress Report

Final report, 31. July, 2011.

1 – Definition of the High risk site

1.1. Location

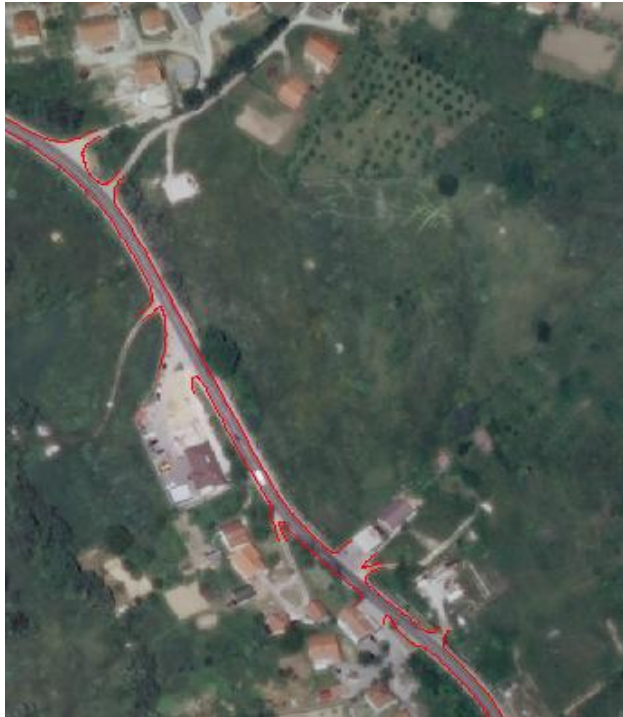
Picture 1: High – risk site

The high – risk site, that I have been treated on road infrastructure is in Vogošća, location Gornji Hotonj, chainage 111 +114 km. Vogošća is a secondary suburb and municipality of

Vogošća is one of two entrances to Sarajevo and therefore there is an enormous flow of traffic, especially at peak hours.

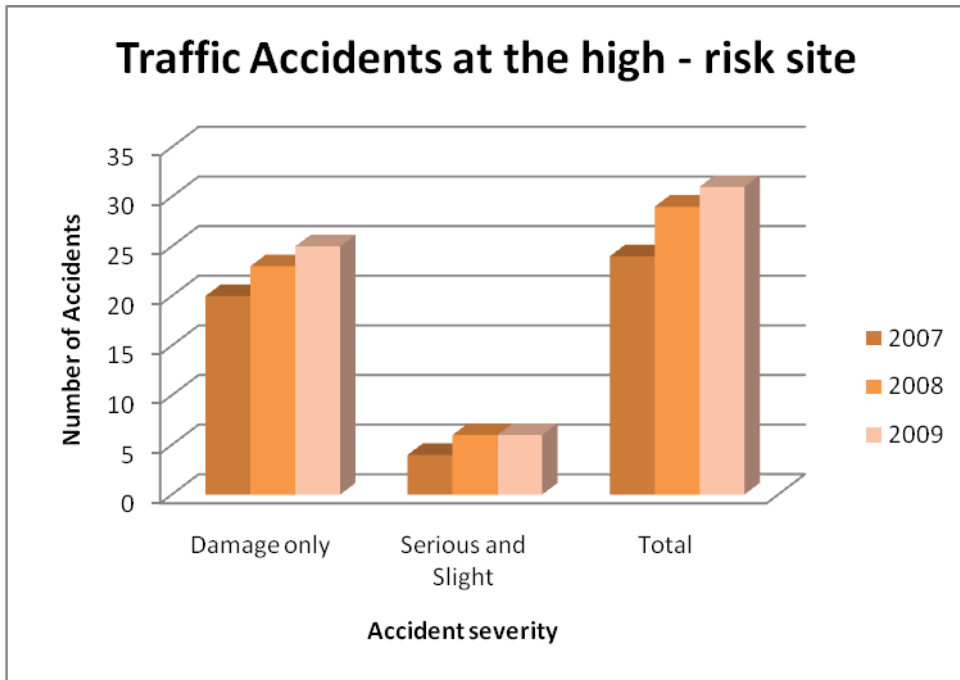
Diagram1: Traffic Accidents on the main road M - 18, section Gornji Hotonj, chainage 111 +114 km

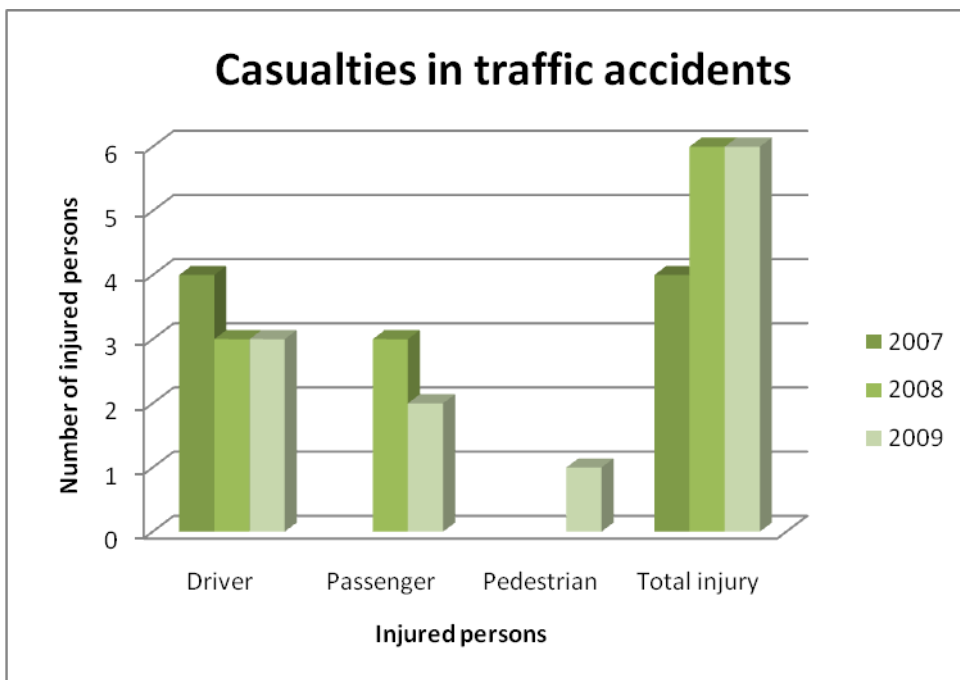
Diagram 2.: Casualties in traffic accidents

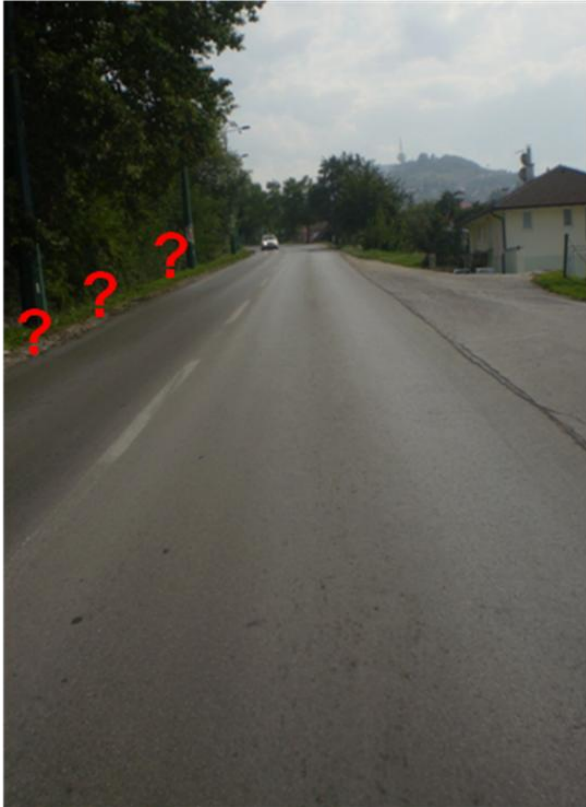
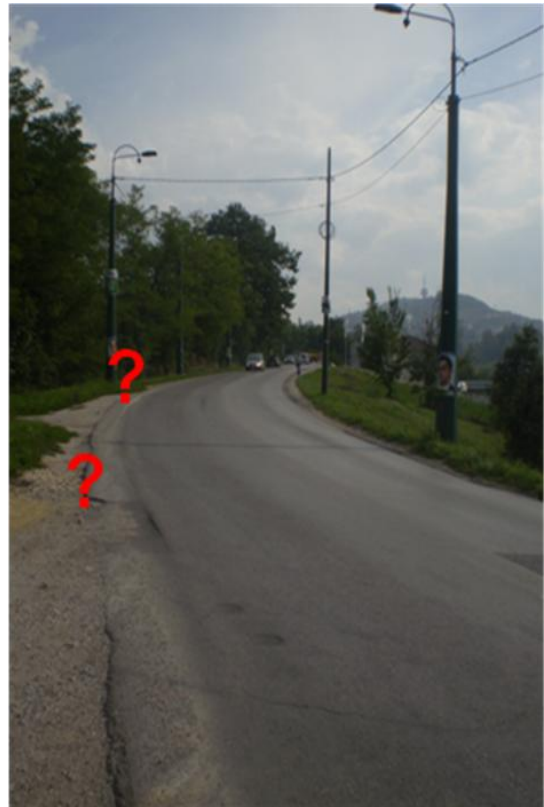
My high risk site was designed without any protective crash barrier. Furthermore, there is not enough space to avoid a potential car crash. If vehicles get off from the road, it will hit a steel poles for lighting.

Picture 2.: Problem: Lack of protective crash barriers

- Installation safety crash barriers and road studs alongside of the road, which implies: update and replace the protective and pedestrian barrier, building berms (planning and alignment), planning and some partial repairs of slopes of cuttings and embankments, retaining walls, some partial repair of concrete curb.

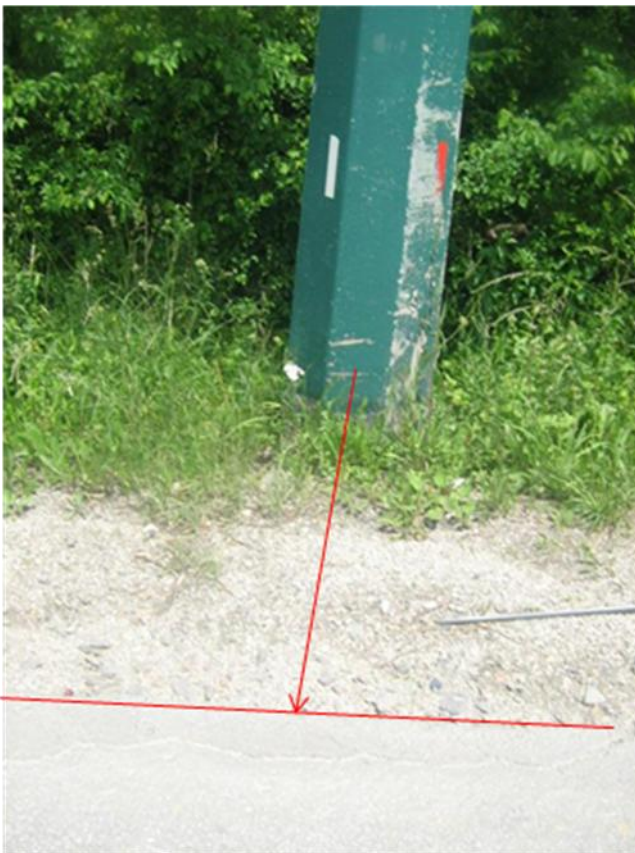
Picture 3.: Problem: Vicinity of street lighting

- Collapsible lighting columns and signs, mounted on shear bolts or made of yielding material and designed for electrical safety
- Improvement of winter maintenance

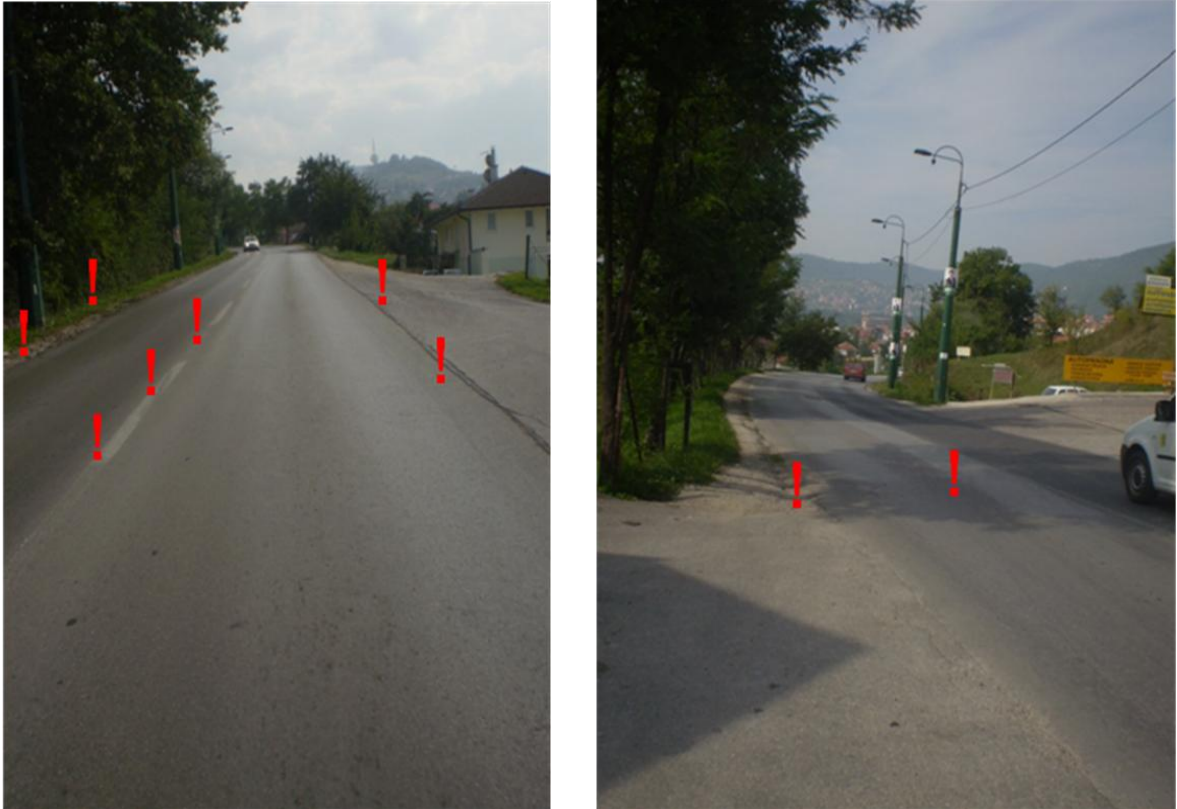
Road pavement have moreover a waved form so that in some places it gives insufficient visibility.

Picture 4: Problem: Lack of adequate road markings

- Installations road markings to avoid scarce visibility of curves, which implies: scraping the damaged wearing course asphalt pavement thickness of 4-5 cm, changing the surface wearing course of igneous units in a given locality.
- Set horizontal and vertical signs, to be more visible to all users of the road, which implies: reconstruction and development of horizontal road markings (distribution and edge line width of 15 cm), building vertical traffic signs and replacing damaged.

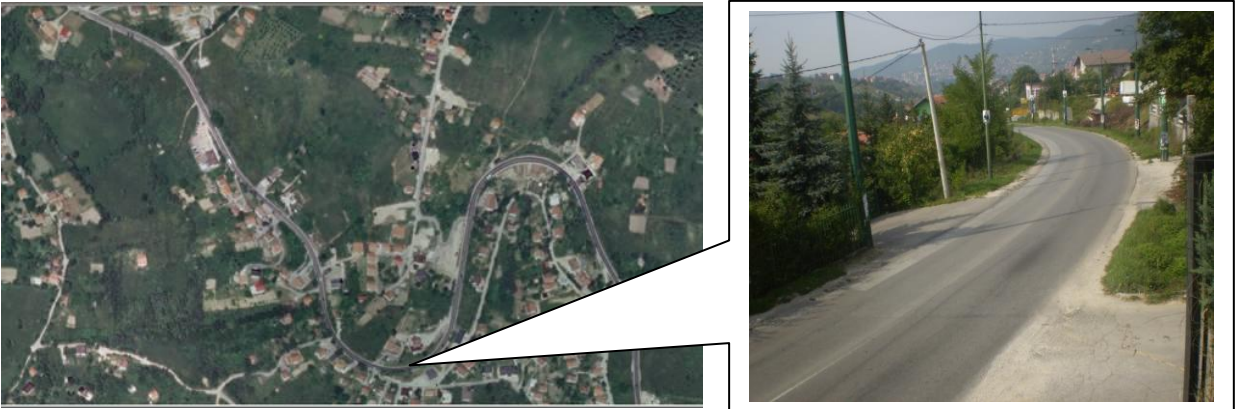
The main problems of this area are curves, lack of visibility, lack of traffic signs, inadequate marking of pavements, inadequate maintenance of roads, lack of protective barriers, insufficient road width to avoid a traffic accident, and the proximity of steel poles for lighting.

Picture 5.: Problem: Curves, lack of visibility, lack of traffic signs

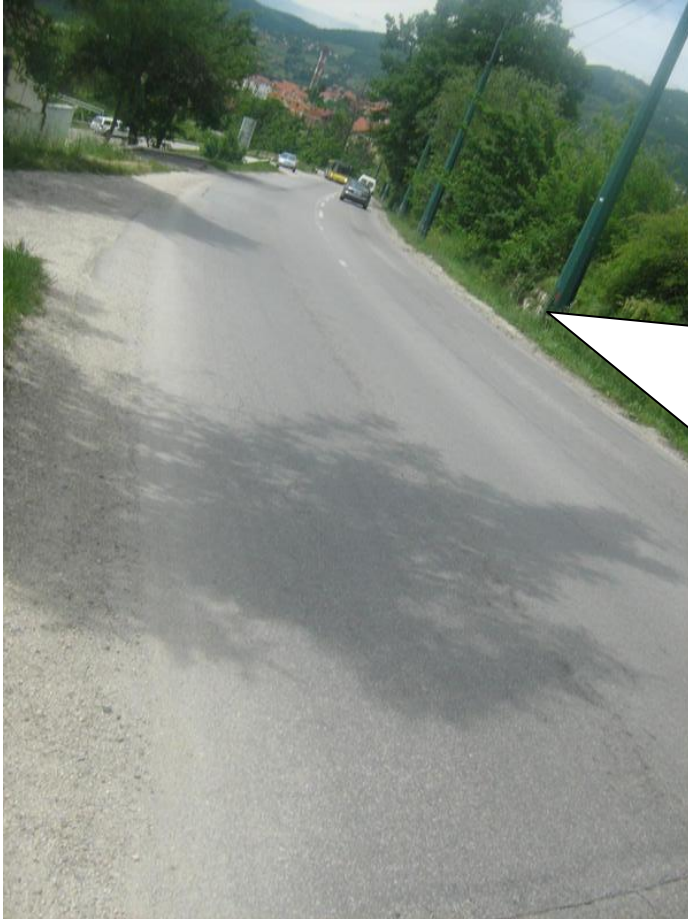
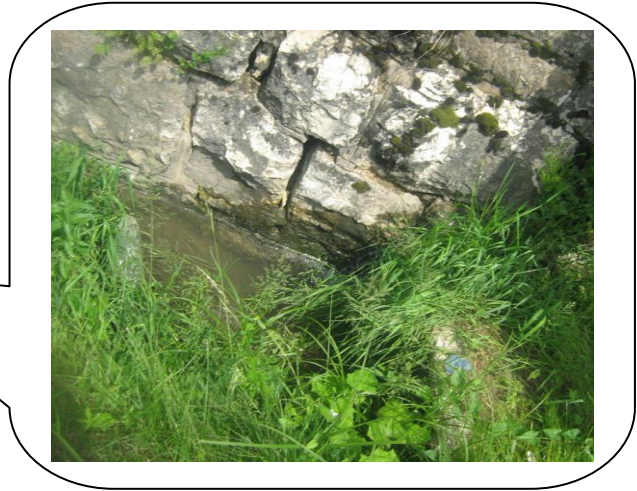
Picture 6.: Problem: Ditch and a water source near the road

- The regulation of drainage (ditches, gutters, drainage, etc.) and set the grid and provide the best possible drainage; cleaning (pavement, drainage system, road, land, equipment, etc.); mowing grass and removing brush.

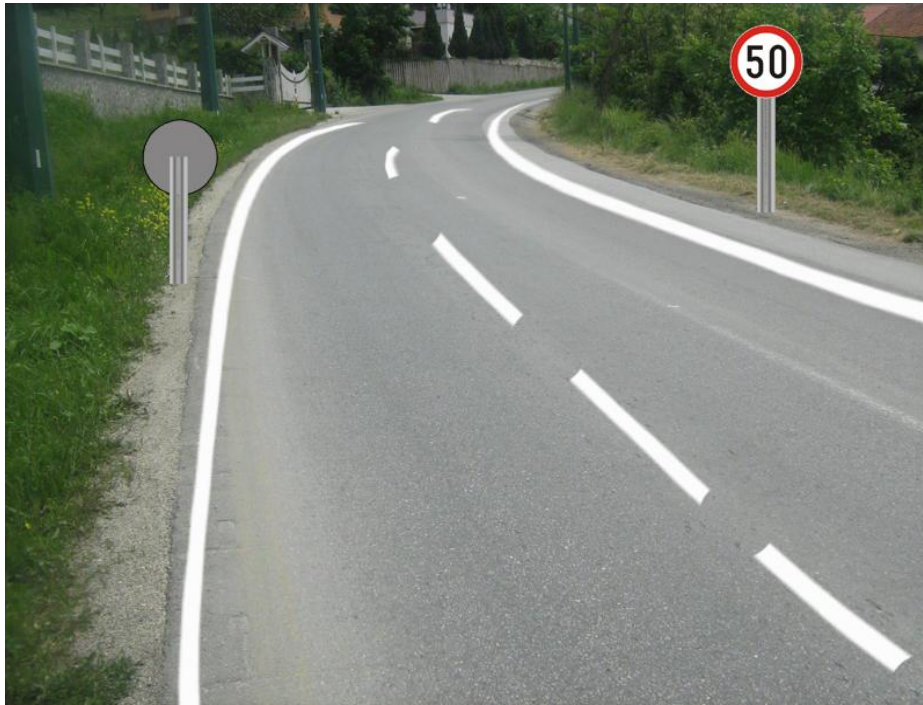
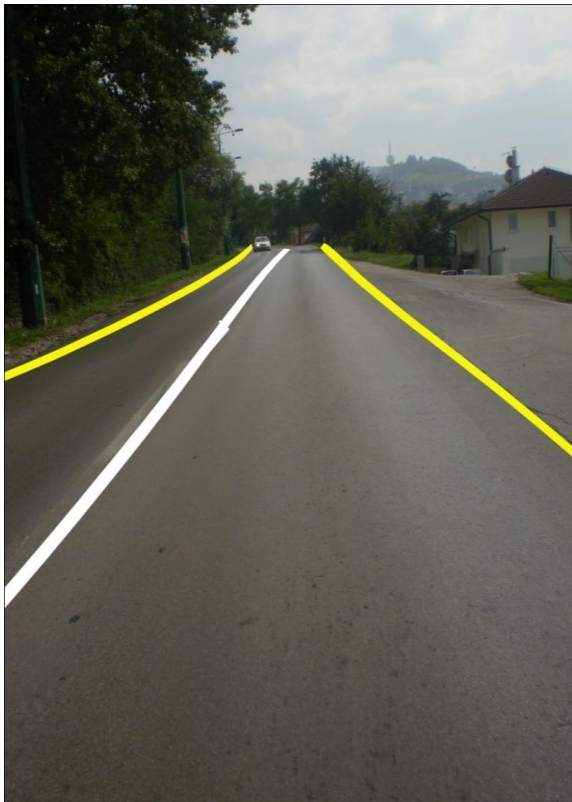
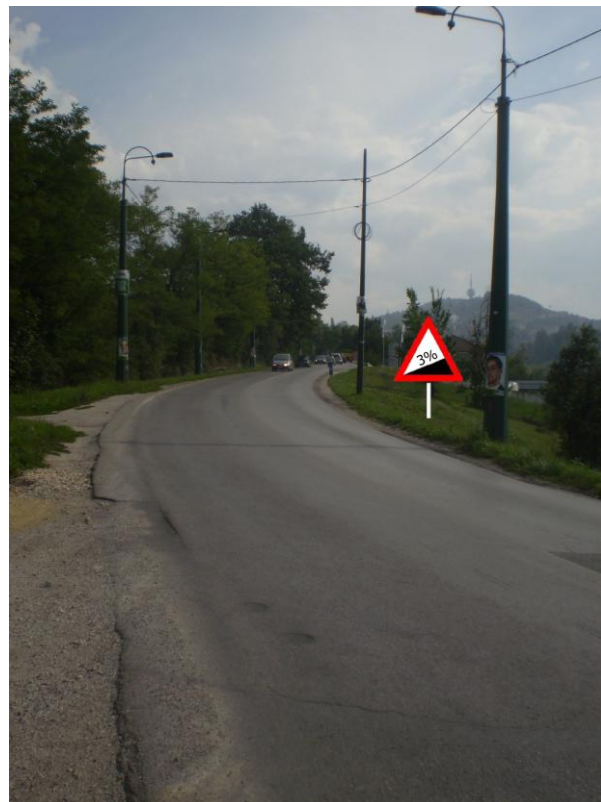
Picture 8.: Proposal to treat high risk site: Pavement road markings and installation horizontal and vertical signs

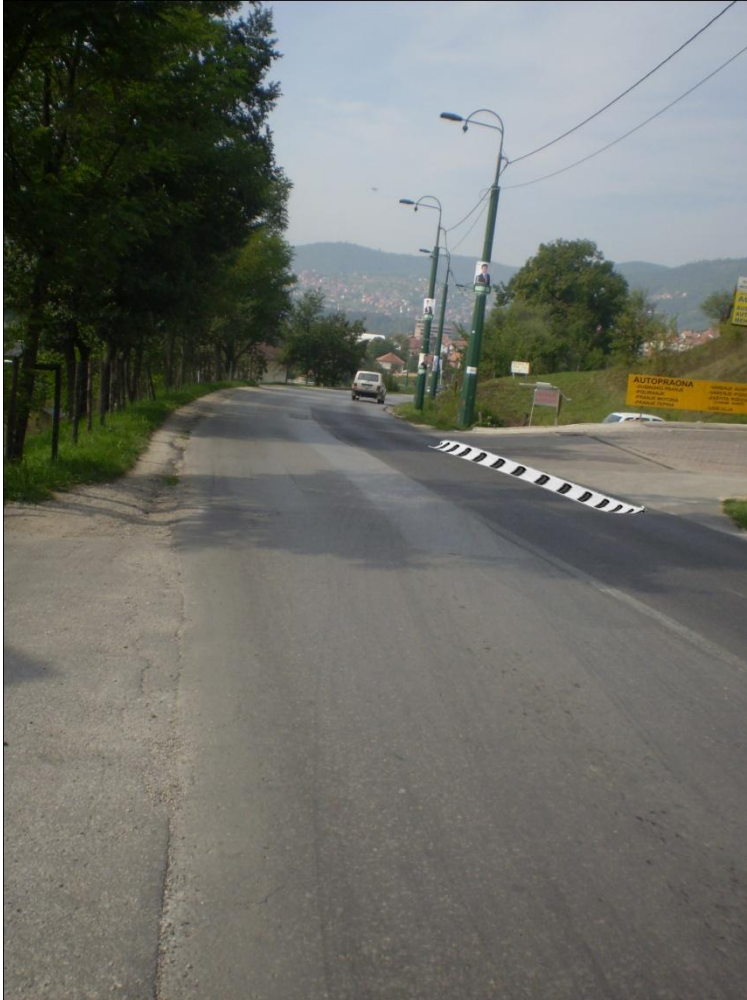
Picture 9.: Proposal to treat high risk site: **Set the grid and provide the best possible drainage**

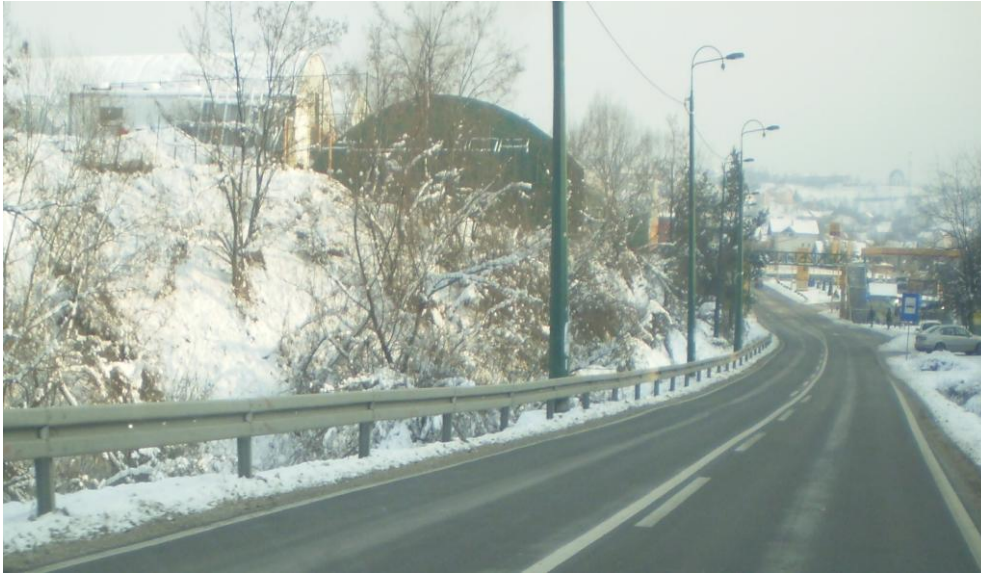
Picture14.: Installation of protective crash barriers

- *Reconstruction and development of horizontal markings on the pavement (distribution and edge line width of 15 cm),*
- *completion of the vertical traffic signs and replacing damaged*
- *complement and replace the protective fences and walking,*
- *arrangement of the drainage system (ditches, gutters, drainage, etc.)*
- *Planning shoulders (planning and alignment),*
- *Planning and some partial repairs of slopes of cuttings and embankments, retaining walls,*
- *some partial repair of concrete curb.*

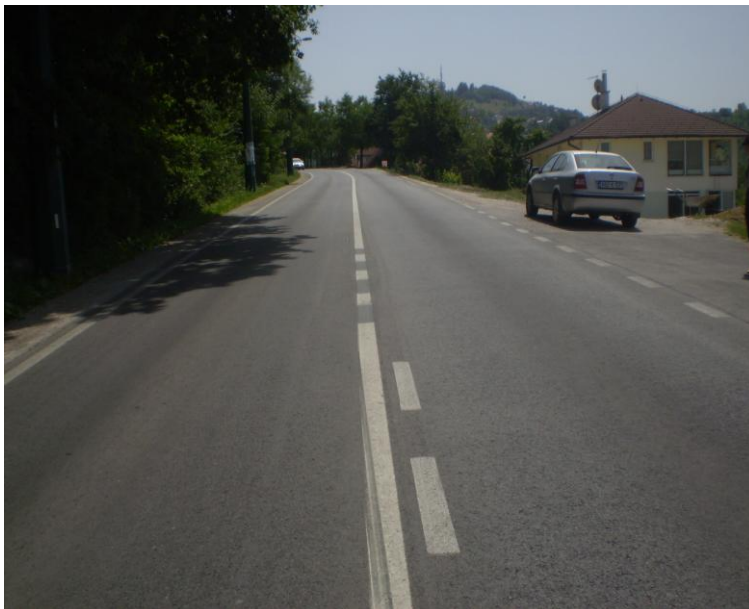
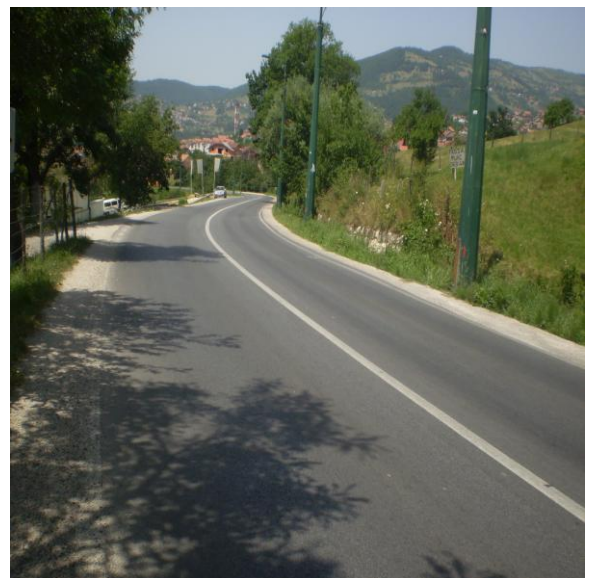
Picture 15: Road pavement (An adequate road markings)

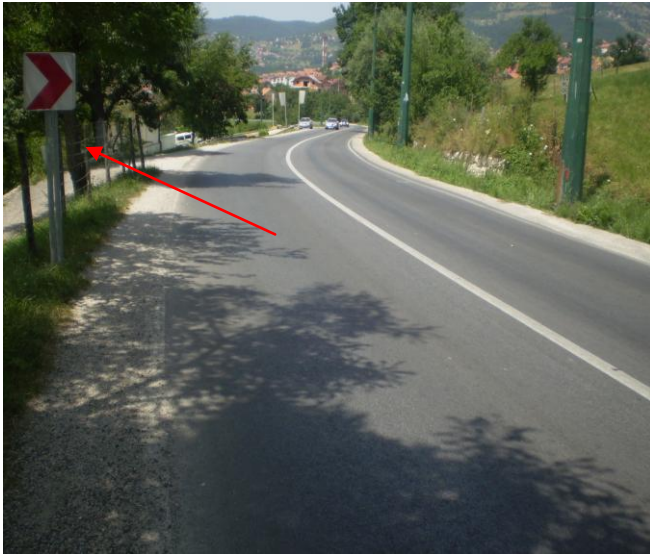
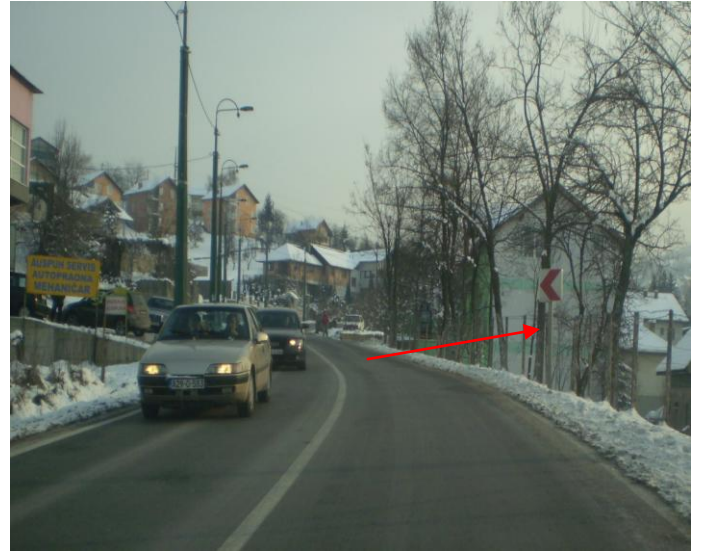
Picture 16.: Installation of the vertical signs
