STARS Project

# European Road Safety Project in the AS-19 Main Road

2011

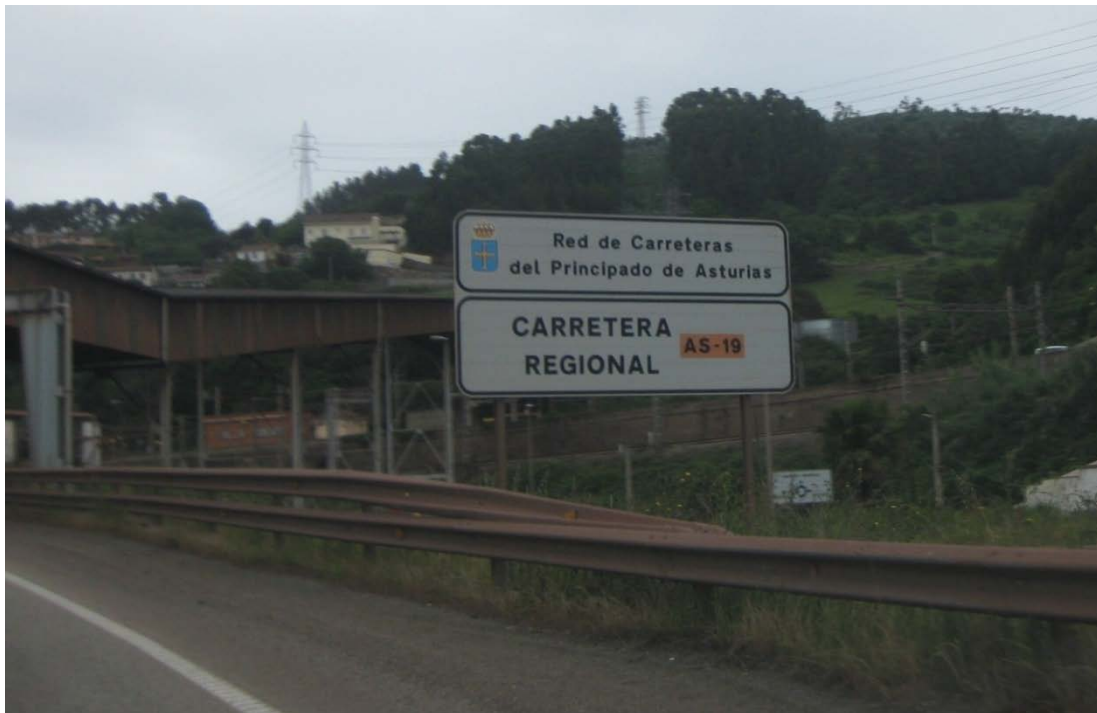
*Illustration 5: The main road called AS-19 is the road in which the campaign is proposed.*

The place selected to implant the campaign is the **AS-19** Main Road. It is a main road that connects the cities of Gijón and Avilés. The itinerary of the road in ascending way according to the mileage passes through the following towns or cities: Gijón, El Empalme, Prendes, Tabaza y Avilés. A map of this road can be seen in the Annex III of this document.

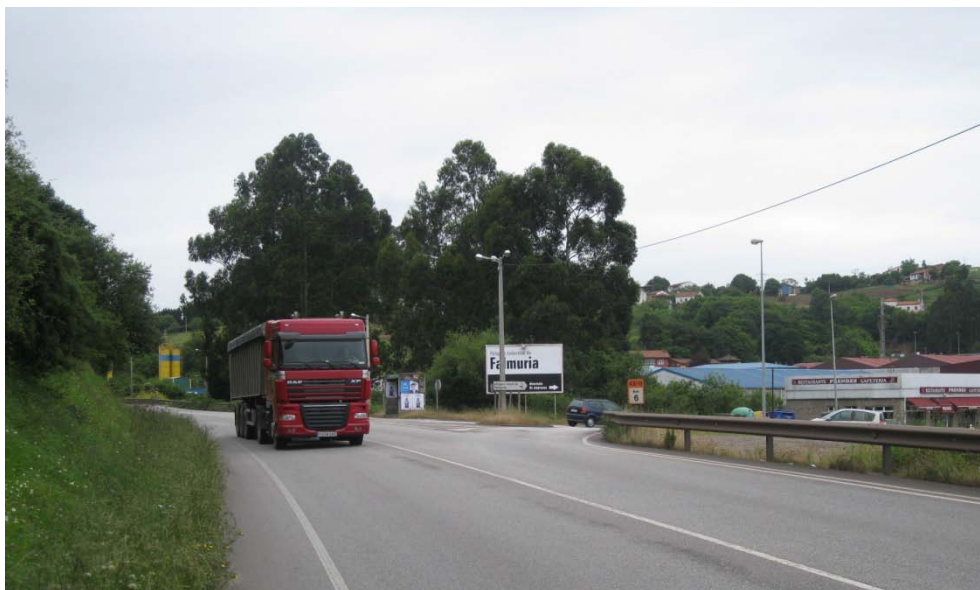
*Illustration 8: Photography of Falmuria Industrial Park's crossing.*

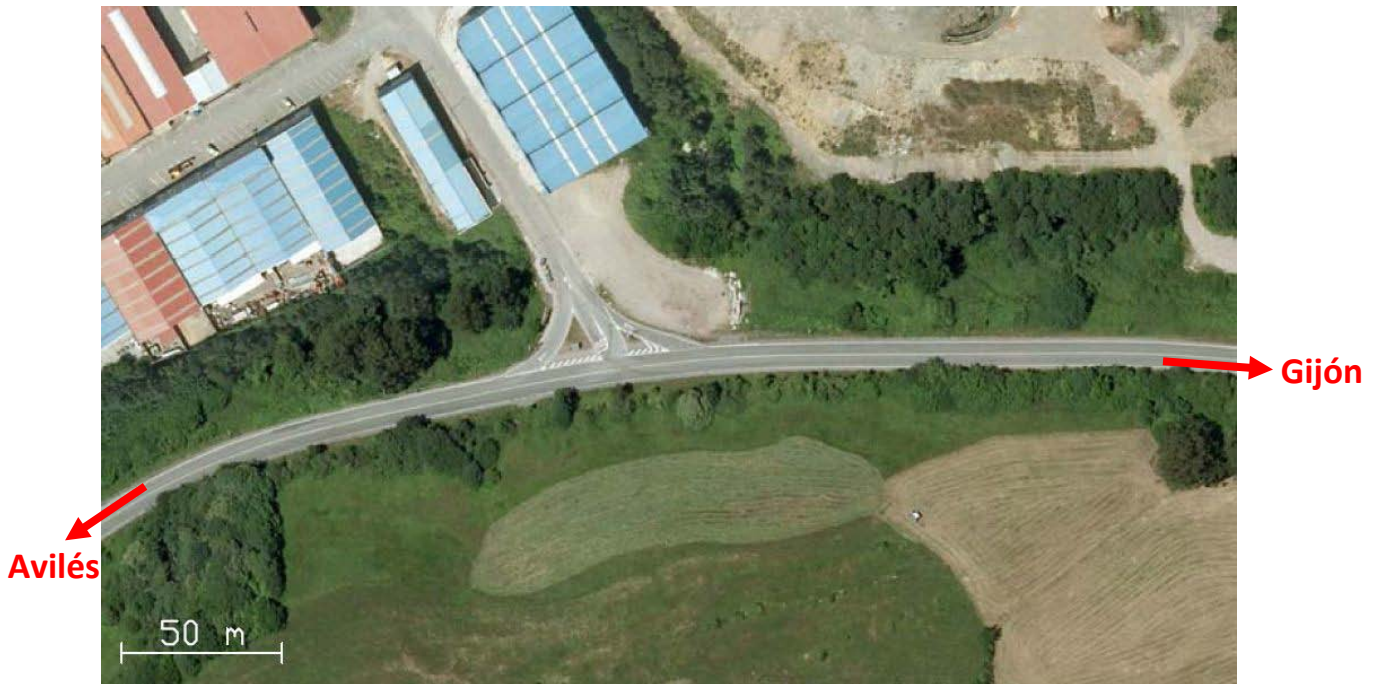
Illustration 9: View from satellite of Falmuria Industrial Park's crossing (K.P. 6.0).

The Illustration 9 shows an image taken from satellite, in which the crossing can be seen. In the Illustration 10, it can be seen a photograph of the crossing, looking in the way to Avilés. The Illustration 11 shows another photograph of the crossing, looking in the way to Gijón. Both photographs have been taken before starting any action.

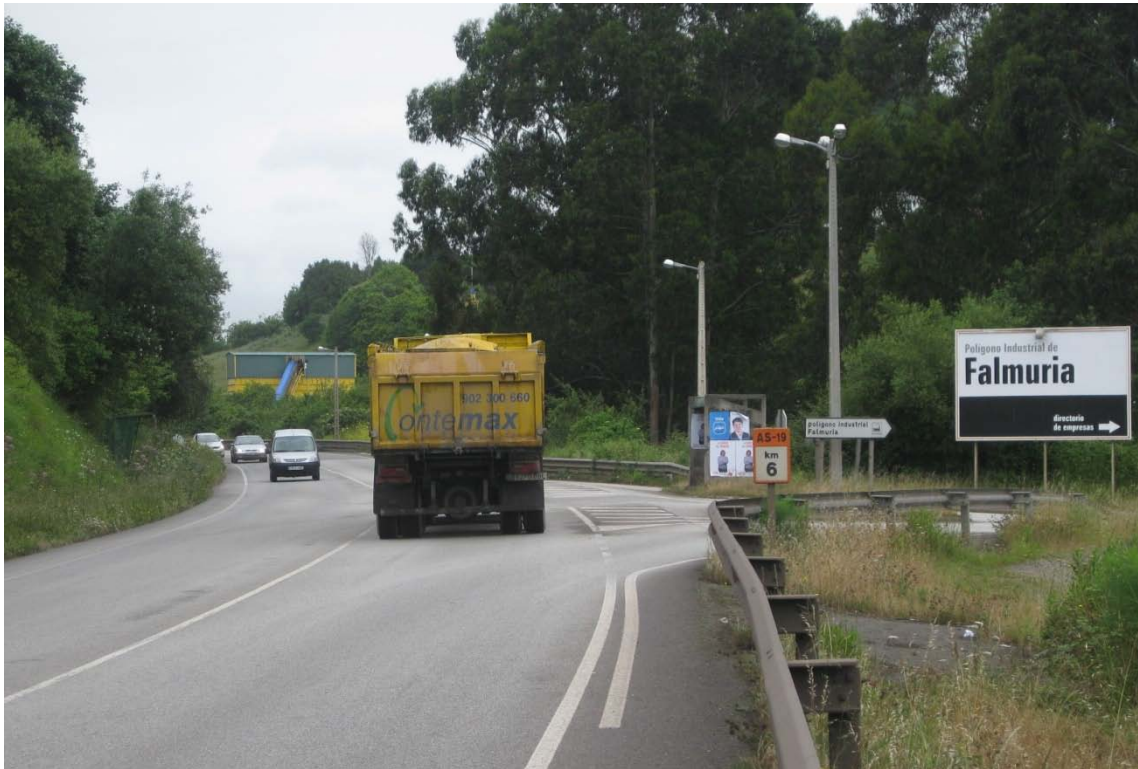
Illustration 10: Falmuria Industrial Park's crossing, looking on the way to Avilés.

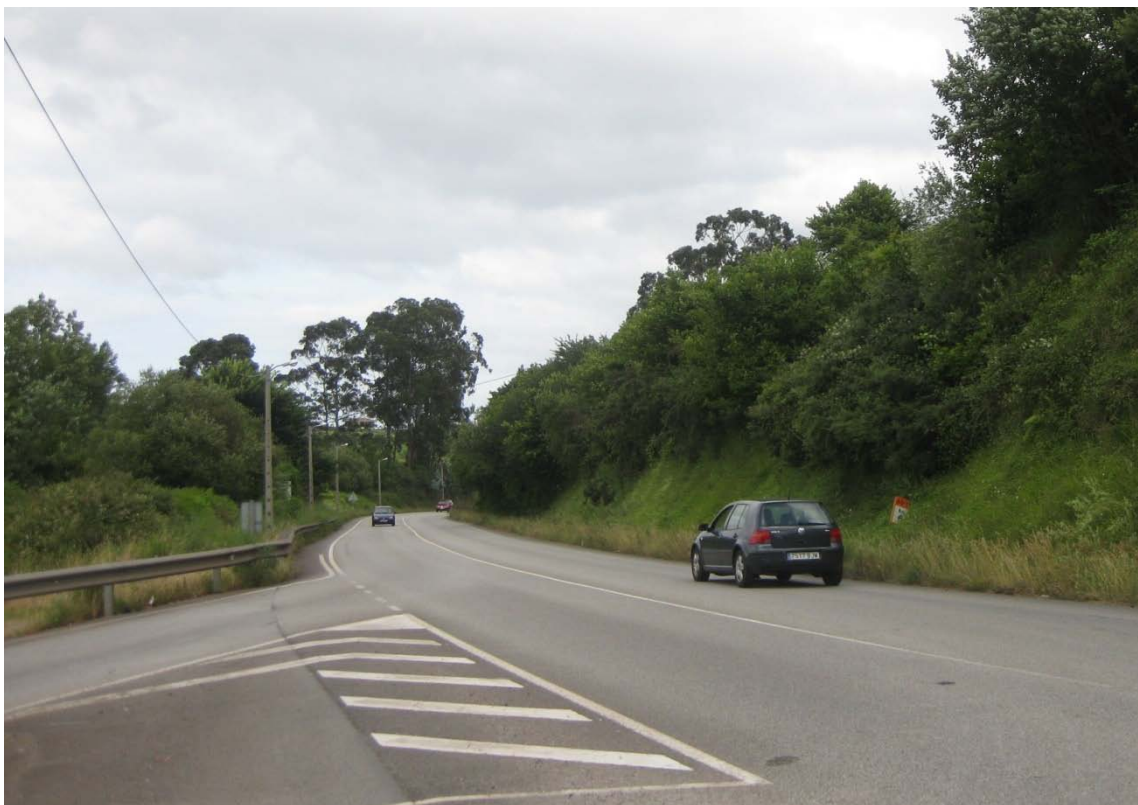
Illustration 11: Falmuria Industrial Park's crossing, looking on the way to Gijón.

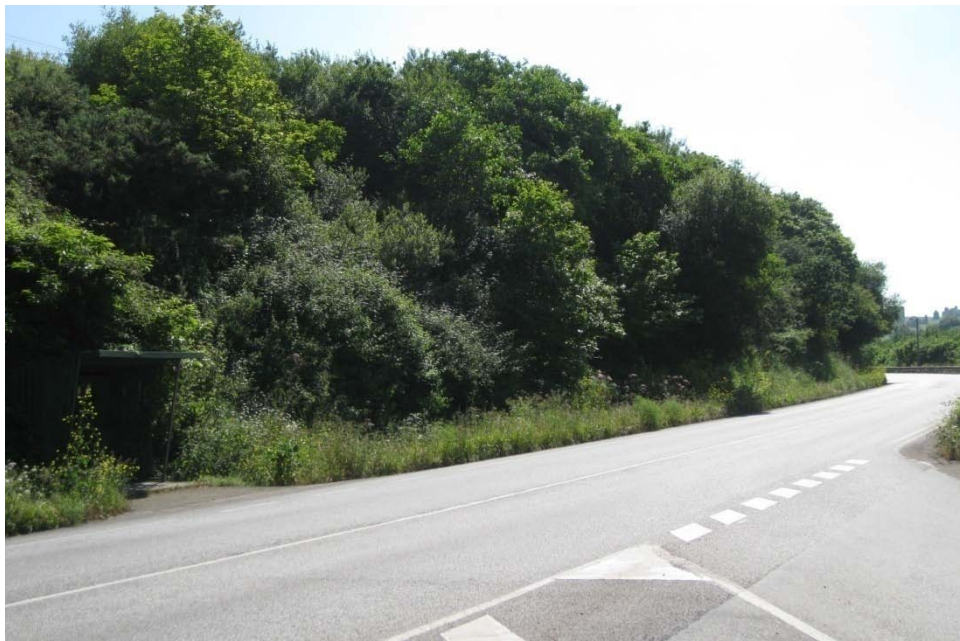
*Illustration 12: The bus stop on the way Avilés-Gijón is located after a curve, where the visibility is limited.*

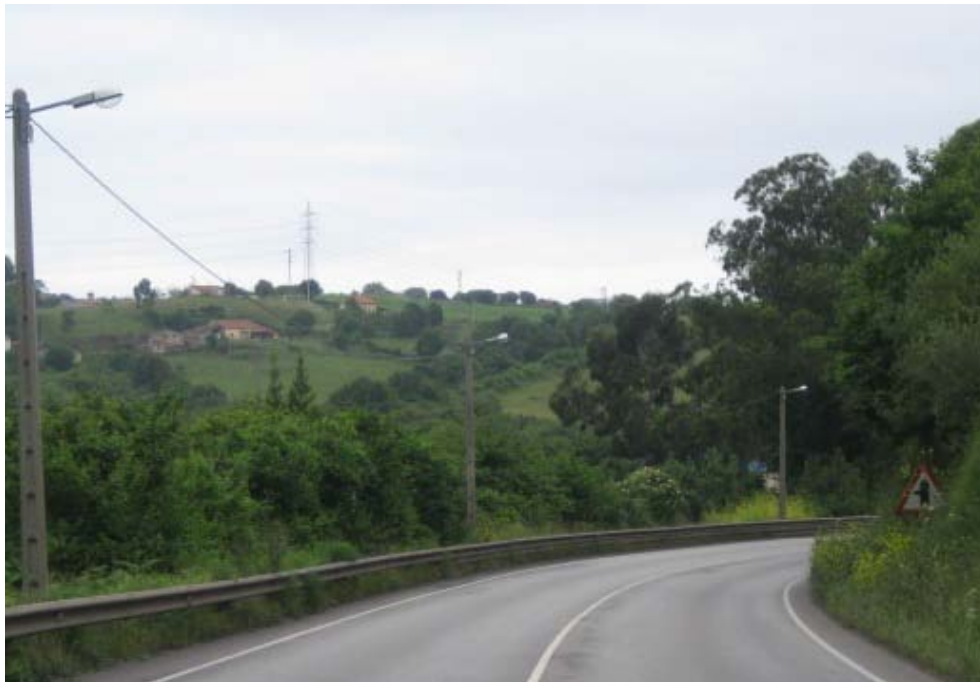
*Illustration 13: Traffic sign before the start of the campaign.*

in each way that warns about the danger of a crossing. However, the traffic sign in the way to Gijón hardly enhances. Many drivers can straight pass this sign. This is because the traffic sign is placed in the curve and cannot be seen until the driver is very close to it. Furthermore, although it is not the general situation, when the weeds grow it is even more difficult to see this traffic sign. The conditions of this traffic sign before the start of the actions of this campaign can be seen in the Illustration 13.

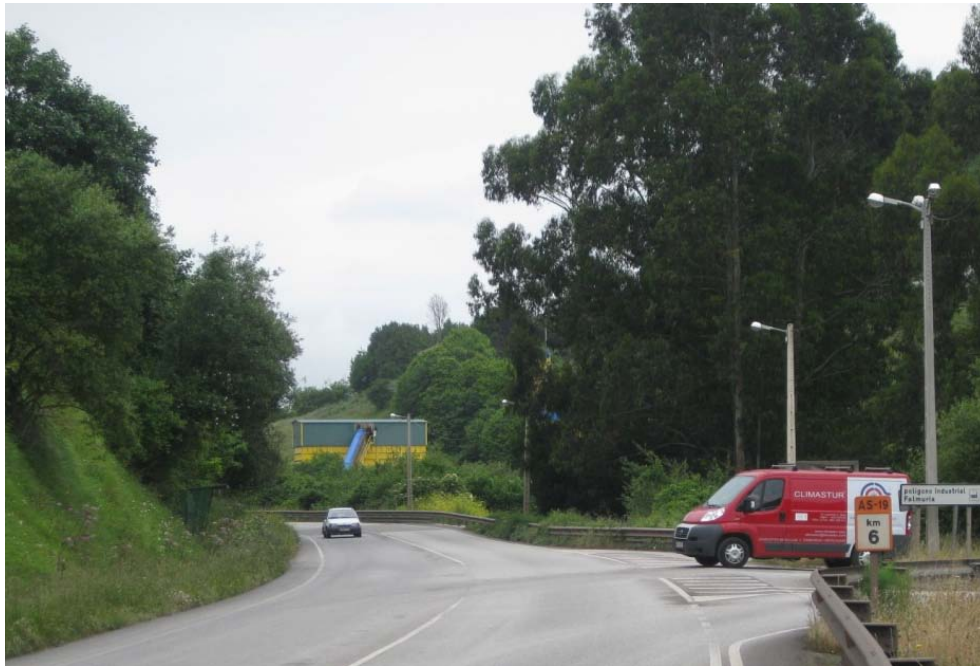
*Illustration 14: In this photo it can be seen the conditions of the road marking before the campaign.*

- The conditions of the road markings are another point to remark. **The lines that delimit the lanes and the crossing are almost removed.** This is because this crossing has a high flow of lorries and heavy vehicles due to the surrounding industrial area. In this stretch, the ADT is about 6000 vehicles, with a high percentage of heavy vehicles. Moreover, there is a considerable amount of lorries that transport coal to a nearby

As it can be seen in the Illustration 14, the white line that delimits the left verge and the continuous line of the axis of the road are almost cleared at the crossing.

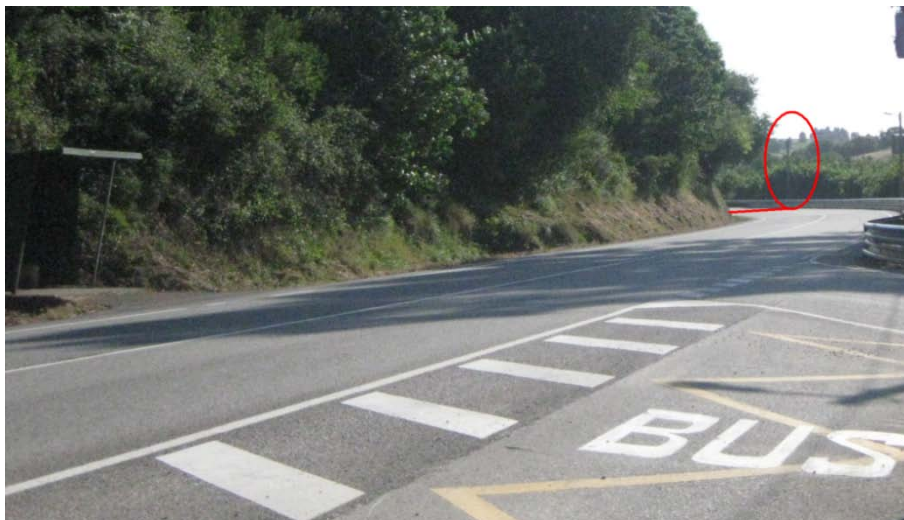
Illustration 17: Visibility distance while trying to incorporate to the AS-19 road from Falmuria Industrial Park.

The crossing visibility is 163 metres. This length has been measured depending on the distance that can be seen from the stop at the incorporation to the AS-19 road (view Illustration 17). The crossing distance can be measured using an orthophoto, as it can be seen in the Illustration 18.

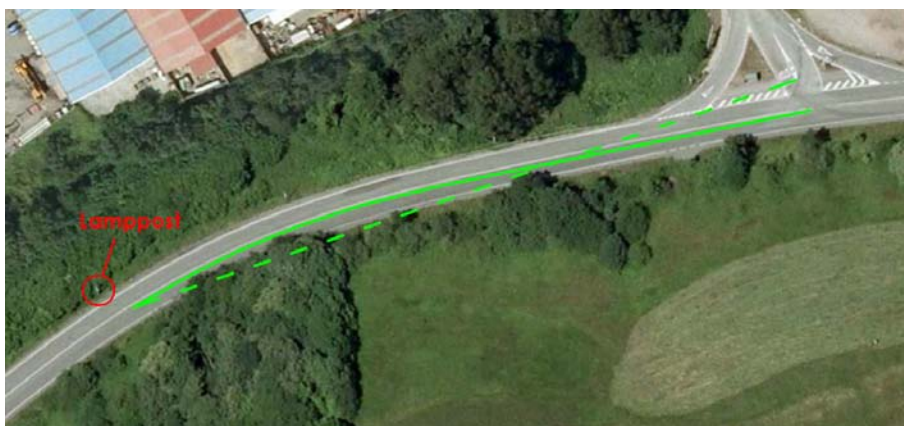
Illustration 18: The crossing distance can be measured using an orthophoto, proving to be 163 m.

Knowing that the crossing distance is 163 m, it is possible to calculate the suitable maximum speed to the crossing. The maximum speed of the preferential road can be calculated using the following expression:

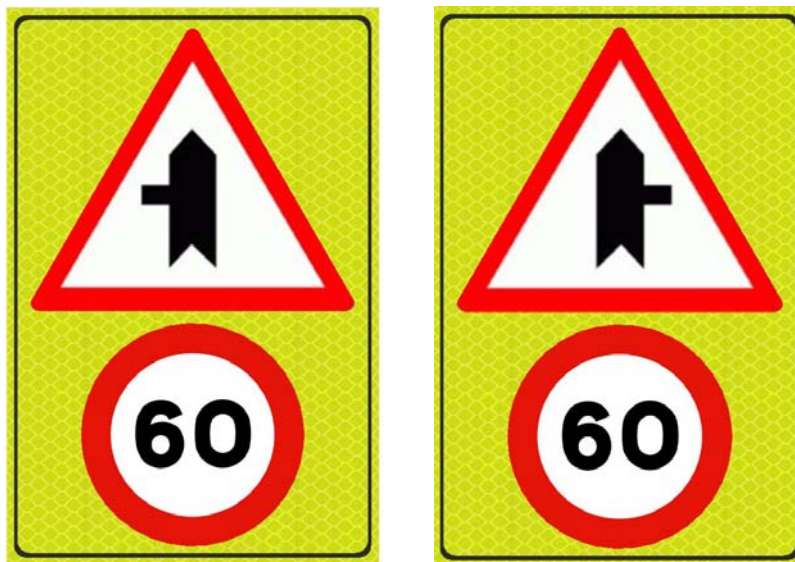
Illustration 19: Fluorescent reflective yellow sheet panels with “dangerous crossing” and “speed limit” signs.

**In order to improve its visibility, the “dangerous crossing” traffic sign is going to be changed by a panel which will have a triangular “dangerous crossing” sign and a circular “speed limited to 60 km/h” sign. The background of the panel will be a fluorescent reflective yellow sheet.**

An example of the two panels that will be placed to sign the crossing can be seen in the Illustration 19. The panel to place in the way from Avilés to Gijón warns about the danger of a crossing at the left, whereas the panel to place in the way from Gijón to Avilés warns about a dangerous crossing at the right. There is a sketch in the Illustration 24 in which it is possible to see the location of these panels.

The fluorescent reflective yellow sheet panels add extra visibility. This is something critical to improve everybody’s road safety. So, the driver is more likely to be warned about the danger, letting him adapt the speed of the car to the new situation. This is not only a benefit for the driver’s safety, but also for other users of the road.

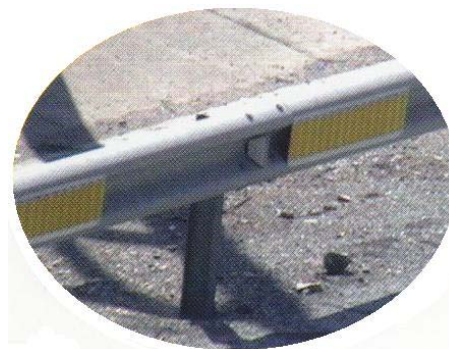
*Illustration 22: Example of the linear delineation system 3M LDS Series 346 installed on a crash barrier.*

The next action consists of putting a linear **delineation system for the crash barrier**, using the **3M LDS Series 246**. An example of a LDS is shown in the Illustration 22. The aim of this action is **to warn drivers that they are in a dangerous stretch and to increase their safety by improving the delineation of the road, not only during the night, but also in broad daylight**.

**This is a simple and new solution to improve in an effective way the visibility of the barrier and the delineation of the route in a dangerous stretch. The vertical undulation of these pieces maximizes the angular faces and so the visibility.**

A sum of **60 linear delineation system 3M LDS Series 346 will be installed** in the crash barrier. There will be **30 white-coloured 3M LDS and other 30 yellow-coloured 3M LDS**. They will be installed mixing the colours: one LDS of each colour. The size of these pieces is: 86 cm long and 15 cm high.

This delineation system will be placed in the right hand crash barrier located just after the crossing (in the way from Gijón to Avilés). There will be placed one delineation piece every 3 meters, starting 7 m after the crossing. The last LDS piece must be at the same point than the traffic panel. It is recommendable to have a look at the sketch in the Illustration 24 for a better understanding.

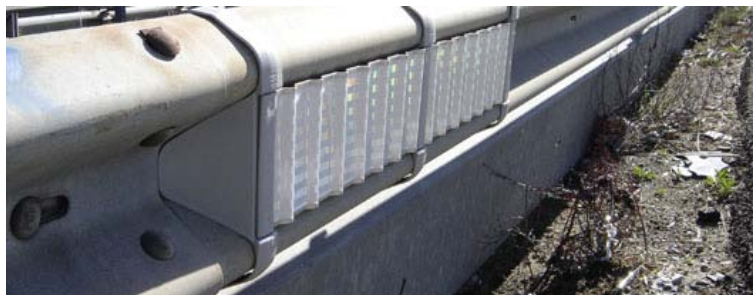
*Illustration 26: White linear delineation system 3M LDS Series 346.*

A sum of **60 linear delineation system 3M LDS Series 346** will be installed in the crash barrier. The half of the delineation pieces will be white and the other half yellow. This is a simple and effective solution to improve the visibility of the barriers in a dangerous stretch in whatever weather condition.

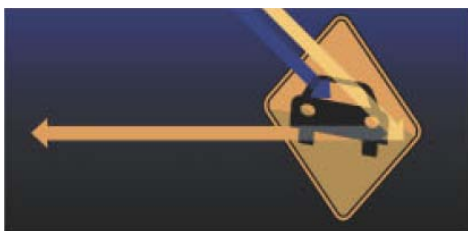
*In the common traffic signs, the ultraviolet light, invisible to human eyes, is absorbed and not returned. This traffic signs only reflect visible light.*

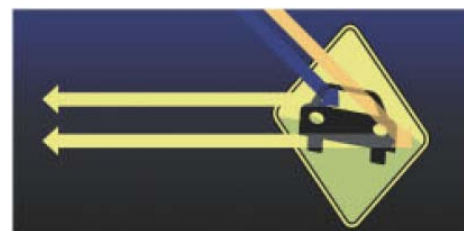
*In the fluorescent signs, apart from the visible light, the existence of fluorescent pigments makes the ultraviolet light – which is invisible to human eyes – to be absorbed and returned to the drivers' eyes as visible light. This gives an extraordinary daytime brilliance.*

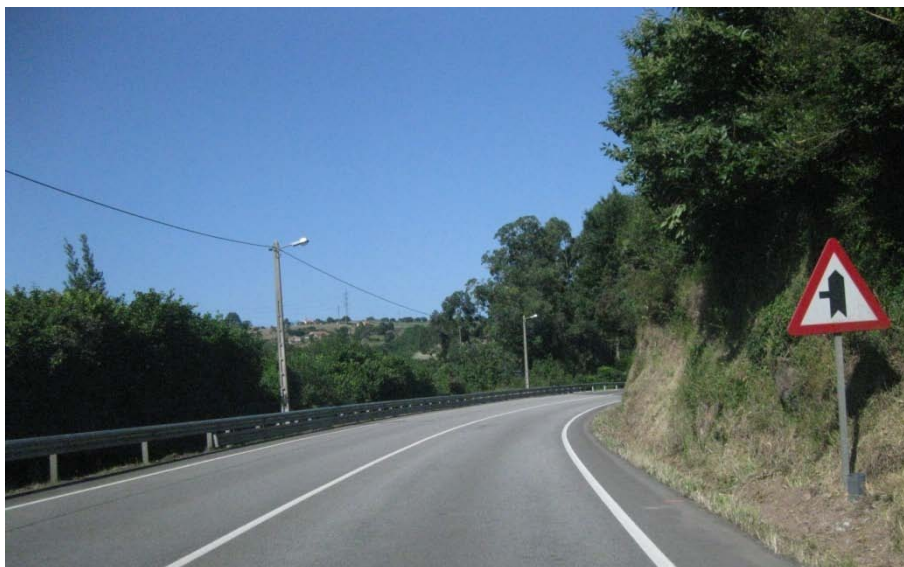
*Illustration 28: Aspect of the road after clearing the vegetation from the ditch.*

- The ditch of the road has been pruned in order to make the other works easy and to improve the aspect of the road. The aspect after clearing the vegetation from the ditch can be seen in the Illustration 28.

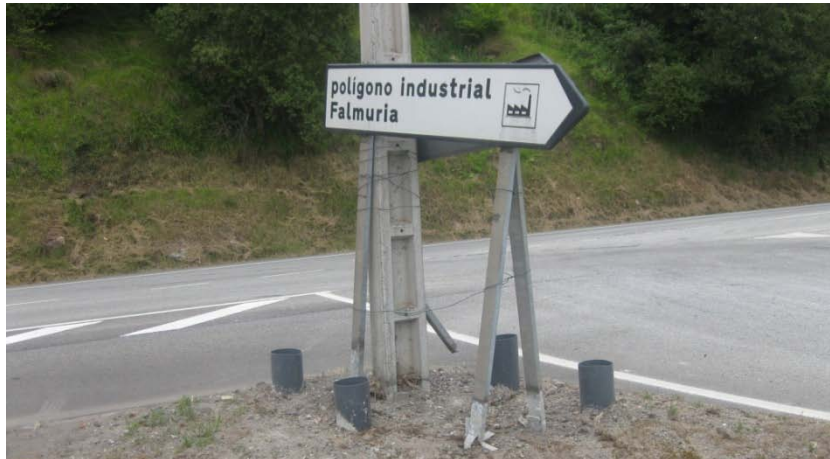
*Illustration 29: The foundations for the new traffic signs and for the panels have been prepared.*

- The metal barriers have been cleaned and the ones that were damaged have been replaced.
- The traffic signs that were damaged have been changed and the foundations of the new traffic signs and panels have been prepared (see Illustration 29).

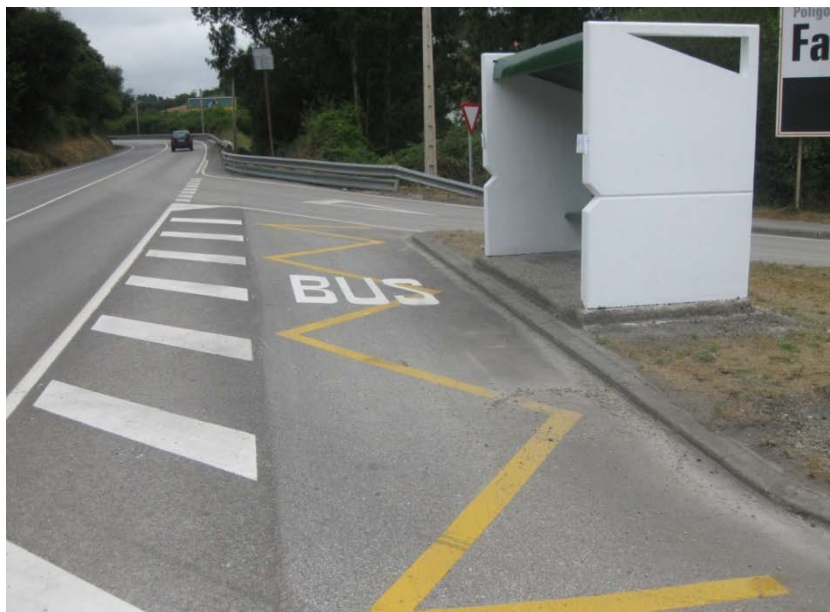
*Illustration 30: Appearance of one of the bus shelters and the road markings after being repainted.*

- The road markings have been repainted.
- Both bus shelters have been cleaned and repainted (see Illustration 30).

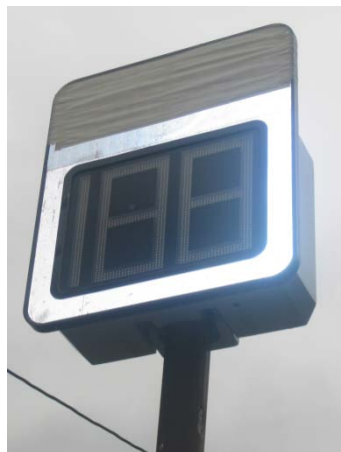
*Illustration 31: Driver feedback sign used to measure the speed.*

The **radar station of a driver feedback sign** has been used to take the measures. This device has the appearance of an informative panel, as it can be seen in the Illustration 31. In order to avoid the drivers' behaviour to change, the display has been switched off during the measuring time.

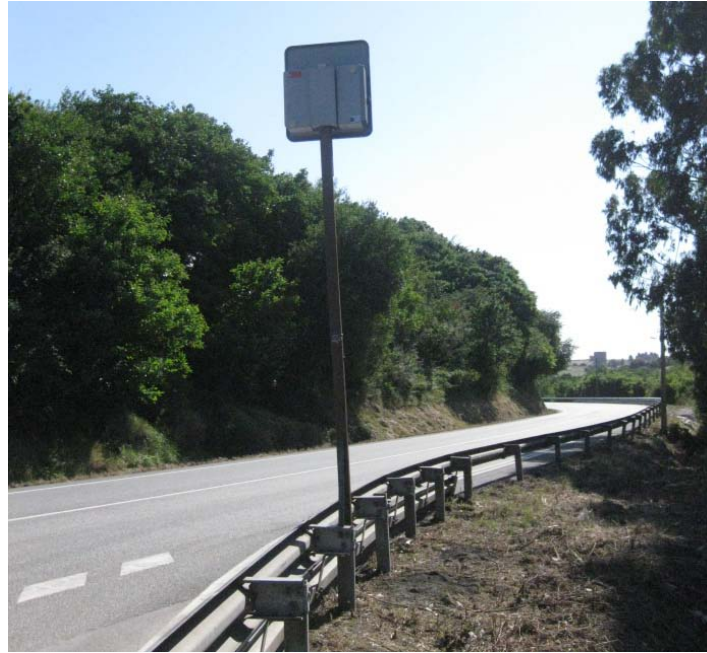
*Illustration 32: The radar station of the driver feedback sign measured the speed of the vehicles in the way from Avilés to Gijón.*

The driver feedback sign has been placed to measure the speed of the vehicles that were going toward the crossing in the way from Avilés to Gijón. The measured stretch is the most dangerous of the crossing: just after the curve. It is possible to see the location of the radar station in the Illustration 32 and in the Illustration 33.

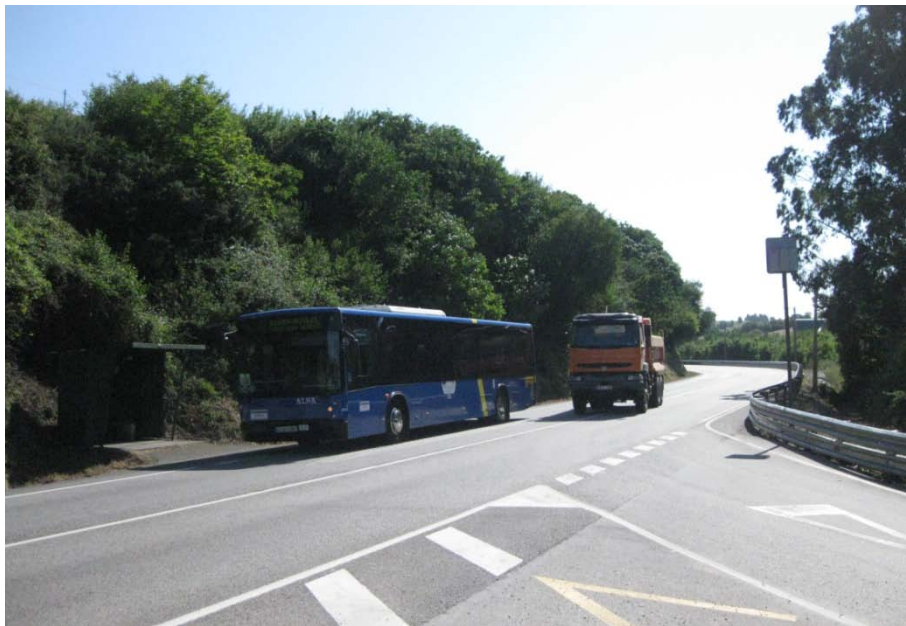
*Illustration 33: Location of the radar and detail of a dangerous situation during the bus stop.*

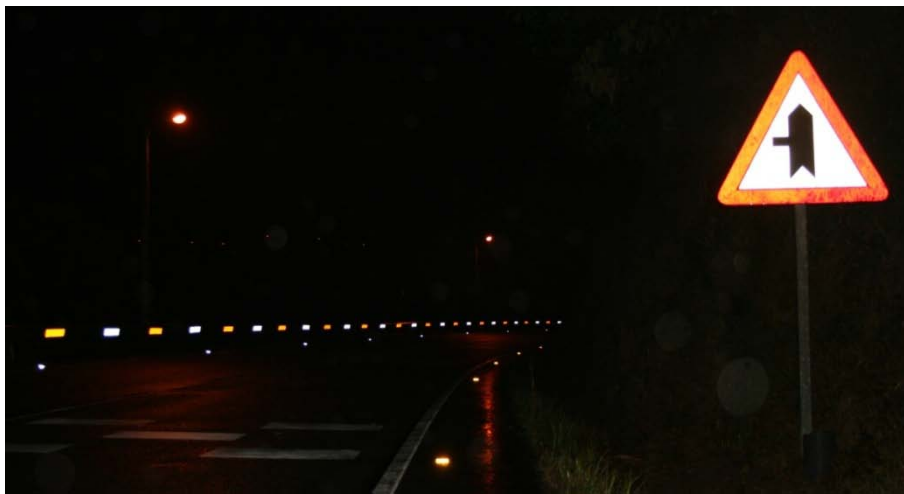
*Illustration 34: Dangerous crossing sign before being replaced by the panel.*

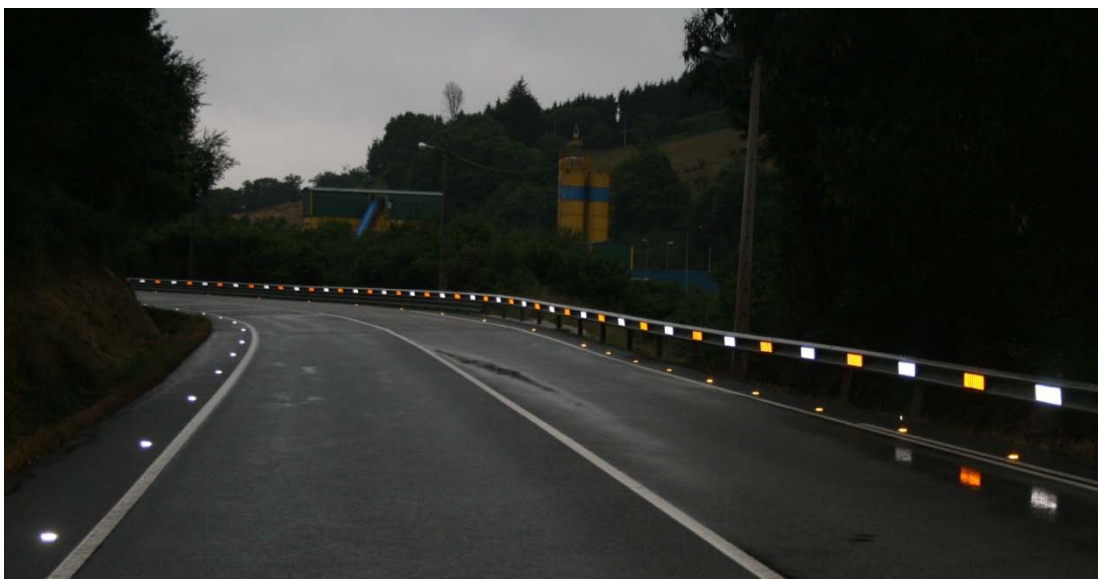
*Illustration 36: Delineation of the curve after the actions of the campaign (in the way from Gijón to Avilés).*

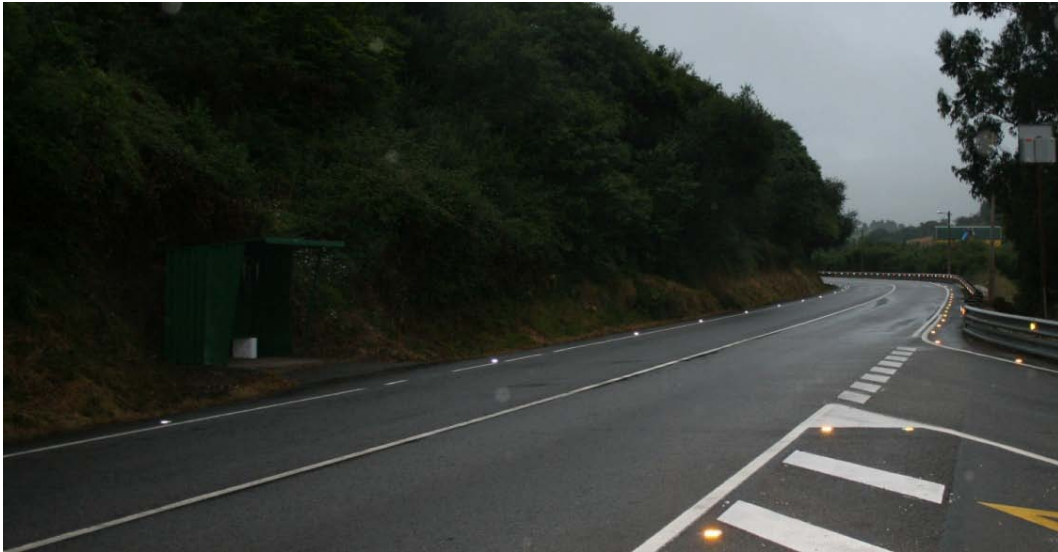
*Illustration 37: Looking towards Avilés from the crossing after the 1<sup>st</sup> set of actions.*

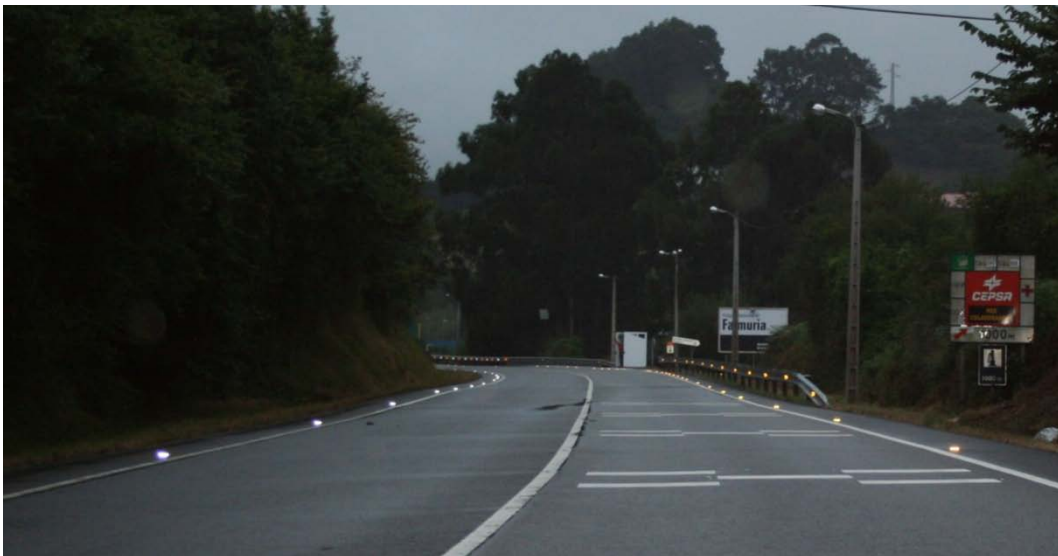
*Illustration 38: Looking to the crossing approaching on the way from Gijón to Avilés, after the 1<sup>st</sup> set of actions.*

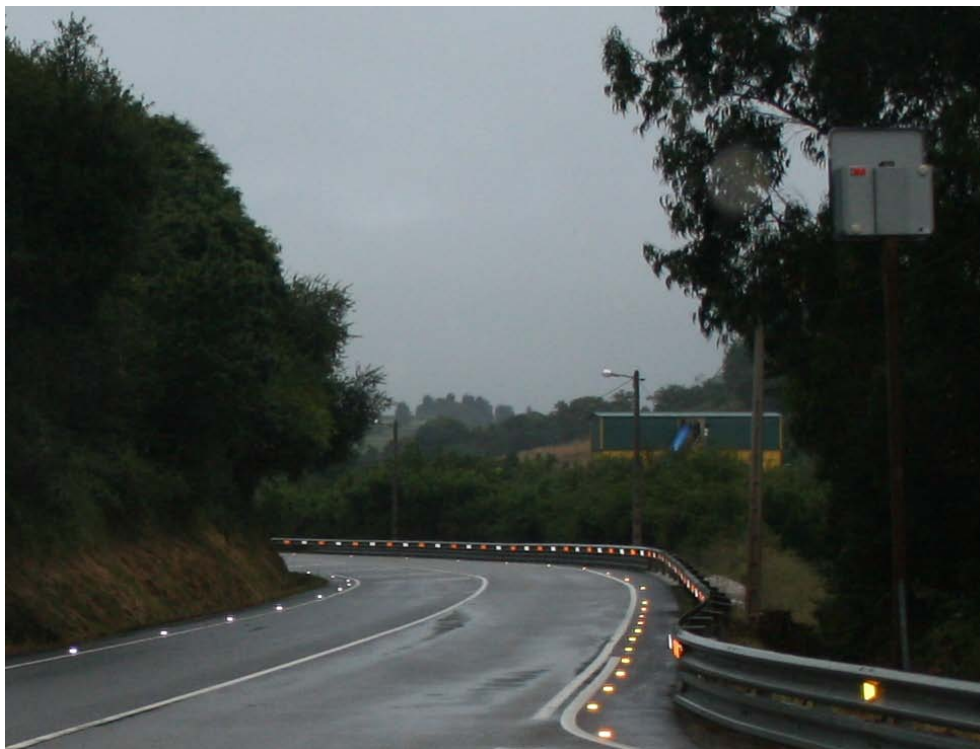
*Illustration 39: Detail of the driver feedback sign placed to measure the speed of the vehicles.*

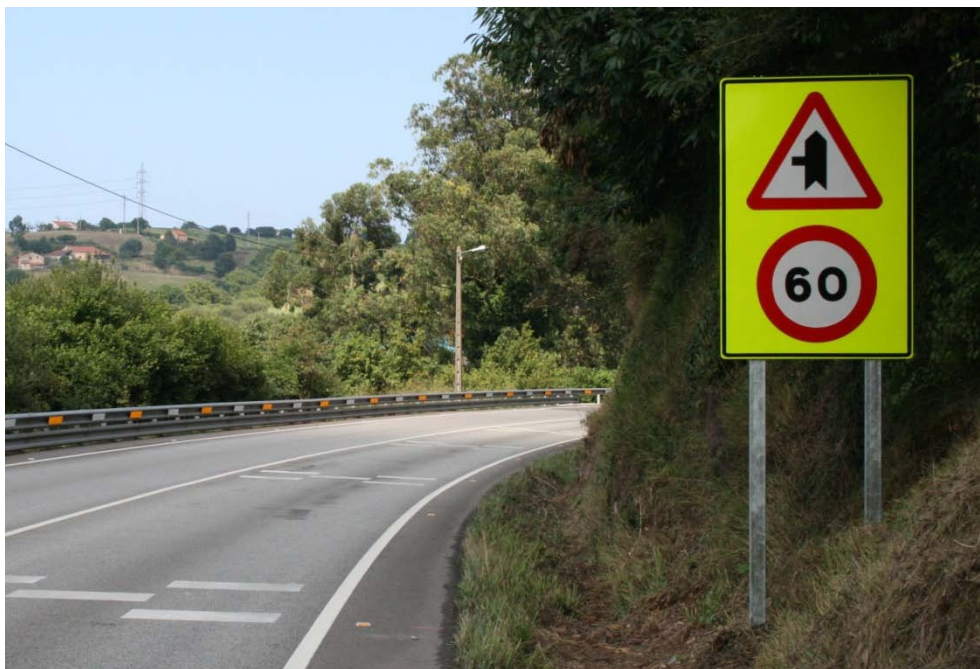
*Illustration 40: Panel used to signpost the dangerous crossing and the 60 km/h speed limit.*

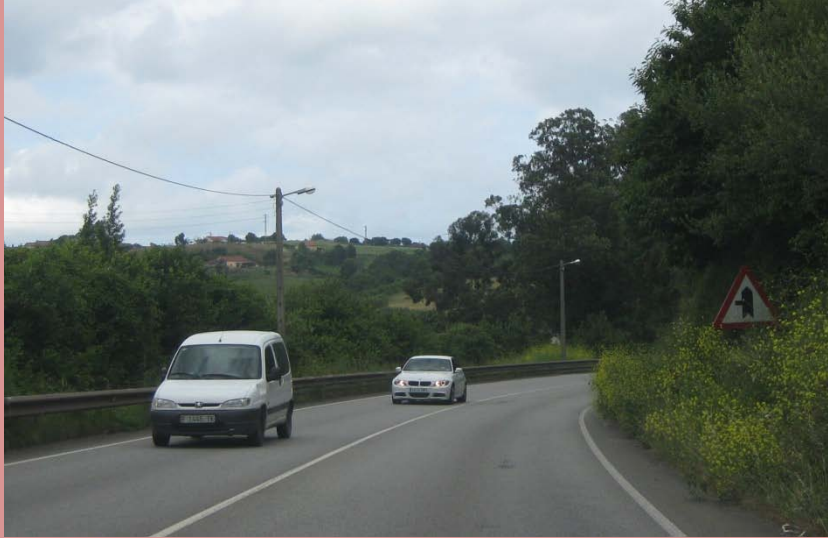
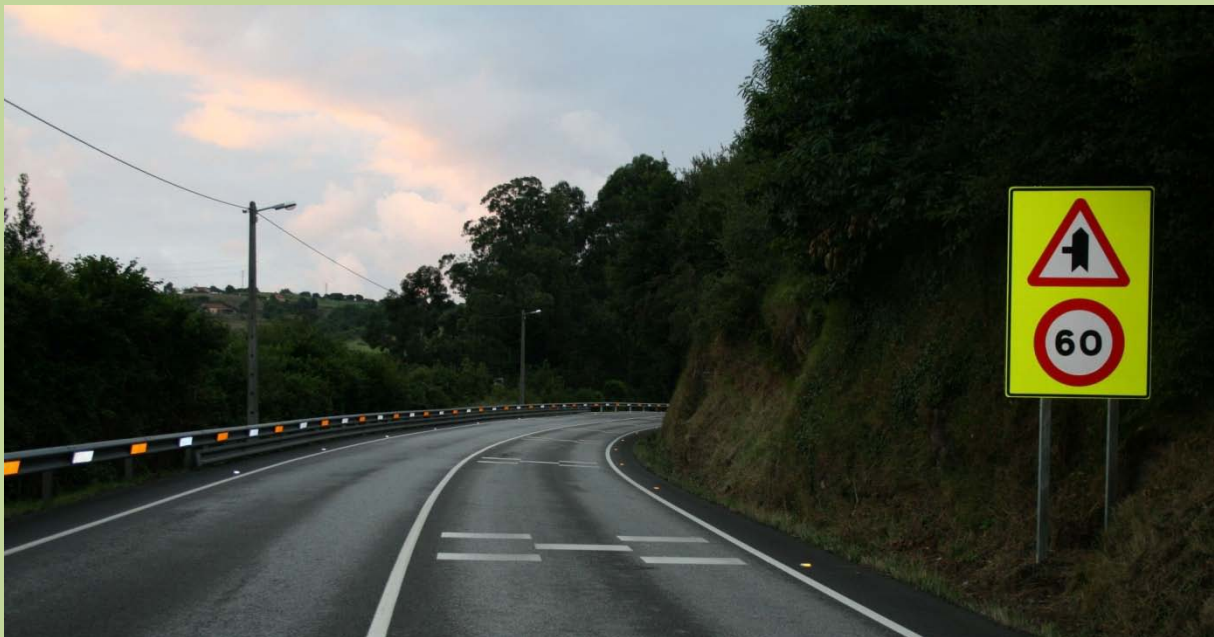
**The dangerous crossing sign was unnoticed for many drivers.**

Nowadays it is rather unlikely that the drivers do not realize that the stretch in which they are driving needs more attention. The sign has been replaced with a high visibility panel. Besides, in the way from Avilés to Gijón, there are also road markings (transversal lines) and retroreflective signs (reflecting road stud and linear delineation system for the crash barrier).

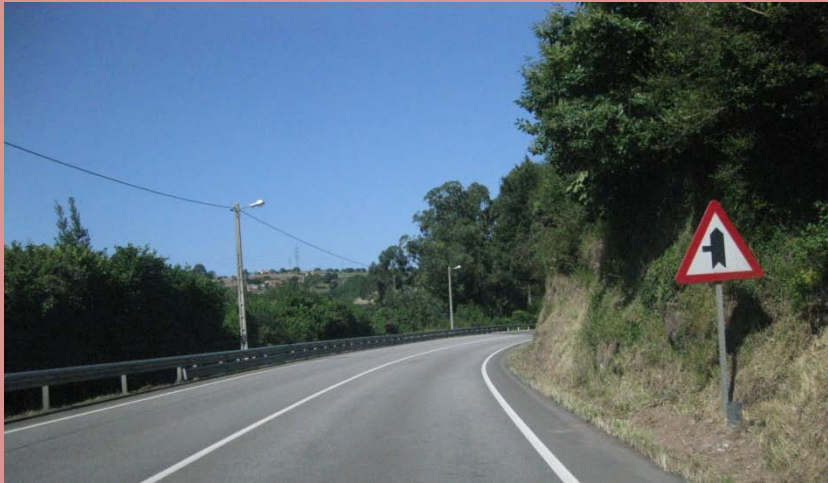
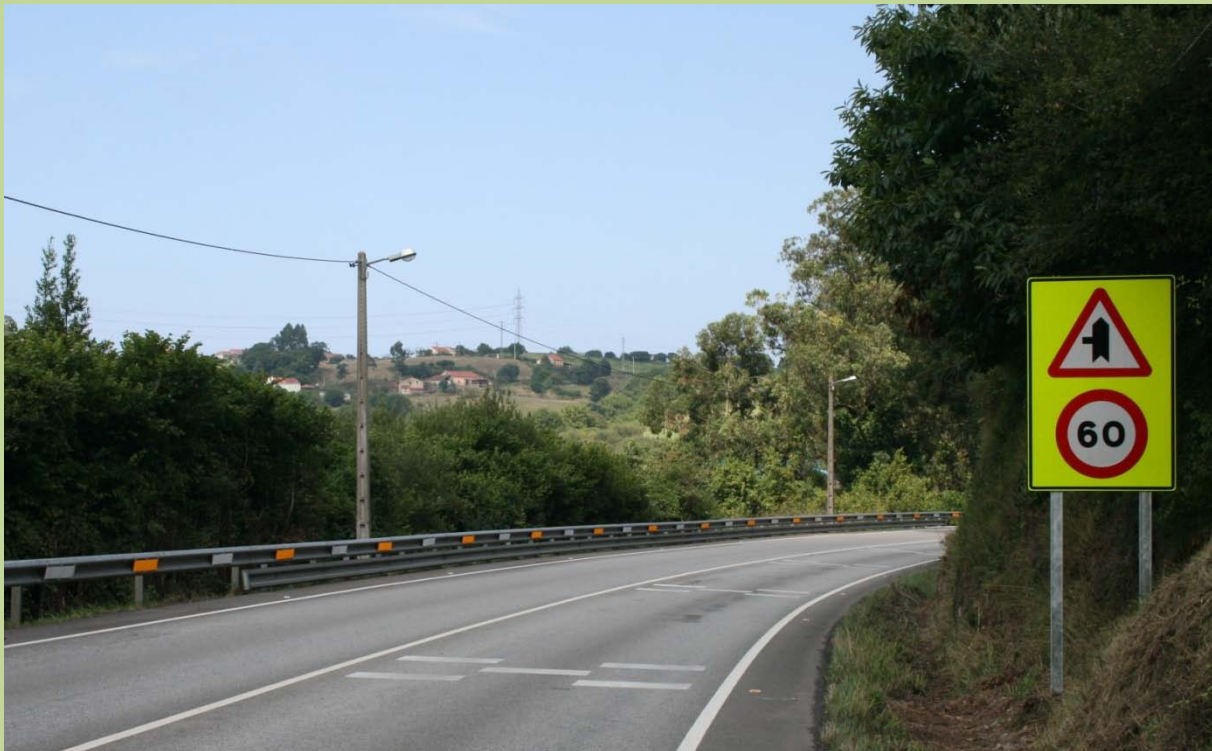
**Before carrying out the actions of this project, there was no speed limit in this stretch. The maximum speed was the generic for the road: 90 km/h.**

**After carrying out the campaign in this stretch, it has been established a new limitation of the maximum speed to 60 km/h. This limit has been calculated in agreement with the Spanish legislation relating to roads, taking into account the crossing distance and the crossing visibility.**

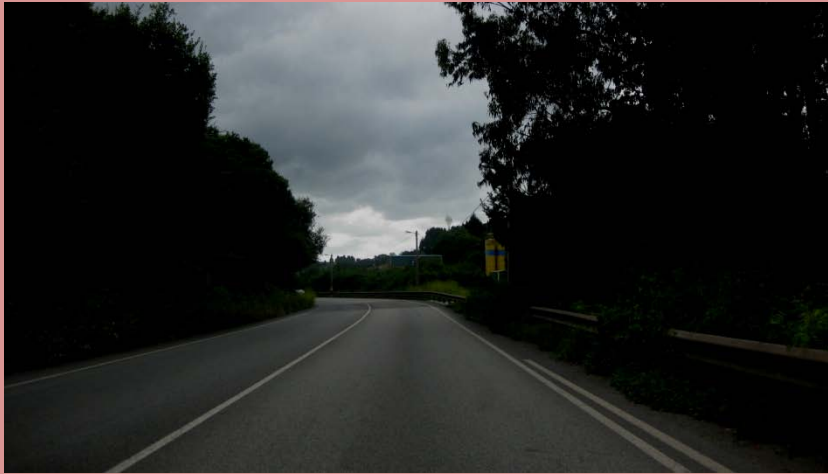
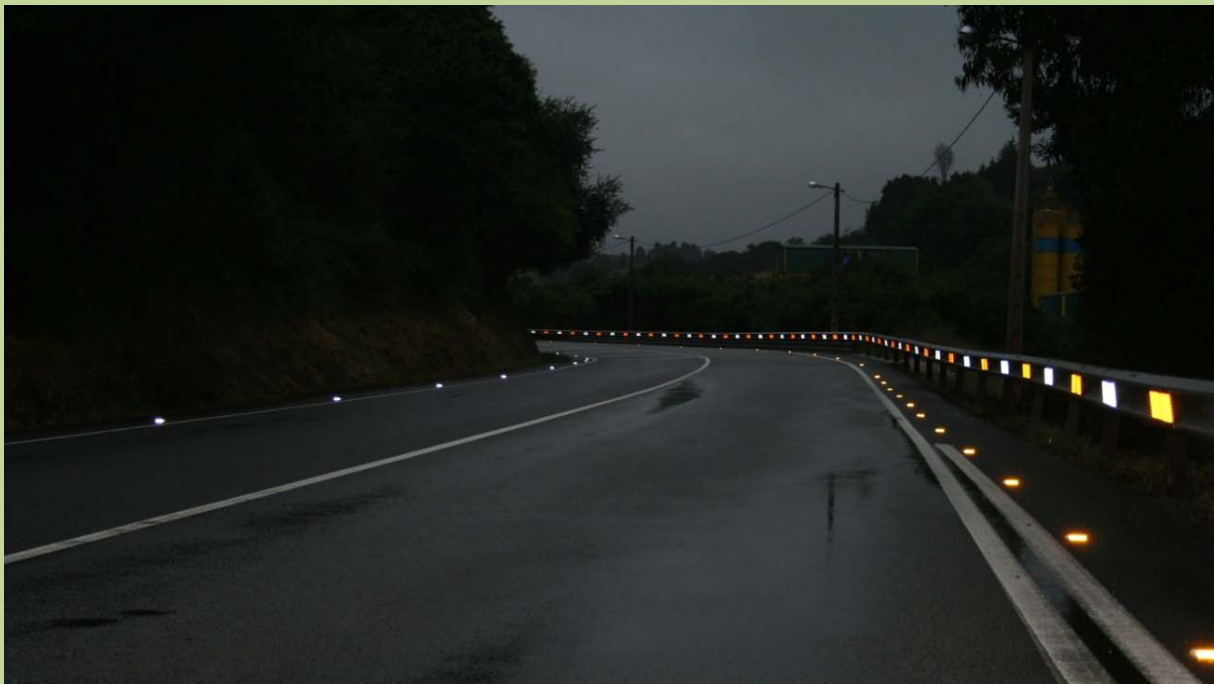
**It is a fact that the half of the accidents took place during the night or with bad conditions of lighting.**

**The actions carried out made a great improvement of the safety in low visibility conditions, because they improved the delineation of the route. In addition, the reflective elements that were used are especially useful in raining conditions.**

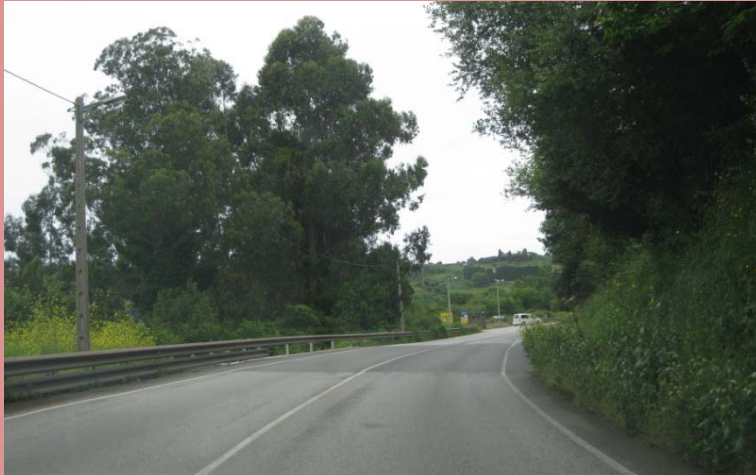
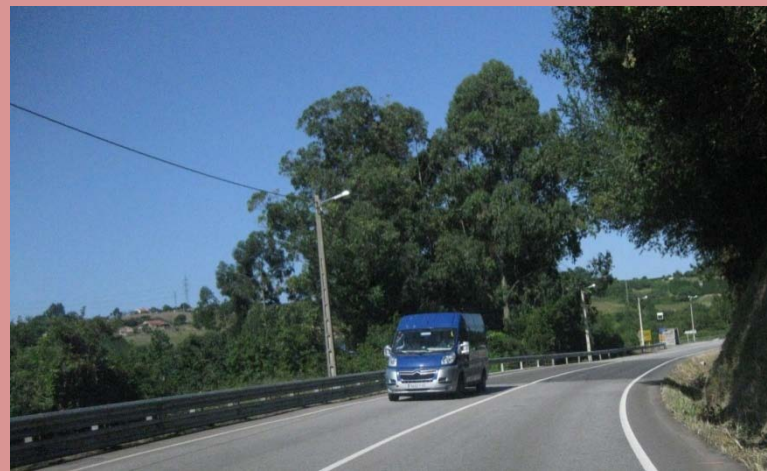
**Before carrying out the campaign, the drivers meet suddenly with the intersection and the bus stops.**

**The drivers are now warned about the proximity to a dangerous stretch with certain anticipation. This helps the drivers to get ready to carry out additional actions, such as an emergency braking.**

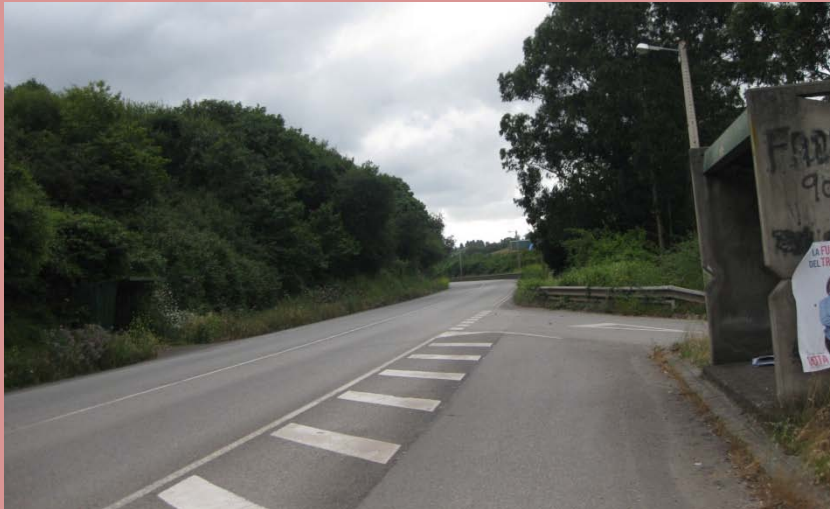
**The most dangerous area is the exit of the curve in the way from Avilés to the crossing, due to the presence of a bus stop in an area of low visibility.**

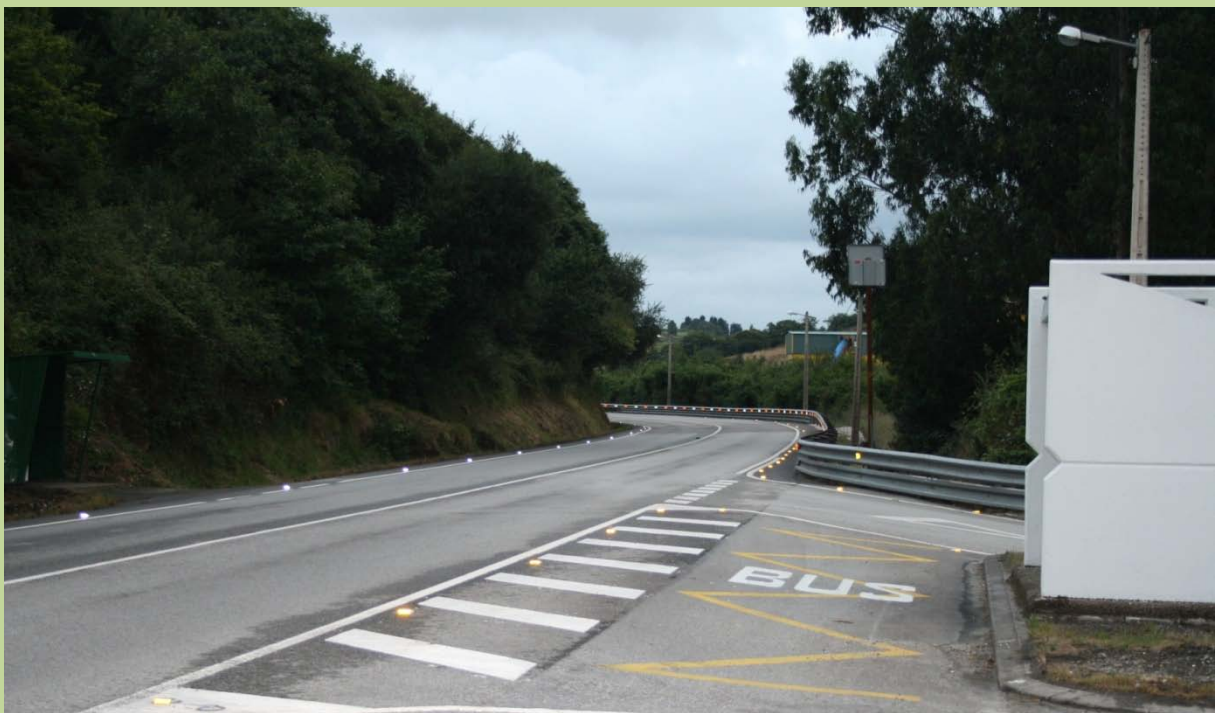
Although the actions include the whole stretch of the crossing (in both ways), they are focused to improve the safety of the vehicles that circulate in the way from Avilés to Gijón for being the most dangerous area. In this stretch the 3M linear delineation system has been placed.
