STARS Project

# European Road Safety Project in the AS-19 Main Road

2011

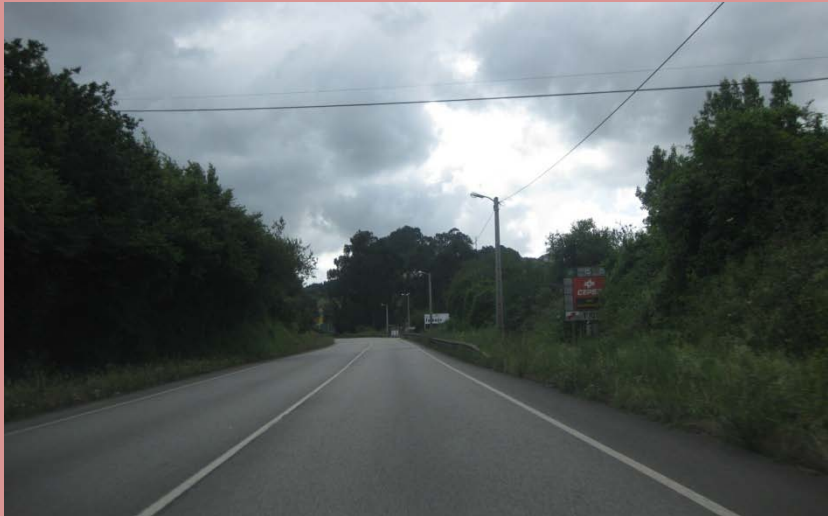
**In the way from Avilés to Gijón, although there is more visibility, it was still a dangerous stretch due to the high traffic flow of this crossing.**

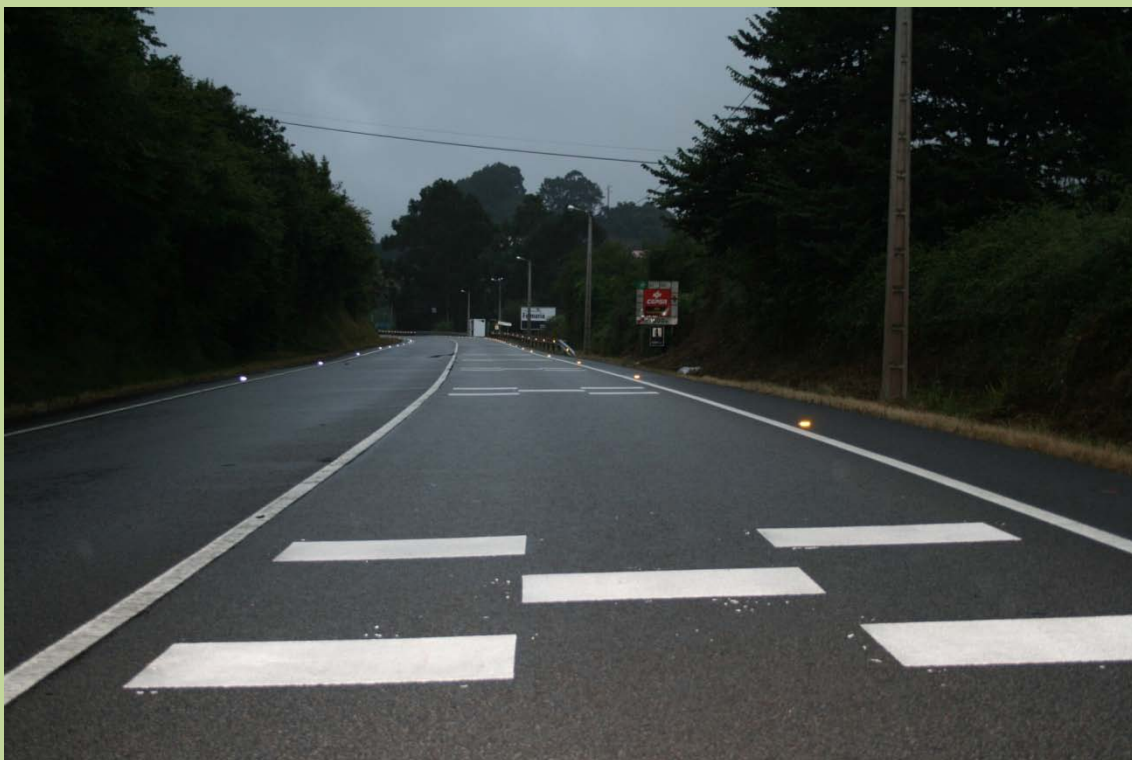
**In the part of the crossing with better visibility the same actions have been carried out, with the only exception that the delineators have not been placed in the crash barriers. It is pursued that the drivers who are driving in this way moderate the speed and drive paying more attention along this stretch, because it is quite probable to come across a vehicle that is crossing the road.**

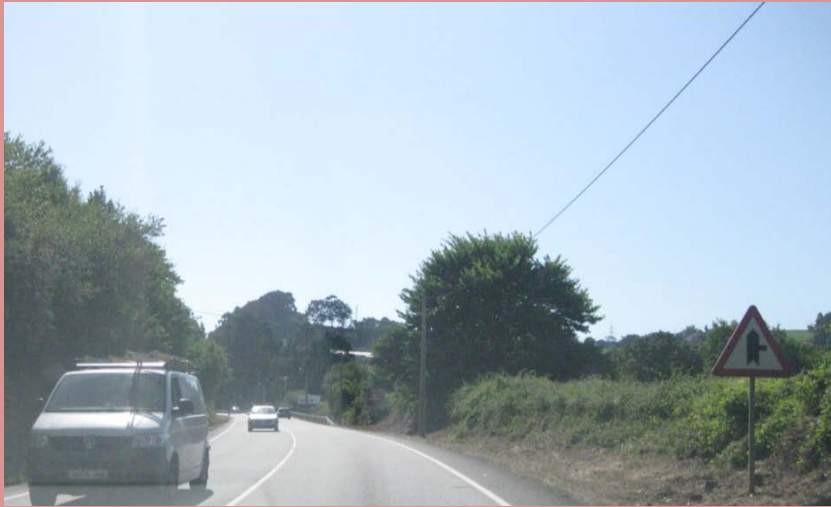
**The conventional sign of dangerous crossing could be unnoticed.**

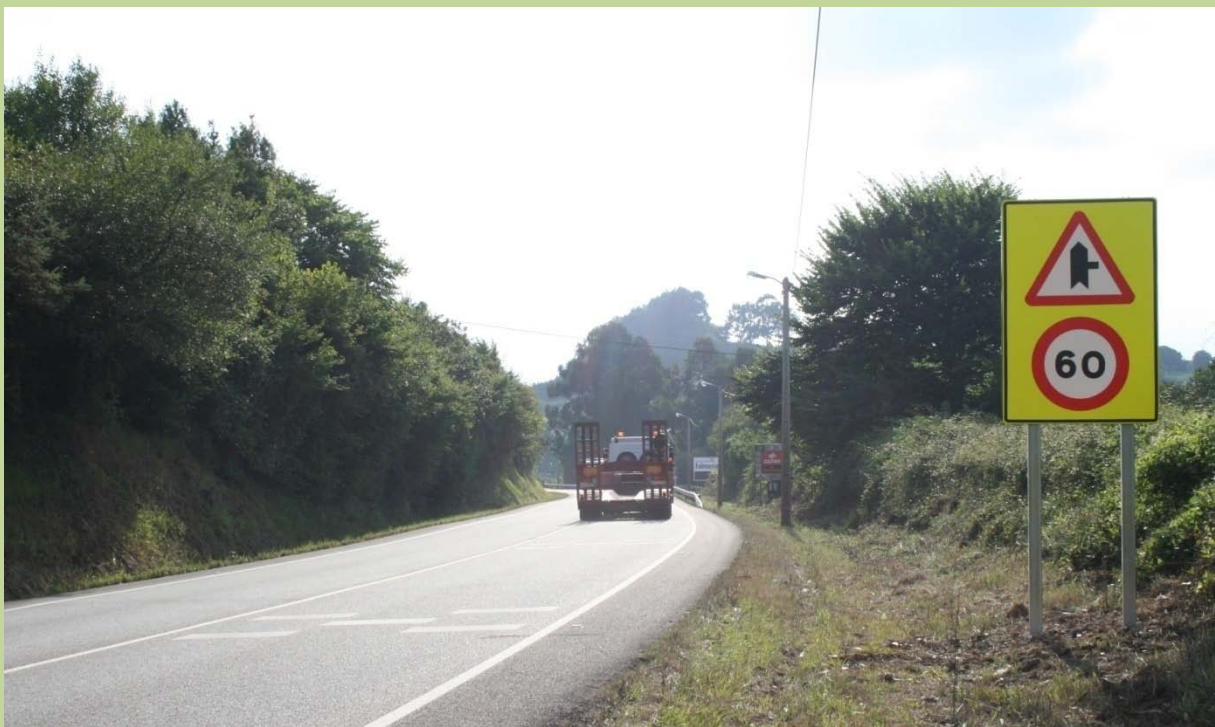
**It is proved that the high visibility panels add extra visibility when drivers are driving with the Sun in front of them. In the way from Gijón to Avilés, the panel is complemented with road markings (transversal lines) and reflective elements (reflecting road studs and reflecting barrier studs).**

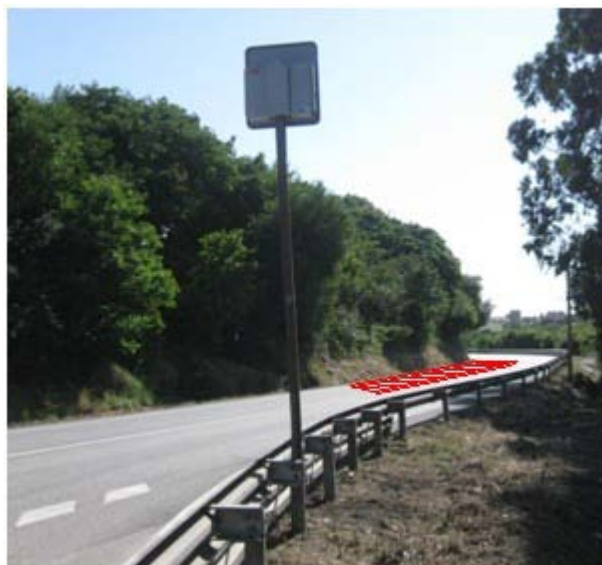
*Illustration 41: Stretch in which it is measured the average speed of the vehicles.*

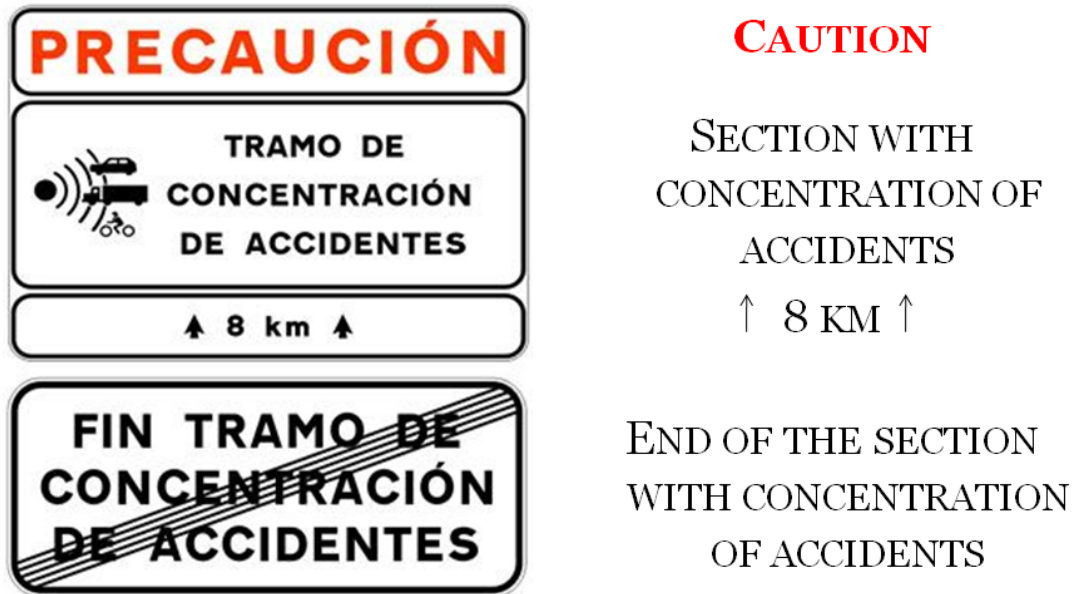
Illustration 52: Signs which are used to signpost the beginning and the end of a stretch of accident concentration.

Certain road stretches are known for having a number of accidents higher than the average. These stretches are in occasions signposted as Stretch of Accident Concentration (at least in Spain). The Illustration 52 shows an example of the typical signs used to signpost the beginning and the end of a stretch of accident concentration.

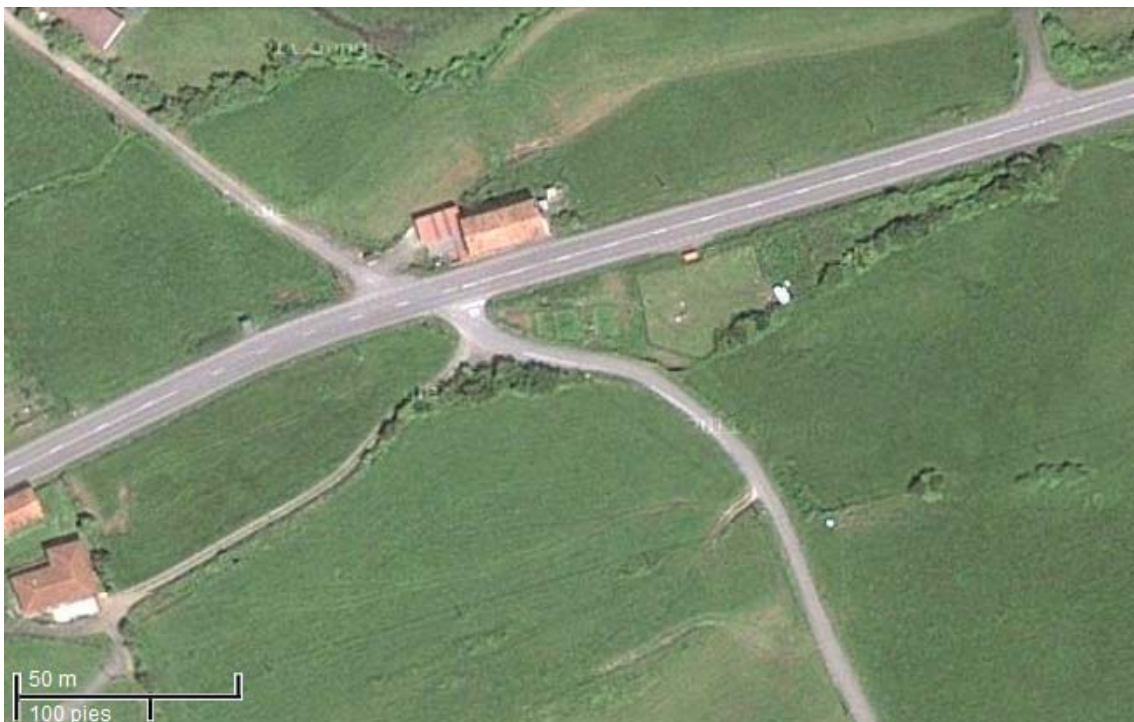
*Illustration 55: Satellite sight of the crossing located in the curve in the stretch of straights (K.P. 9.4).*

Besides, it is necessary to highlight that this point is doubly dangerous because it not only consists of a opened curve between two straights, but also **in the middle of the curve there is a crossing that gives access to several villages**. In the Illustration 55, it can be seen a satellite photography of the location of this point.

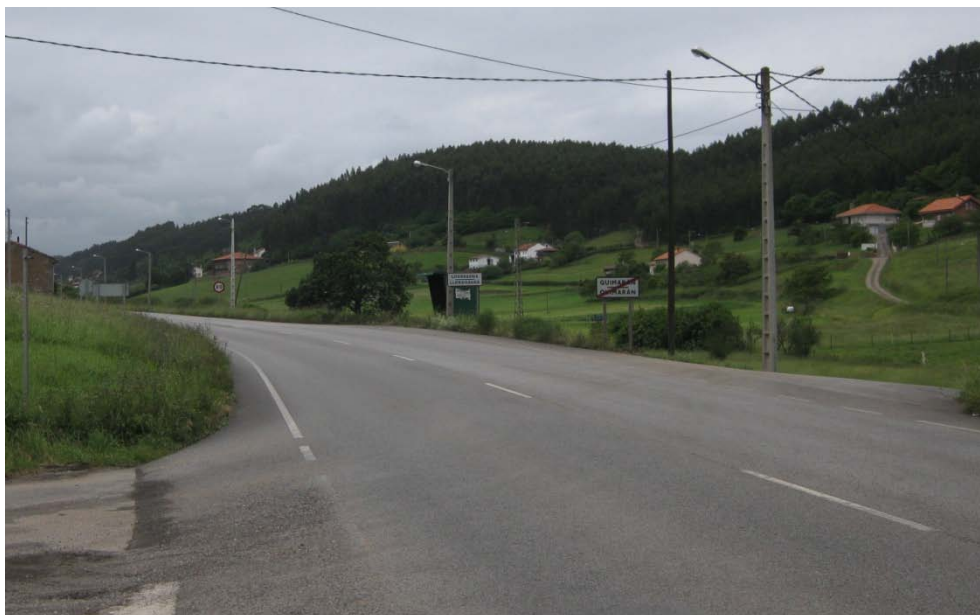
*Illustration 56: View from the crossing, on the way from Avilés, visibility is too small.*

- Drivers who join to the AS-19 Main Road from this crossing have very little visibility of the vehicles that circulate on the way from Avilés to Gijón. In the Illustration 56 it is possible to appreciate the low visibility that there is in the crossing on the way from Avilés. In this way, it is possible to have the case of which a vehicle joins to the AS-19 Main Road just in the moment in which another vehicle comes to this point with high speed. There is a considerable risk of rear-ended collision.

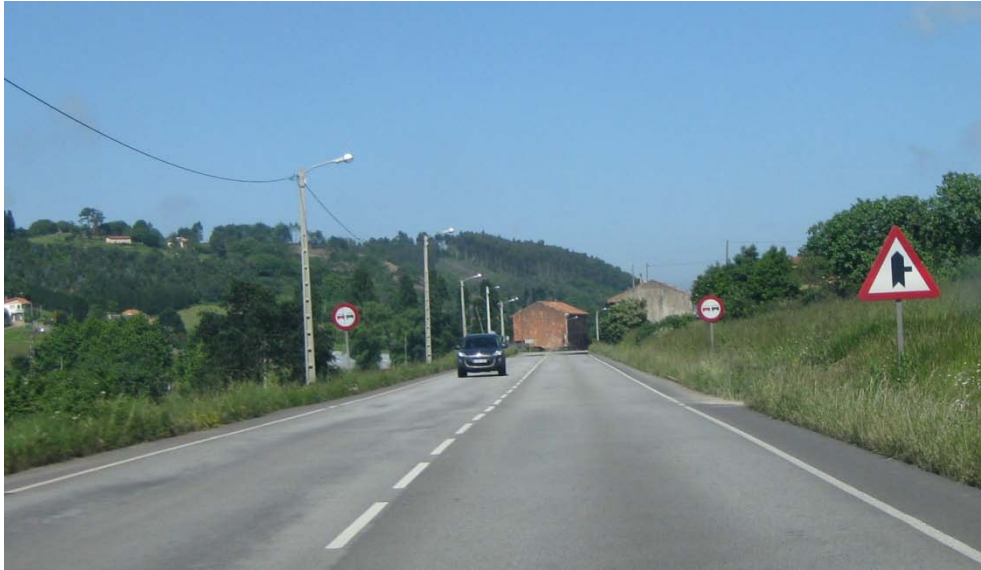
*Illustration 57: Signposting of the existence of the crossing in the curve.*

- It has been observed that there is a sign indicating the existence of a crossing in one side of the road (in the left side on the way from Gijón to Avilés and in the right one in the opposite direction), as it can be seen in the Illustration 57. In fact, just after the sign there is not only an exit for this side, but there is also another on the other side. This has as consequence that the drivers do not pay attention to the possible exit of a vehicle from both sides of the road, increasing the risk of accident.

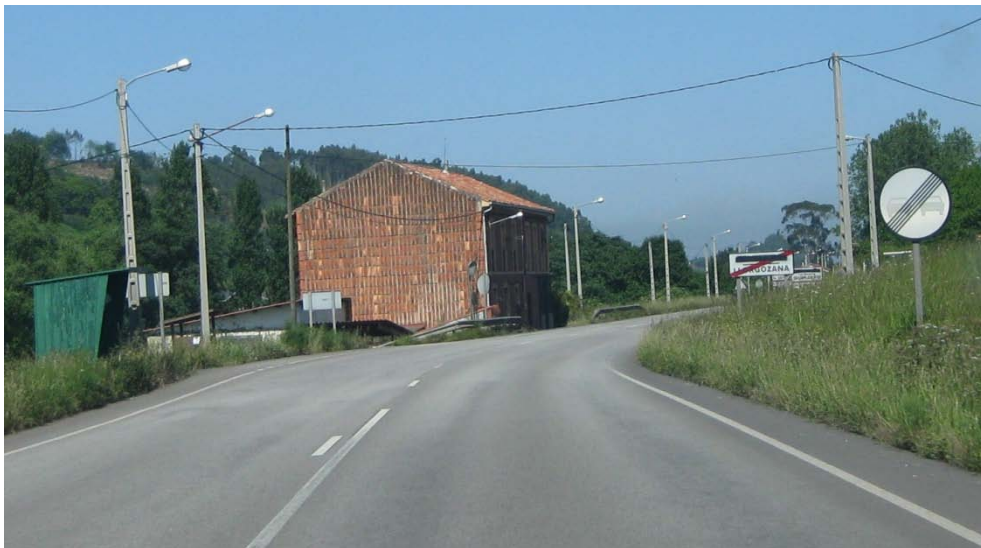
*Illustration 58: Sight of the curve on the way from Gijón. The visibility of the crossing is low.*

- On the way to Gijón, as it can be seen in the Illustration 58, there exists a sign that allows overtaking just before the curve. This does that the condition of low visibility of the crossing is more highlighted, because the vehicles that are driving from Avilés, can do it with a maximum speed of 110 km/h if they are doing an overtaking manoeuvre, allowed in this point.

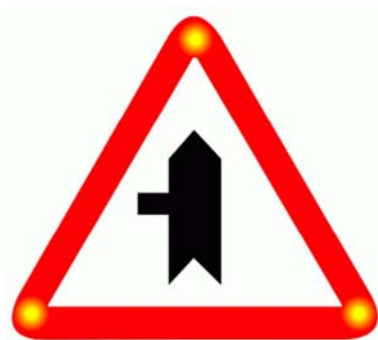
*Illustration 59: Representation of the light sign proposed to warn about a dangerous crossing.*

- The second proposal, and that was complementary to the previous one, was consisted of **lighting the signs** that announce a dangerous crossing. This sign would have the double objective of warning the drivers and explaining why they should moderate the speed and why they should drive with more attention at this point. The Illustration 59 shows an example of the light signs. It is to highlight that in this stretch of the road there is street lighting, from which it might be possible to take the electrical supply.

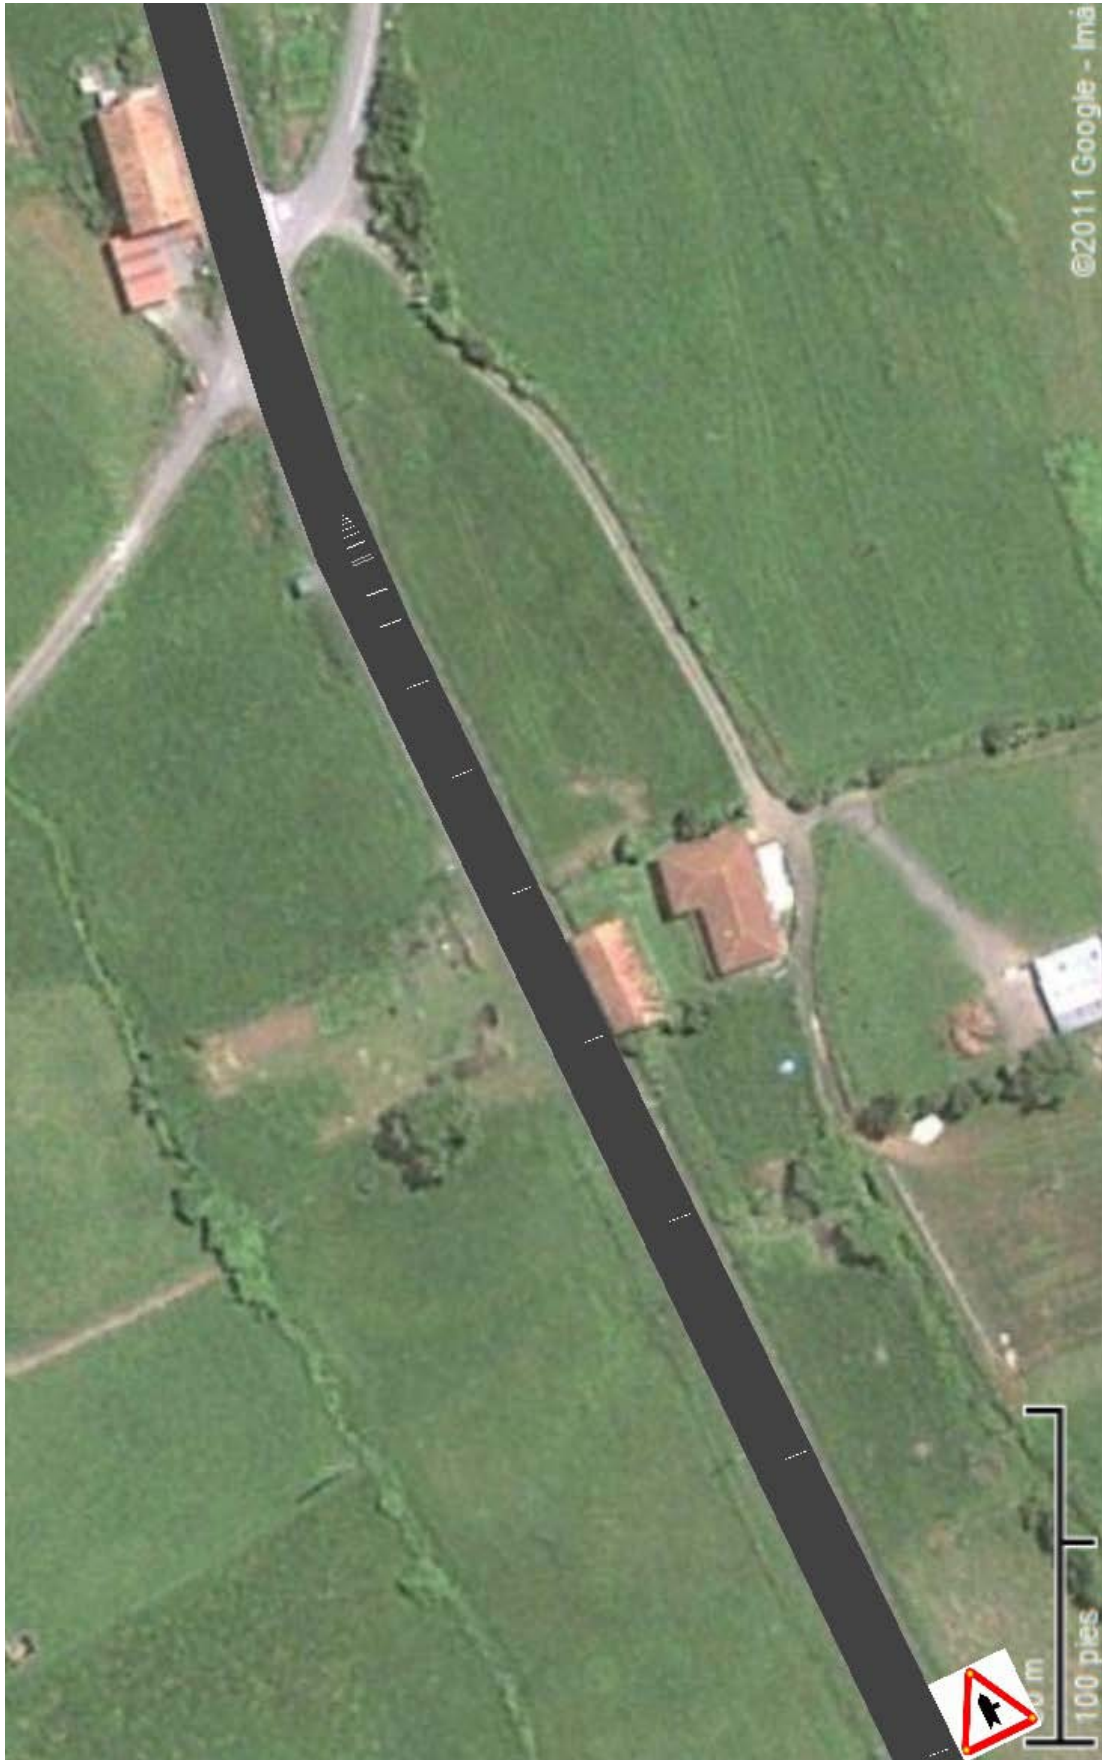
Illustration 60: Virtual picture of how the stretch of the crossing would be with the transversal white lines.

- The first proposal was to paint **transversal white lines** in the road. The lines would have the same function as the transversal warning lines. There would be painted white road markings in the right lane in each way of the road. The function of these white lines would be warning the drivers that they are coming to a dangerous crossing in which it is necessary to reduce the speed to guarantee the safety in the road. The Illustration 60 shows a virtual picture of how the road would be, and the Illustration 61, shows a sketch of the lines that were proposed to paint.

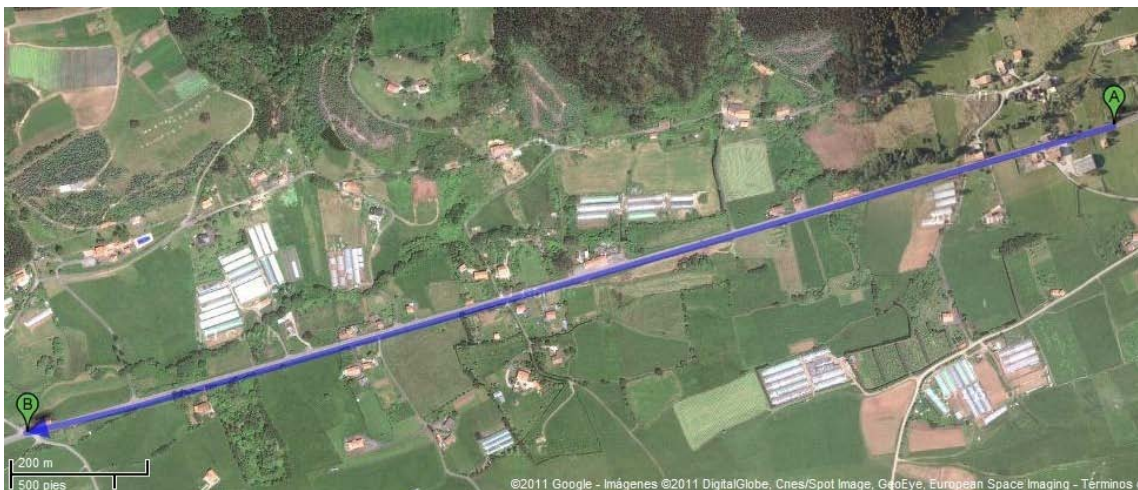
*Illustration 62: Satellite sight of the first straight (K.P. 7.7 to K.P. 9.4).*

- The first straight is located between the kilometre points 7.7 and 9.4. It has a length of 1700 m.

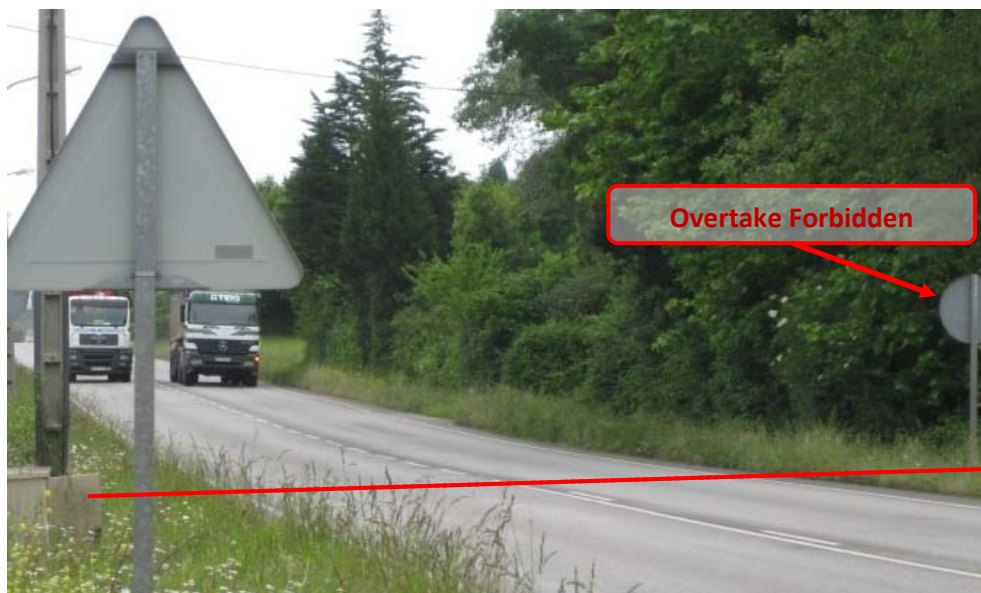
Illustration 68: Truck overtaking another one (1<sup>st</sup> straight).

All these factors joined to the fact that the road is used especially by people who is working or going and coming from the place of work (habitual drivers), do that hurries and confidence appear. Every day it takes place many manoeuvres that put in danger the safety of the drivers. To understand clearly which these types of situations are, there is an example in the Illustration 68, in which we can see a truck overtaking another one. Although it cannot be seen in the photography, it is possible to image what happened a few seconds after taking the photo: the green truck finished the overtaking in an area where it was not allowed to overtake because of a brow of a hill.

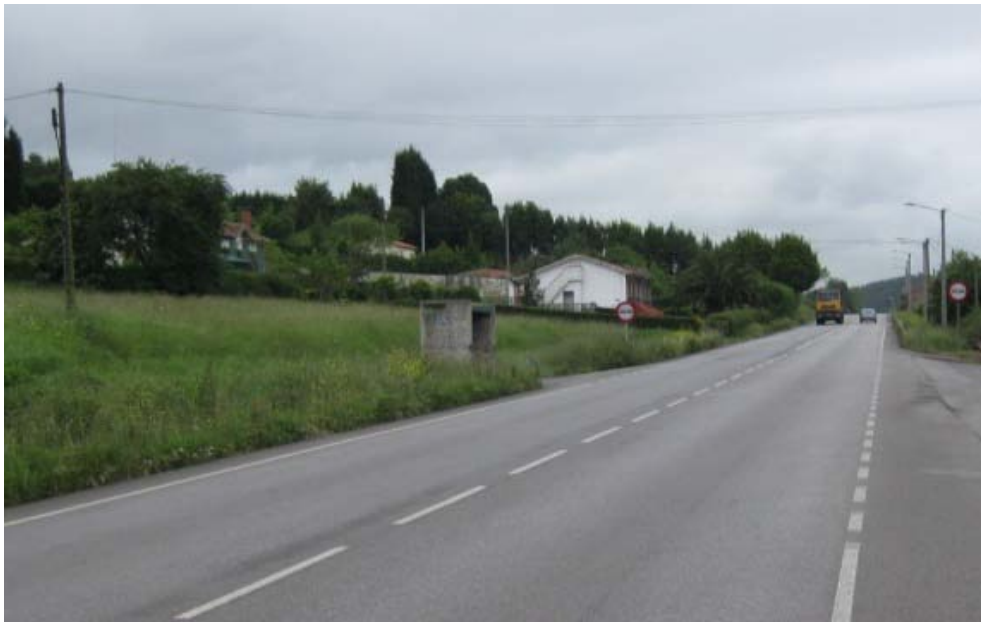
*Illustration 69: Overtake forbidden due to a brow of a hill (1<sup>st</sup> straight).*

There is the possibility that the drivers do not see with sufficient anticipation the sign of “overtake forbidden”, and believe that they have full visibility to do the manoeuvre due to the mentioned optical effect that takes place for the successive brow of hills.

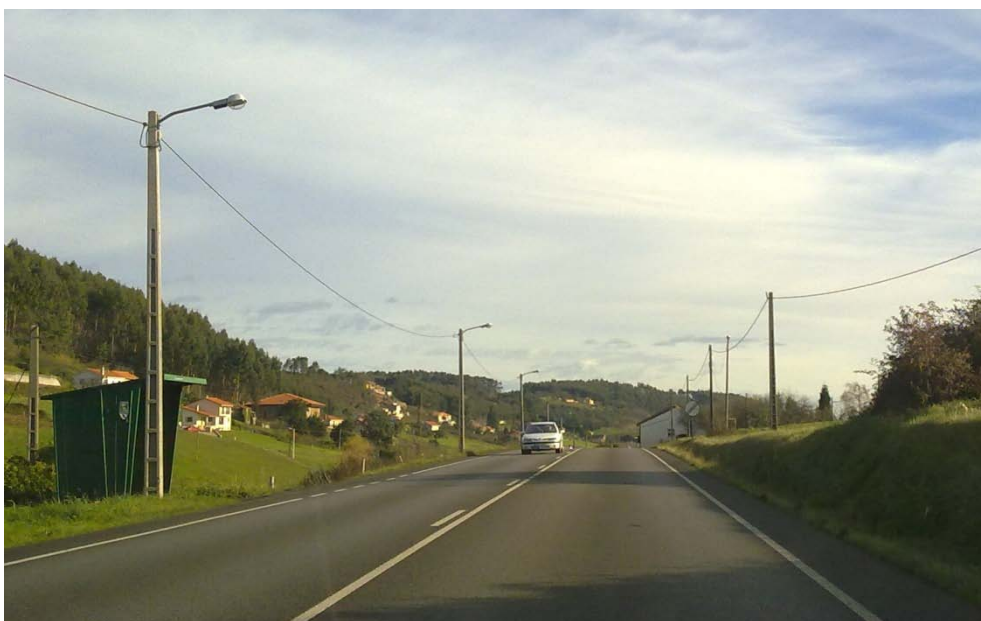
*Illustration 70: Another brow of a hill with a bus stop (3<sup>d</sup> straight).*

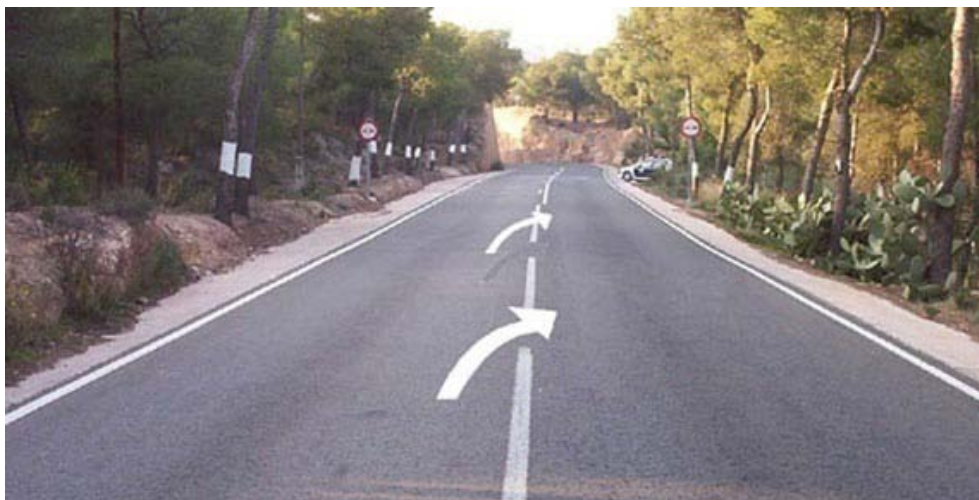
*Illustration 72: Example of the application of the return arrows in a road.*

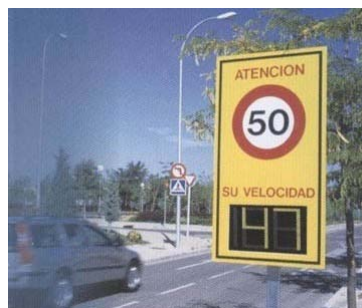
Illustration 75: Example of a driver feedback sign and indication of the speed limit.

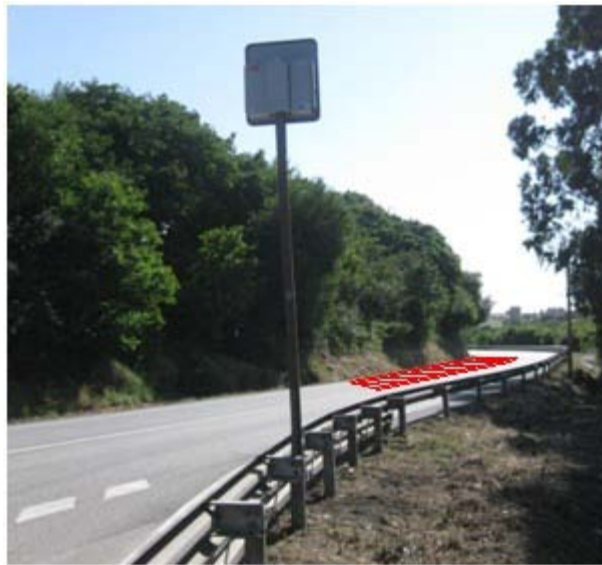
In this annex it is carried out a statistical study of the evolution of the speed as a result of the campaign. The measures have been taken using a radar station that calculates the speed of the vehicles that are driving towards the crossing in the way from Avilés to Gijón. This radar station measures the average speed of a stretch of approximately 50 meters, placed between the exit of the curve and the bus stop. The Illustration 76 shows where the radar station was located.

*Illustration 76: Stretch in which the measures of the average speed of the vehicles are taken.*
