STARS Project Report

Intra-Urban Speed Impact Study of a
Two-Way System for Speed Reduction

Munich, July 2011

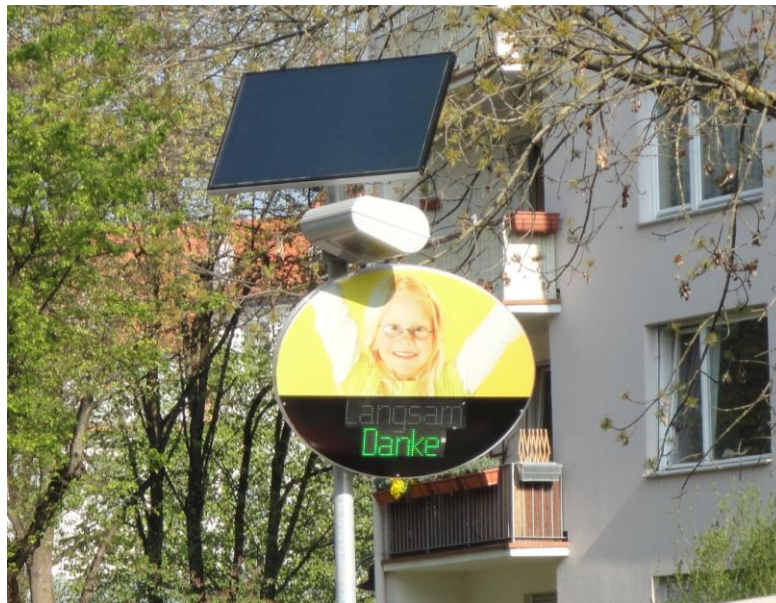
Figure 1 Example of a Dialog-Display Used for the Study

In this report, an impact on speed reduction due to the use of Dialog-Displays is assessed. Dialog-Displays have previously showed its effectiveness on speed reduction (Dittrich, Maier, 2009). The display consists of a shield with two areas: upper area where a motivating picture is printed and a bottom area where a two-line LED display is placed. In case a driver obeys the speed limit, a message “Danke” (Thank you) appears in green letters. Otherwise, it displays “Langsam” (Slow down) in red color (See Figure 1). Additionally, the display has embedded speed radar and data storing unit connected by means of GPRS to the server for downloading and transmission data. This data was used for the analysis of the vehicle speeds.

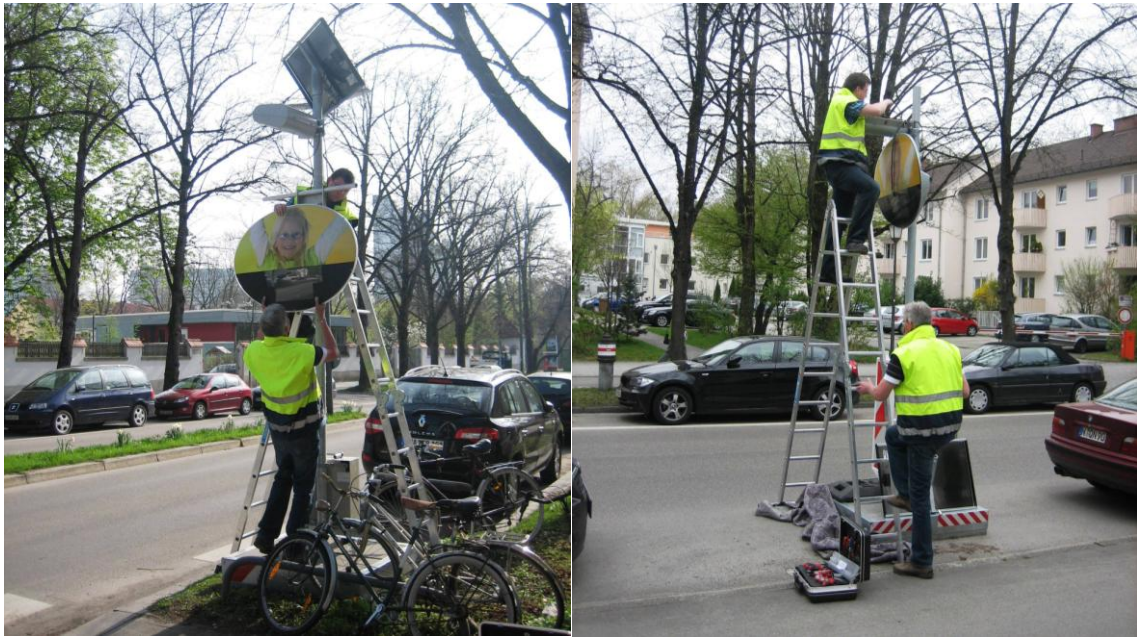
Figure 7 Installation of Dialog-Displays on Denningerstraße in Munich (Left direction Richard-Strauß-Straße; Spot 3; Right: direction: Herkomerplatz, Spot 1)

After the first week of speed measurements of the situation before installation of the devices, the speed reduction system was installed in both directions: Herkomerplatz and Richard-Strauß-Straße (Spot 1 and 3 according to the plan represented on Figure 5). The installation process of the Dialog-Display is represented of Figure 7 below. Figure 8 and Figure 9 represent the installed Speed reduction system as well as the detector system for the assessment of the previous situation. Figure 10 represents three speed detectors used for an assessment of the speed situation behind the speed reduction system in both directions.

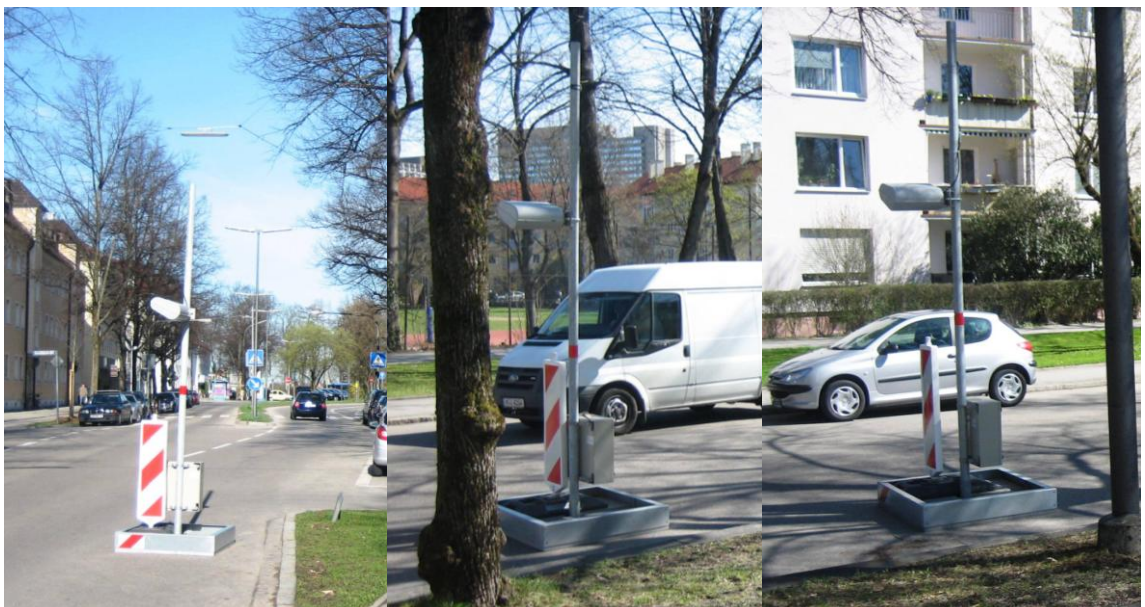
Figure 10 Speed Measurement Detectors. Spot 2 (left), Spot 4 (middle), Spot 5 (right)

The speed measurement as well as count and classification of the vehicles in both directions were made using TOPO.plus detectors from RTB Broer Company. The detectors used measure vehicle speed, length, number of axles and acoustic characteristics of the vehicles (RTB, 2008). TOPO.plus detectors are certified to be used on German road, fulfil BAST⁴ requirements and follow TLS 2002⁵ German technical instructions. In accordance with the aforesaid norm, the vehicles are classified into 8+1 classes. A further description of the vehicle classes is represented in Appendix 2.

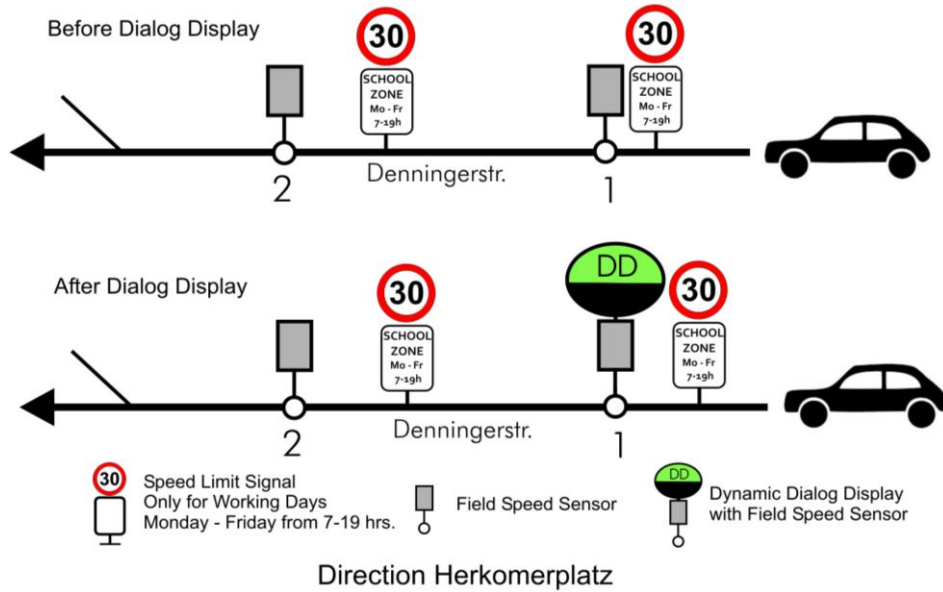
Figure 12 General Layout of Speed Detectors, Disposition and Dialog-Display Installation. Direction Herkomerplatz

In Figure 12 the average speed profile is depicted along the observation period. The graph was divided in two segments; the first corresponds to the Spot 1 and the second to the Spot 2. It is noticed how the speed profile has changed along the time and the distance travelled, until partially falls down before reaching the Spot 2. This drastic speed reduction is caused mainly because motorists have to slow down before approaching the zebra crossing; besides, the school sign affected as well their driving behaviour. This was located close to the place where the Spot 2 was installed.

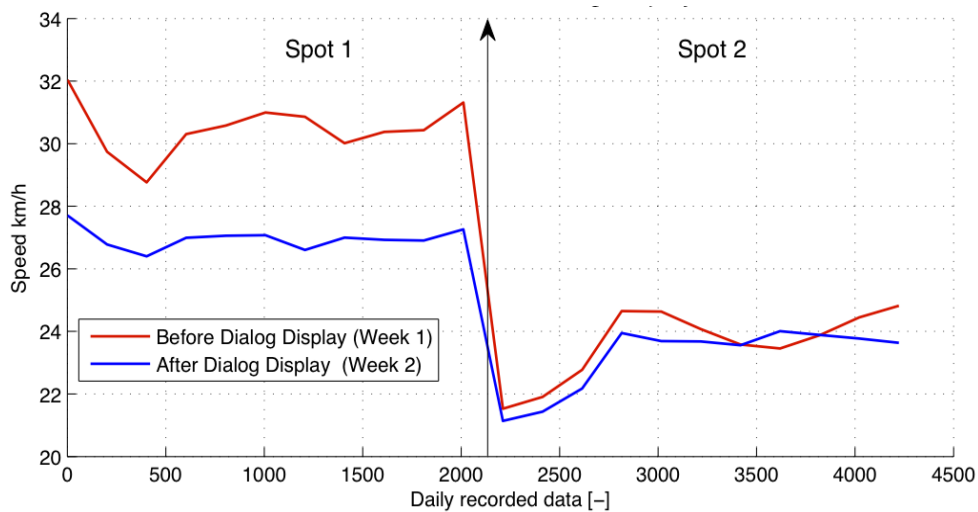
Figure 13 Average Speed Before and After the Dialog-Display Installation for Spots 1 & 2

The red line on Figure 13 depicts the average speed profile analysed based on the sample of the Week 1, while the blue line depicts the average speed profile after the installation of the Dialog-Display, correspondent to the dataset analysed for the sample of the Week 2. It can be seen that the average speed while cars were passing through the Spot 1 was 29 km/h, before the Dialog-Display; after installation the average speed was 25 km/h. Likewise, before the installation, the average speed for Spot 2 was 23 km/h, whereas after the installation, the average speed was 21 km/h.

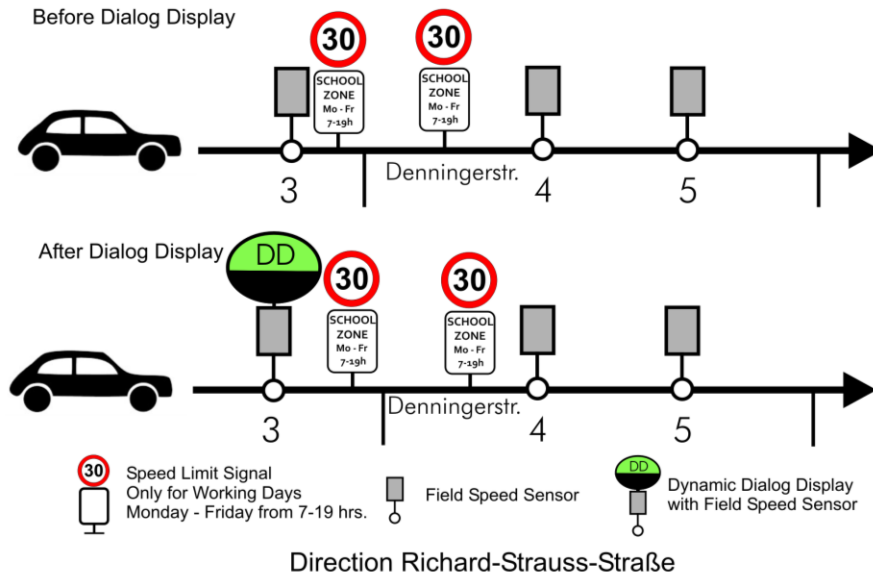
Figure 14 General Layout of Speed Detectors Disposition and Dialog-Display Installation. Direction Richard-Strauss-Straße

Figure 14 shows the arrangement of the opposite direction towards Richard-Strauss-Straße. The placement of the speed detectors is shown as well as the posted speed limit. The Dialog-Display placement is also illustrated along the study section.

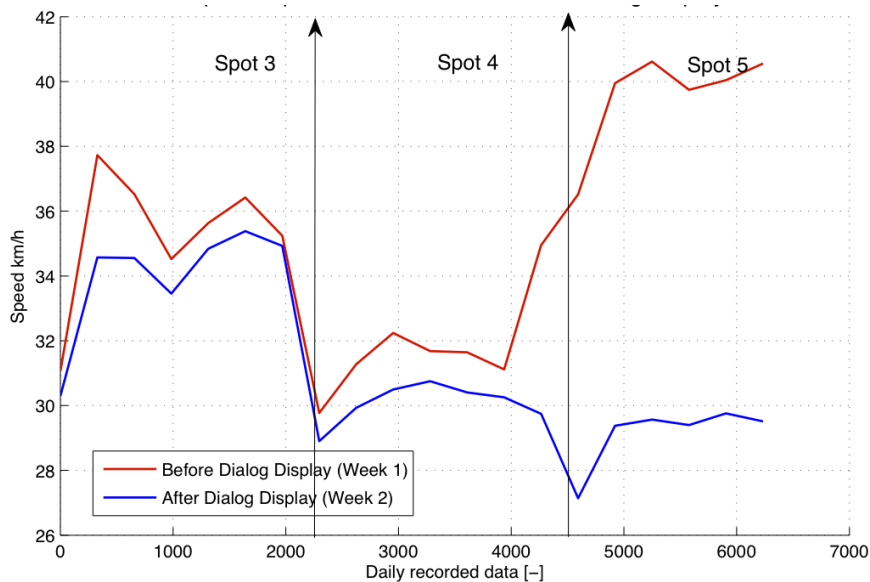
Figure 15 Average Speed Before and After Dialog-Display Installation for Spots 3, 4, & 5

Figure 15 presents the analysis based on the data obtained from the speed detectors. Here the red line represents the average speed profile before the Dialog-Display, showing how the average speed behaved along the section. It is remarkable how just after leaving the Spot 3 (which is located very close to the pedestrian crossing) the motorists began to speed up, regardless the posted speed limit of 30 km/h. After passing through the Spot 4 and reaching the number 5, the speed profile increases constantly and exceeds the speed limit. After the installation of the Display, the reduction of the speed is notorious, as seen in the blue line, which is depicted in the plot. The motorists after leaving the

study area around Spot 5 reduced their average speed significantly in comparison with the situation before the Dialog-Display. The average speed before the Display along the study section was about 36 km/h, while after the installation the average speed calculated was 31 km/h.

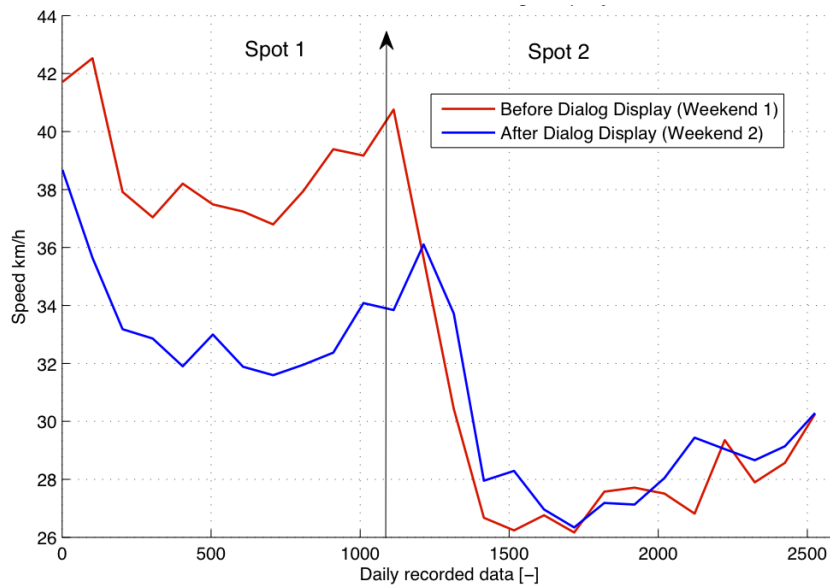
Figure 17 Average Speed Before and After Dialog-Display Installation for Spot 1 & 2 during Weekends

The red line depicts the average speed profile before the installation of the Display, whereas the blue depicts the average speed after the installation. The average speed before the Display was 41km/h for Spot 1, after the installation, the average speed calculated was 35 km/h at the same Spot. Similarly, for the Spot 2, the average speed before was 32 km/h while, after the Dialog-Display this was 30 km/h.

It is interesting to notice, how the speed profile behaves more or less the same during the working days as during the weekends. Ultimately, it is also clear how the speed dropped after the installation of the device (See blue line), especially along the section where the Spot 1 was installed. It is again remarkable how the Dialog-Display had clear influence on the driving behaviour of the motorists, by reducing their mean speed along the study area.

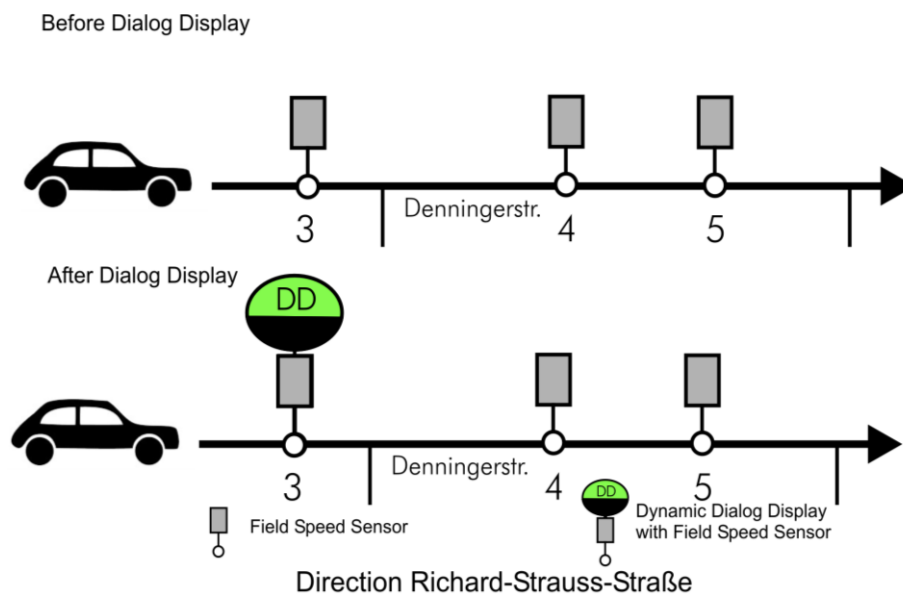
Figure 18 General Layout of Speed Detectors Placement and Dialog-Display Installation. Direction Richard-Strauss-Straße (50 km/h Speed limit - Weekends)

Figure 18 depicts the general layout of the installation devices on the opposite direction towards Richard-Strauss-Straße. Again the speed detectors and the Dialog-Display are shown. Figure 19 presents the average speed profiles along the study area and it is divided in three main segments, where the first segment represents the average speed computed based on the data gathered of the speed detector 3, the next segment represents the average speed obtained from speed detector number 4, and the last segment of the plot represents the average speed computed based on the data of the speed sensor 5. The red lines depict the average speed profile before the implementation of the Dialog-Display, while the blue line depicts the average speed profile after the implementation of the device. The characteristics of both lines are quite similar; however, the effect of the Display is notorious. The average speed before the device reaches about 40 km/h, while after the installation, it reached as much as 39 km/h.

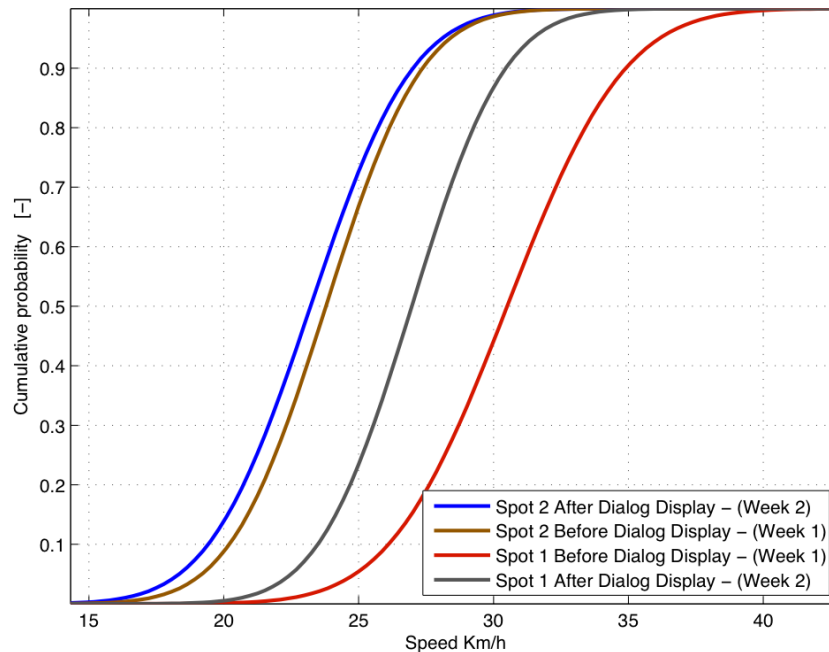
Figure 20 Cumulative Probability of Driving Speed for Spots 1 & 2

Figure 20 depicts the cumulative density of the average speed at the Spot 1 and 2 (entering and leaving the study section), before and after the Dialog-Display installation. It is noticed how the curves shifted to the left after the device installation. This means, for example at the Spot 1, that there was a significant increment of at least 40% (48 - 88% See figure below) of drivers that approached the study section with the appropriate speed limit (30 km/h); however, at the spot 2 the percentage of reduction was minimum due to the fact that the drivers were approaching the School Zone and the pedestrian crossing was just few meters away (See Figure 6). The comparison was done taking as a parameter the posted speed limit of 30km/h. For more statistical analysis concerning cumulative probabilities along the study area, see Appendix 4.

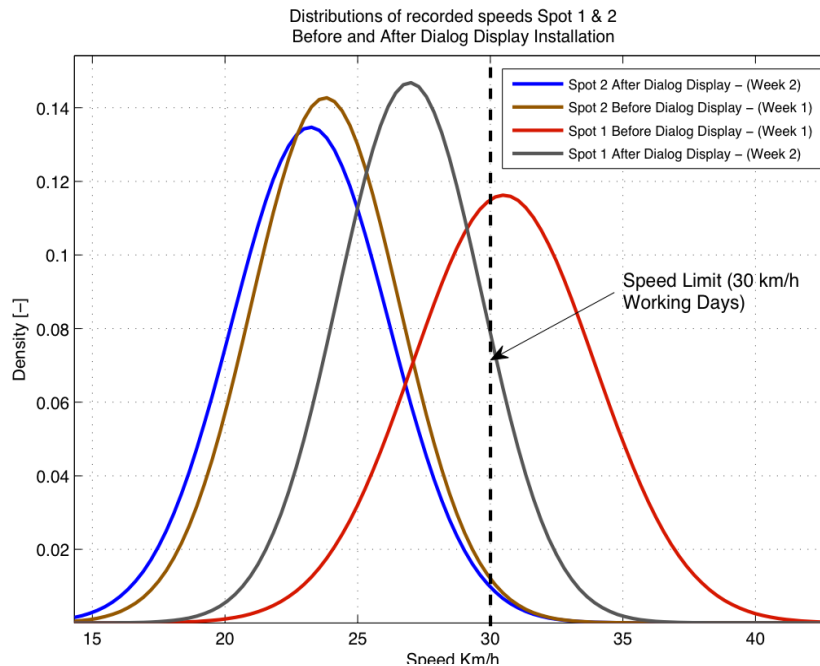
Figure 21 Speed Distribution for Spots 1 & 2 Before and After Dialog-Display

The selected dataset was evaluated, and the data which did not match with the propose of the analysis was excluded. (Data, which was not properly gathered by the speed detectors, was eliminated from the sample). Later on, the data from the Weeks 1 and 2 were plotted, as distributions. Here was noticed that the dataset behaved as normally distributed as it is shown in Figure 21. Before the installation of the device, the recorded data was more towards to the right; meaning that more drivers of drivers exceeded the posted speed limit. After the installation, the amount of observations moved towards to the left. It is notorious again, how a significant amount of drivers has reduced their mean speed after the Dialog-Display as it is shown in Figure 21.

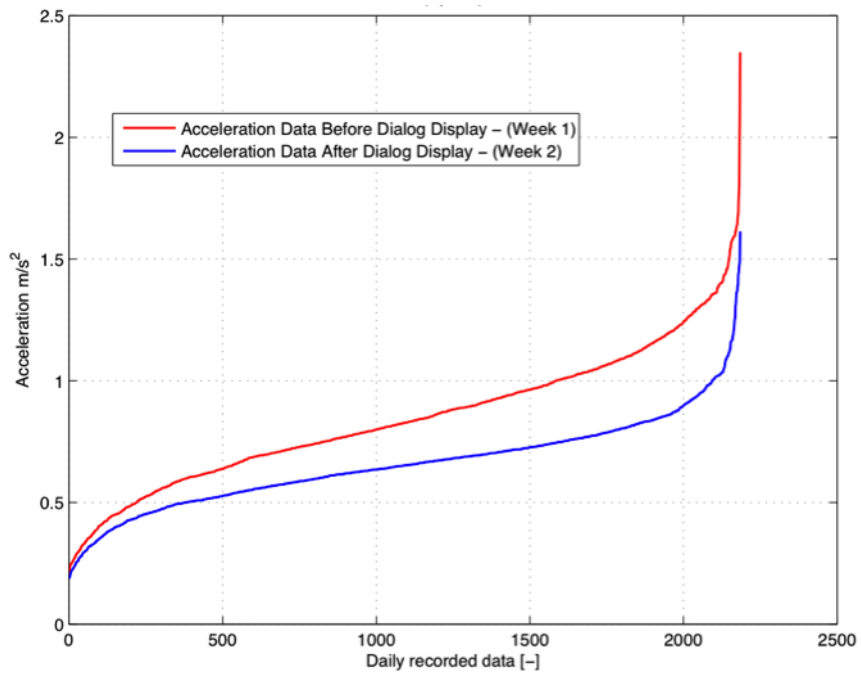
Figure 22 Acceleration data Before and After Dialog-Display

Ultimately, one more method to evaluate if the installation of Dialog-Display worth the efforts was evaluation of mean accelerations of the motorists. In this case, the acceleration was calculated based on the speed already measured by the speed detectors during Working days. This speed was treated as a *Final Velocity (FV km/h)*, and the *Initial Velocity (IV km/h)* was taken as a zero. The time (t sec.) was later on calculated between the two parameters, based on the distance, which was measured from the installation of the speed detector (Spot 1) till the other extreme of the street (312 m approx.), towards Richard-Straus-Straße, exactly where the cars have to stop because of the presence of a traffic light ($IV = 0$).

After being defined the methodology, the mean acceleration was computed before and after the installation of the device. Figure 22 plots this final results, the red line represent the acceleration before the measure; Notice how the acceleration was higher as compared with the acceleration after (blue line). It can be seen as well, how drivers reduced their acceleration before approaching the Dialog-Display, indicating once again the effectiveness of the device.

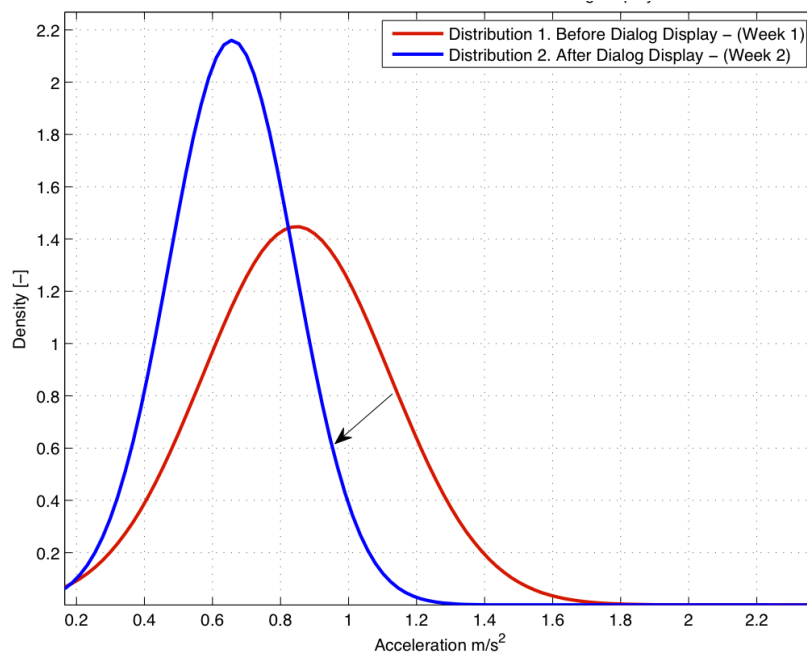
Figure 23 Acceleration Distribution Before and After Dialog-Display for Spot 1 during - Working Days

Figure 23 is regarding the acceleration of drivers, illustrates the normal distribution of the acceleration before and after the device installation. While for instance in the first Week most of the acceleration values fell between the range of 0.6 – 1.2 m/s^2 . After the installation the range was between 0.4 m/s^2 and 1.0 m/s^2 , meaning that less drivers were tempted to accelerate, and in consequence to speed up.
